BELVIDERE AVENUE IN WEST BERGEN NEIGHBORHOOD OF SURVEY AREA (WARD) B4 bel

NJHSI: 1985

NEW JERSEY OFFICE OF CULTURAL AND ENVIRONMENTAL SERVICES  
HISTORIC PRESERVATION SECTION  
DISTRICT/STREETSCAPE CONTINUATION SHEET

N.J. HISTORIC SITES INVENTORY

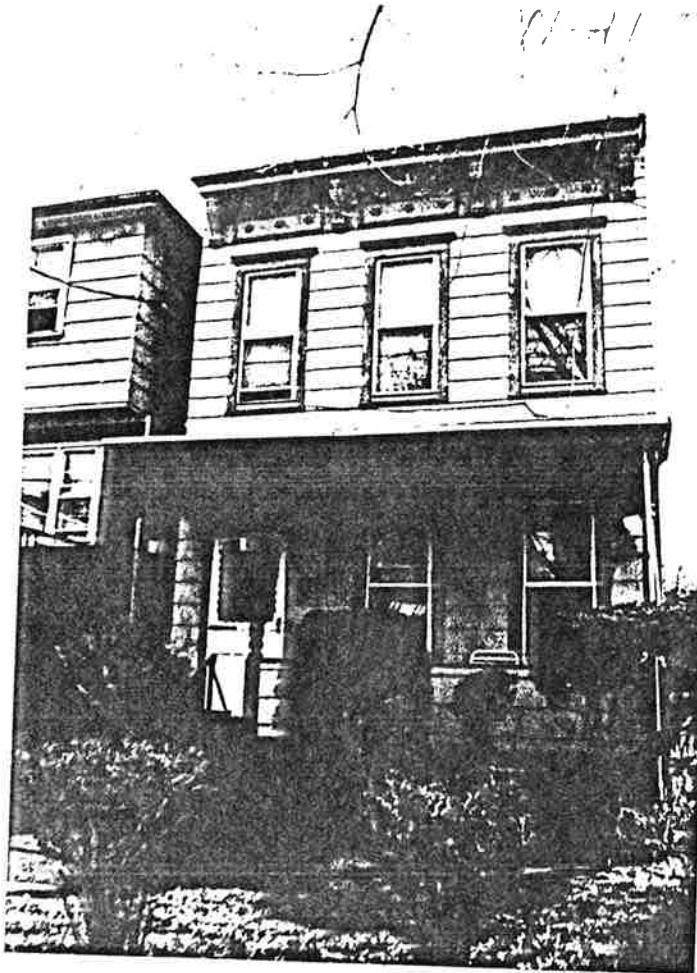
Map No. 1

| MAP # | ADDRESS/LOCATION : PROPERTY NAME | DATE | Sign to<br>C/S<br>D/S | Condition | USE | DESCRIPTION: Style, Ext. Wall Fabric, Fenestration, Form, Roof,<br>Major Features, Alterations, Stories, etc. | NEGATIVE<br>FILE # |
|---|---|---|---|---|---|---|---|
| 1 | 10 Belvidere Avenue<br>Block 1741 | late<br>19th<br>cent. | P<br>theme | G R <sup>1</sup> | Italianate, 2 story frame, 3 bay, detached residence, with full front porch with flat roof, supported by 3 turned posts. Principal cornice has 4 large brackets with smaller consoles, and raised panels in the fascia. Porch features scroll brackets in the fascia, and raised panels as well; 1 over 1 windows have full wood enframe-ments and drip moldings above the lintels. Exterior clad in asbestos shingles, which also were used to enclose the porch railing. Set back from street by a relatively deep front yard. | Contact<br>227/19 | |

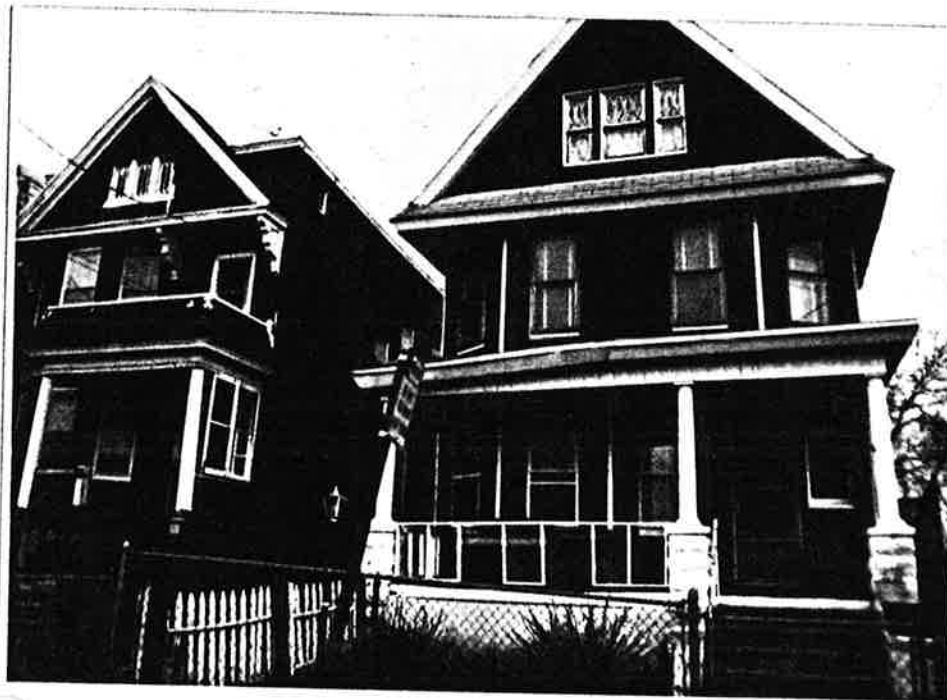
Map No. 1

| MAP # | ADDRESS/LOCATION : PROPERTY NAME | DATE | Significance | Condition | USE | DESCRIPTION: Style, Ext. Wall Fabric, Fenestration, Form, Roof, Major Features, Alterations, Stories, etc. | NEGATIVE FILE # |
|---|---|---|---|---|---|---|---|
| 1 | 59 Boyd Avenue<br>(between J.F. Kennedy Mem.<br>Blvd. and West Side Ave.)<br>Block 1793 | <i>early<br/>20th<br/>cent</i> | P<br>theme | F | 1<br>R | Queen Anne, 2 1/2 stories with high basement, detached wood frame residence, 2 bays wide. The exterior is clad in asbestos shingles resembling shakes. Side entry is set atop a wooden stairway in the northernmost bay. The balcony of the second story projects over the entry bay, and is supported by two wood columns. The attic story features a projecting gable with a central, tripartite window. The gable is supported by three large wood brackets, with incised ornamentation. The windows of the second and first floors are 1 over 1, aluminum. | Contact<br>224/4 |
| | 63 Boyd Avenue<br>Block 1793 | <i>early<br/>20th<br/>cent</i> | P<br>theme | F | 1<br>R | Queen Anne, 2 1/2 stories with high basement, detached wood frame residence, 4 bays wide. The exterior is sheathed in aluminum siding. The entry is set in the northernmost bay, atop a stone stoop. The home has a front porch spanning its width, and is roofed. The porch roof is supported by 3 unevenly-placed wood columns, set upon rock-faced stone plinths. The attic story has a grouping of three double-hung windows, each with a pattern of intertwined arcs in the upper sash. Between the attic story and the second story is a sloping roofed overhang. The windows of the first and second floor are aluminum, double-hung. Other alterations include a replacement porch railing, cement infill beneath the front porch, and aluminum flashing applied at the edges of roofed and sided areas. | Contact<br>224/4 |

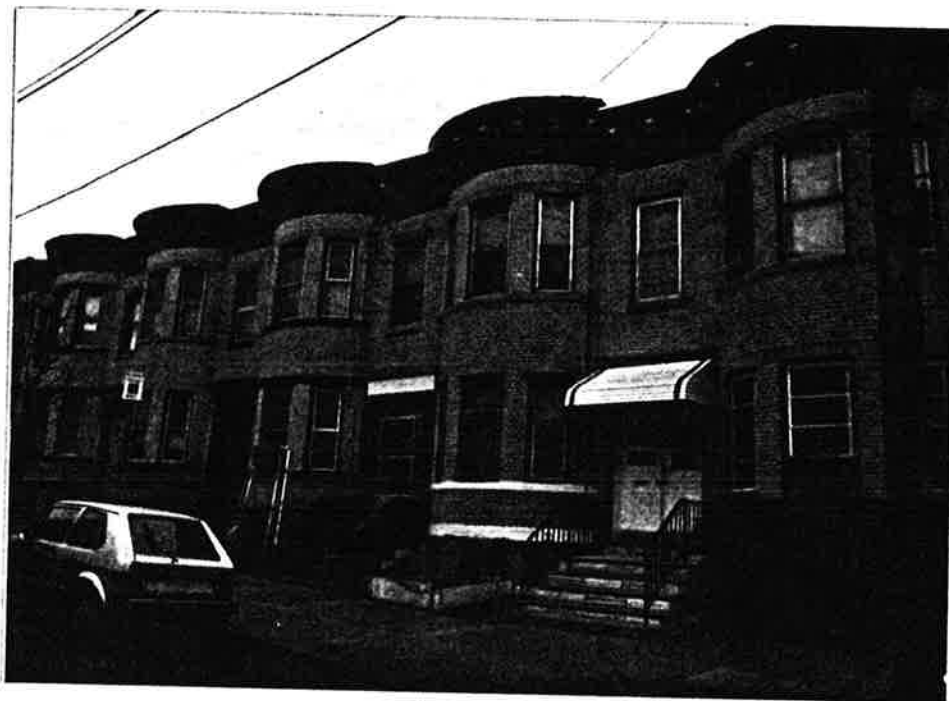
Map No. 2

| MAP # | ADDRESS/LOCATION : PROPERTY NAME | DATE | Significance to D/S | Condition | USE | DESCRIPTION: Style, Ext. Wall Fabric, Fenestration, Form, Roof, Major Features, Alterations, Stories, etc. | NEGATIVE FILE # |
|---|---|---|---|---|---|---|---|
| 2 | 77-79 Clendenny Avenue<br>Block 1797 | 19th cent | P theme | G R <sup>1</sup> | | 2 story, frame, Carpenter Gothic double-house with full front porch, and 6 bays; with a peaked attic story over central 4 bays and paired, arch-headed attic window in central location; bracketed cornice and porch entablature; 2 over 2 windows on first and second stories; original entry survives on northern half of home, but was replaced to the south; alterations include vinyl or asbestos shingles, replacement porch posts and porch enclosure, and iron porch and hand railings. | Contact 221/34 |

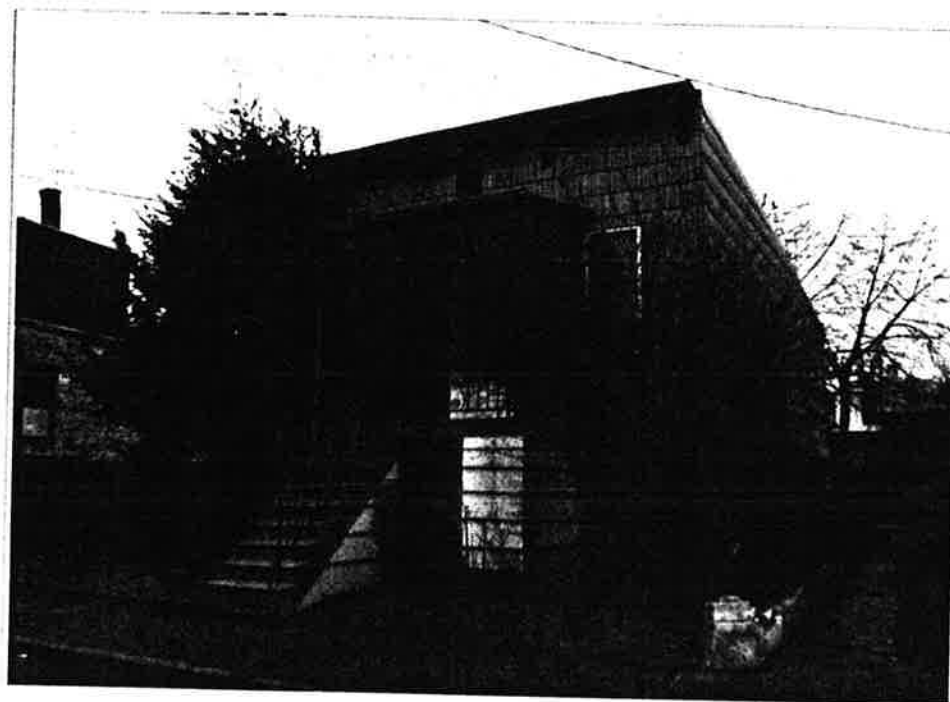
Map No. 4

| MAP # | ADDRESS/LOCATION : PROPERTY NAME | DATE | Significance | Condition | USE | DESCRIPTION: Style, Ext. Wall Fabric, Fenestration, Form, Roof, Major Features, Alterations, Stories, etc. | NEGATIVE FILE # |
|---|---|---|---|---|---|---|---|
| 4 | 181-183 Clendenny Avenue<br>Block 1757 | 1840-<br>1873 | P<br>theme | F | R | A pair of wood-frame, Eastlake-styled attached homes, 3 bays wide. Both are clad in asbestos shingles and have aluminum 1 over 1 windows, side entries set atop 7 steps, and have peaked main roof and porches running the length of the grouping. # 183 retains its 4, slender porch posts, which are square in section; its contoured (porch) rail with square spindles, and angular column capitals; #181 has porch railings in replacement ironwork, iron porch posts, and sided-over column capitals (assuming they lie beneath the horizontal siding). The homes each have but one window centered over the middle bay of the second floor, and share a chimney which rises from the party wall. | Contact<br>221/19 |

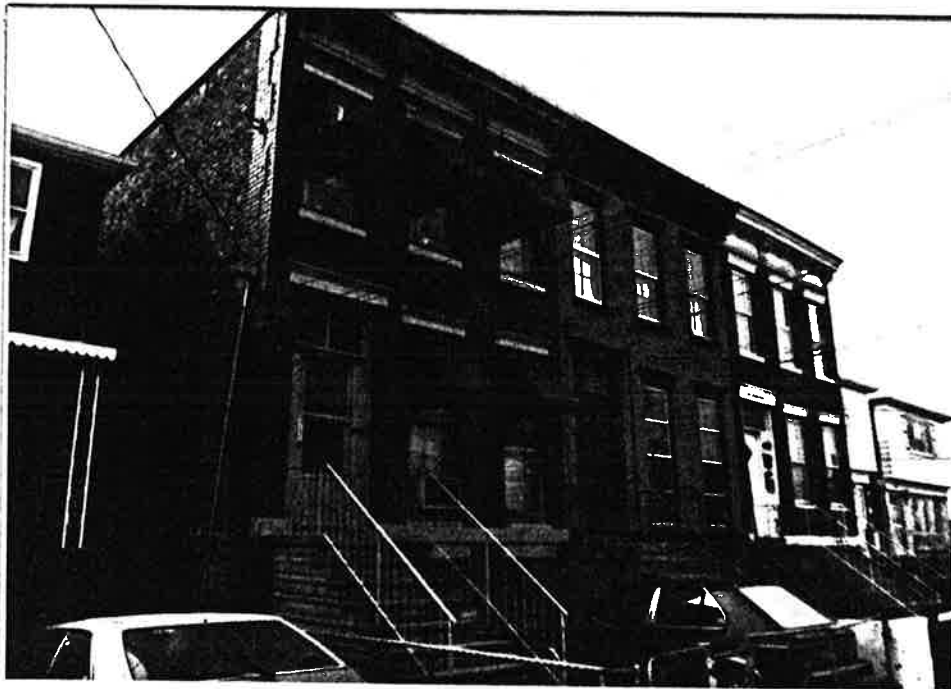
Map No. 3

| MAP # | ADDRESS/LOCATION : PROPERTY NAME | DATE | Significance | Condition | USE | DESCRIPTION: Style, Ext. Wall Fabric, Fenestration, Form, Roof, Major Features, Alterations, Stories, etc. | NEGATIVE FILE # |
|---|---|---|---|---|---|---|---|
| 3 | 217-221 Culver Avenue<br>Block 1295 | <i>c 1880</i> | P<br>G<br>theme | <sup>1</sup><br>R | | A grouping of 3 identical, 3-bay-wide transitional Greek Revival/Italianate brick and brownstone rowhouses, 2 1/2 stories high, with wood, bracketed cornices, high basements and stoops; #219 retains its wood, 4-over-4 windows, original entry door and enframingent, and parlor floor windows. Alterations include resurfaced stoops, replacement stoop and areaway railings, and aluminum, 1 over 1 windows. | Contact<br>227/24 |

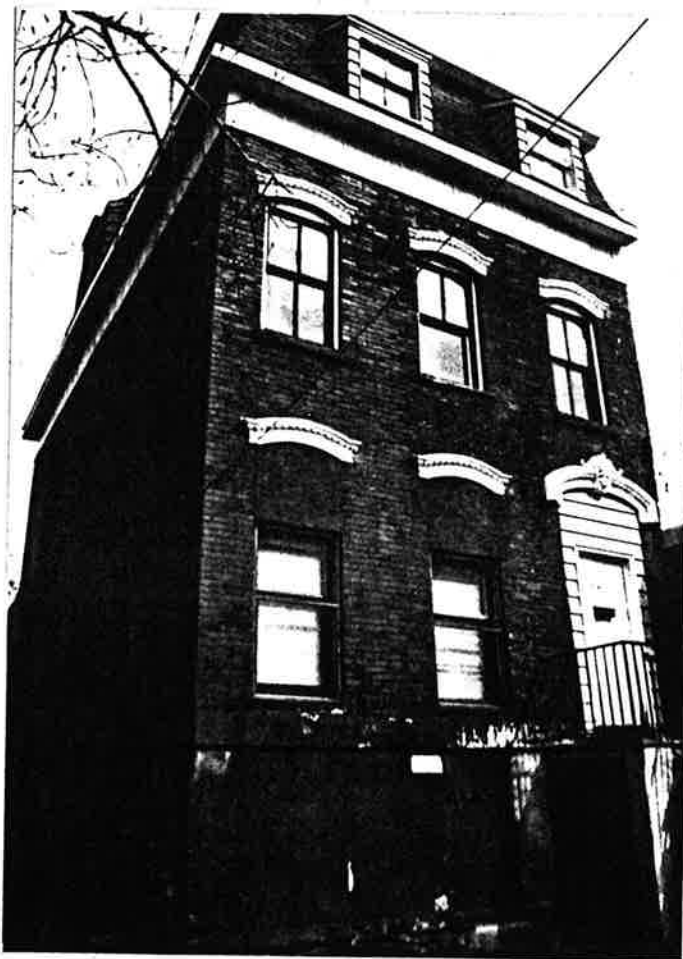
Map No. 4

| MAP # | ADDRESS/LOCATION : PROPERTY NAME | DATE | Significance to D/S | Condition | USE | DESCRIPTION: Style, Ext. Wall Fabric, Fenestration, Form, Roof, Major Features, Alterations, Stories, etc. | NEGATIVE FILE # |
|---|---|---|---|---|---|---|---|
| 4 | 240 Culver Avenue<br>Block 1296 | c-1880 | P<br>theme | G | R | A detached, brick, 3 1/2 story Second Empire home with a high basement, mansard roof pierced by 2 dormer windows on the Culver Ave. side, segmentally-arched window lintels with stylized dentelation, and an entry door lintel with a foliate keystone. Alterations include parlor floor windows that have been shortened in length, square-headed replacement windows, removal of the original door enframement and replacement of door with one of reduced size, with aluminum siding used as infill, and replacement stoop railing. | Contact<br>227/25 |
