SAINT ALS NEIGHBORHOOD

Jersey City, New Jersey

NJHSI # 0906 - B6

## DISTRICT/STREETSCAPE CONTINUATION SHEET

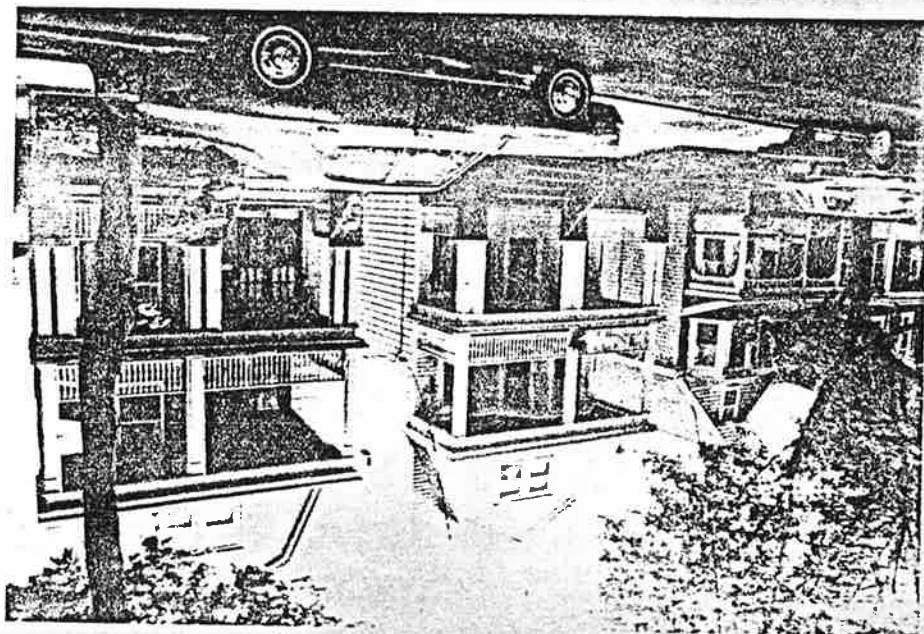
Site No. 0906-B6 con  
 15, 17 & 19 Condict Street  
 Jersey City, N.J.  
 Photo May. 201/29  
 MAP # 1 & 2

| MAP # | ADDRESS/LOCATION : PROPERTY NAME | DATE | NEIGHBORHOOD | Condition | DESCRIPTION: Style, Ext. Wall Fabric, Fenestration, Form, Roof, Major Features, Alterations, Stories, etc. | NEGATIVE FILE # |
|---|---|---|---|---|---|---|
| 1. | 15 Condict Avenue<br>Block: 1662 Lot: 3 | 1896-1908 | N | E R | Vernacular; frame/wood shingles; rectangular with side entrance; 2 bays: 1/1 sash; gable; 2 1/2. 3 bay porch with turned posts plain brackets spindle frieze. Projecting 2 story tripartite pavilion; rectangular window in gable end. | Contact:<br>201/29 |
| 2. | 17 & 19 Condict Avenue<br>Block: 1662 Lots: 1-2 | 1919-1928 | N | E R | Vernacular/Colonial Revival; replacement aluminum and wood shingles; 2 bays: 1/1 sash; 2 1/2 stories; flat with projecting gambrel pavilion on gable end. 2 bays, 2 tiered porch on paired plain square posts set on brick plynths (1st story), wooden railings. double rectangular side entrance doors, multi-paned. Paired rectangular window in gable end. | Contact:<br>201/29 |

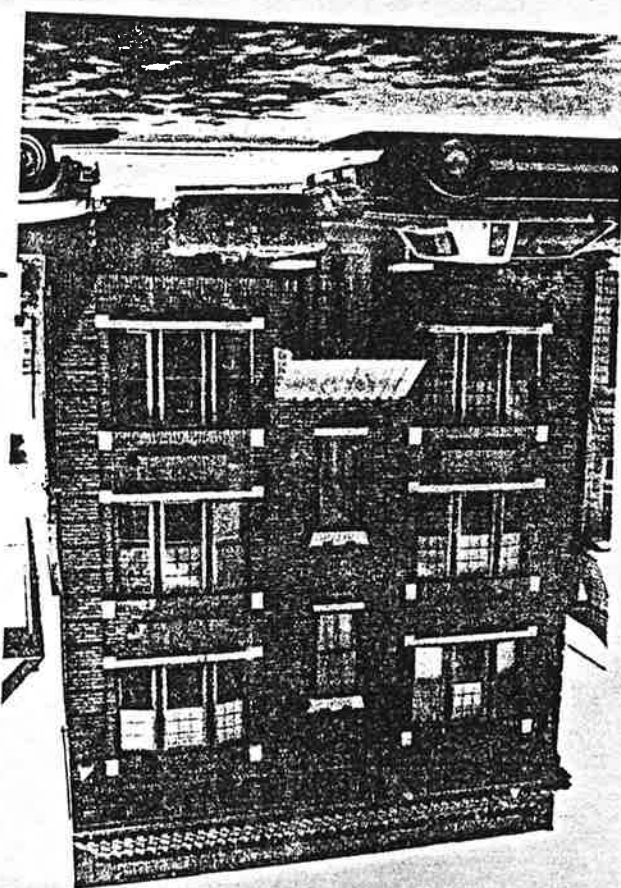
Site No. 0902 B6 Jew  
 240 Gerrit Ave.  
 Jersey City, N.J.  
 Photo May No. 201125  
 Map No. 6  
 C. 1915

| MAP # | ADDRESS/LOCATION : PROPERTY NAME | DATE | Significance | Condition | DESCRIPTION: Style, Ext. Wall Fabric, Fenestration, Form, Roof, Major Features, Alterations, Stories, etc. | NEGATIVE FILE # |
|---|---|---|---|---|---|---|
| 6. | 240 Jewett Avenue<br>Block: 1822 | c.1915<br>on 1919<br>Atlas | P<br>Theme | E R <sup>2</sup> | Vernacular/Italianate; brick & dumbell with central main entrance; 3 bays: 6/1 sash; flat roof; 3 1/2 stories; Central double rectangular multipaned entrance door, aluminum canopy. Flanked by 2 pairs of 3 slightly projecting windows. Same window arrangement is repeated in upper stories. Stone sills, brick banding with stone blocks at corners. Raised rectangular brick panels between each story of tripartite window groups, above doorway are 2 single rectangular windows on each story with stone sills and lintels. In between windows are cruciform and diamond pattern. Heavy over hanging cornice with thick consoles, recessed rectangular panels, modillions. Synthetic tiles on roof area Rectangular panels in upper parapet. 2 frame residences were demolished before construction of the present edifice. | Contact<br>201/25 |

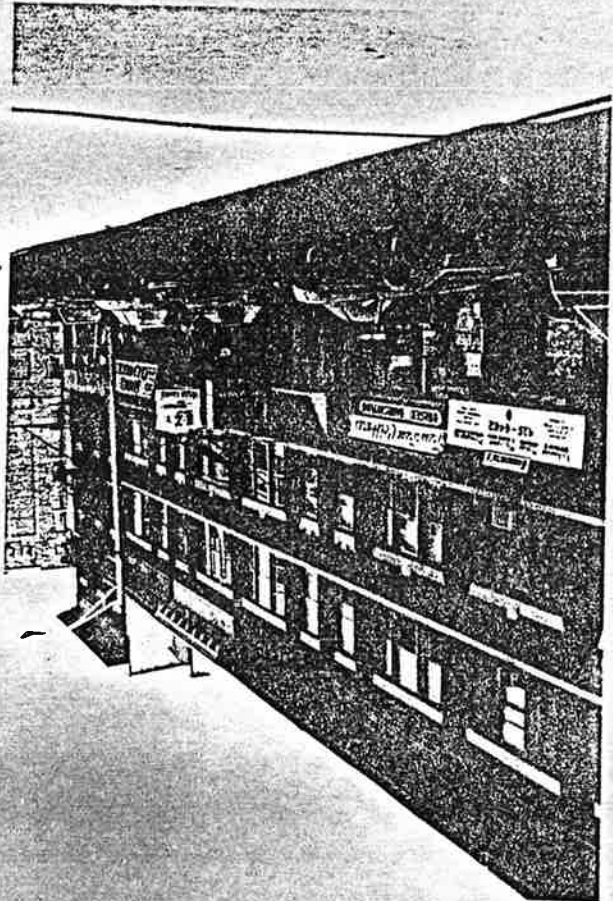
Site No. 0906 B6 WSA  
 716-724 West Side Ave  
 Jersey City, N.J.  
 Photo neg. 205/27A  
 Map #1  
 1909-1919  
 New SE

| MAP # | ADDRESS/LOCATION : PROPERTY NAME | DATE | 8<br>#<br>1<br>2<br>3<br>4<br>5<br>6<br>7<br>8<br>9<br>0 | Condition | DESCRIPTION: Style, Ext. Wall Fabric, Fenestration, Form, Roof, Major Features, Alterations, Stories, etc. | NEGATIVE FILE # |
|---|---|---|---|---|---|---|
| 1B. | West Side Streetscape<br>716 and 738 West Side Avenue<br>2 attached corner buildings. | 1908-<br>1909 | Y<br>Dist. | E C/R | Italianate; brick, stone details, aluminum and glass storefronts; rectangular; flat roof 3 X 7: 1/1 sash; flat roof; 4 stories.<br>1st story replacement storefronts. Upper stories: Continuous stone banding molding separates stories. Stone lintels over all windows with keystone (Except 4th story windows which have a straight lintel). 3 story fire escape on facade.<br><u>Roof Area:</u> Carved frieze area, recessed panels. Then denticulated pattern then modillions under projecting cornice. | Contact<br>32/8<br>205/26A |

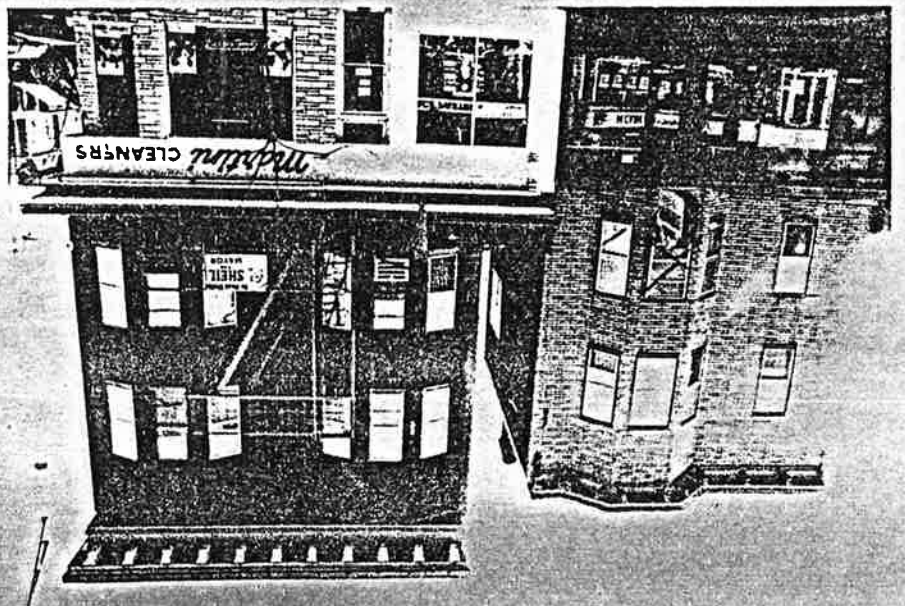
Site No. 0906 B6 WSA  
 740-744 West Side Ave.  
 Jersey City, N.J.  
 Photo May. 32/7  
 Map # 2 & 3  
 1896-1908  
 1908-1919

| MAP # | ADDRESS/LOCATION : PROPERTY NAME | DATE | 8<br>#<br>1<br>2<br>3<br>4<br>5<br>6<br>7<br>8<br>9<br>0 | Condition | DESCRIPTION: Style, Ext. Wall Fabric, Fenestration, Form, Roof, Major Features, Alterations, Stories, etc. | NEGATIVE FILE # |
|---|---|---|---|---|---|---|
| 2. | 740-742 West Side Avenue<br>(NE: Corner Fairview Avenue) | 1896-<br>1908 | P<br>Dist. | R C/R | Italianate; frame, replacement asbesto shingles, Rectangular; 1st story 4 bays, 2 storefront entrances, above 2 bays 1/1 sash; flat roof; 3 stories. Recent unsympathetic storefront, early cornice molding retains some original brackets and denticulated patterns. Above storefront are 2 projecting tripartite 2 story pavilions. Central fire escape. Projecting cornice, denticulated pattern modillions.<br>1873: property of Thomas Andrews. | Contact<br>32/7 |

| MAP # | ADDRESS/LOCATION : PROPERTY NAME | DATE | Significance | Condition | DESCRIPTION: Style, Ext. Wall Fabric, Fenestration, Form, Roof, Major Features, Alterations, Stories, etc. | NEGATIVE FILE # |
|---|---|---|---|---|---|---|
| 3. | 744 West Side Avenue | *1908-1919<br>c.1910 | Y<br>Dist. | G | Italianate; wood/replacement asbestos shingles; 1st story, 2 glass storefront windows, 3 entrances, upper stairs 2 bays; 1/1 sash; flat roof; 3 stories. 1st story: 2 projecting store front windows supported by consoles flank 2 single rectangular glazed entrance doors with rectangular transoms. Replacement door on north side of facade. Projecting cornice molding with modillions. Upper stories: 2 story projecting tripartite pavilion on south side of facade. Hinge sign attached to 2nd story. Projecting roof cornice with denticulated pattern, consoles and modillions. 1873: property of Thomas Andrews | Contact<br>32/7 |
