Beach Street in Sparrow Hill Neighborhood of Survey Area
(Ward D) 0906-D1 bec NJHSI:0906, Jersey City, Hudson County

NEW JERSEY OFFICE OF CULTURAL AND ENVIRONMENTAL SERVICES
HISTORIC PRESERVATION SECTION
DISTRICT/STREETSCAPE CONTINUATION SHEET

District/Streetscape Continuation Page # 1 Inventory # 0906-D1-bea

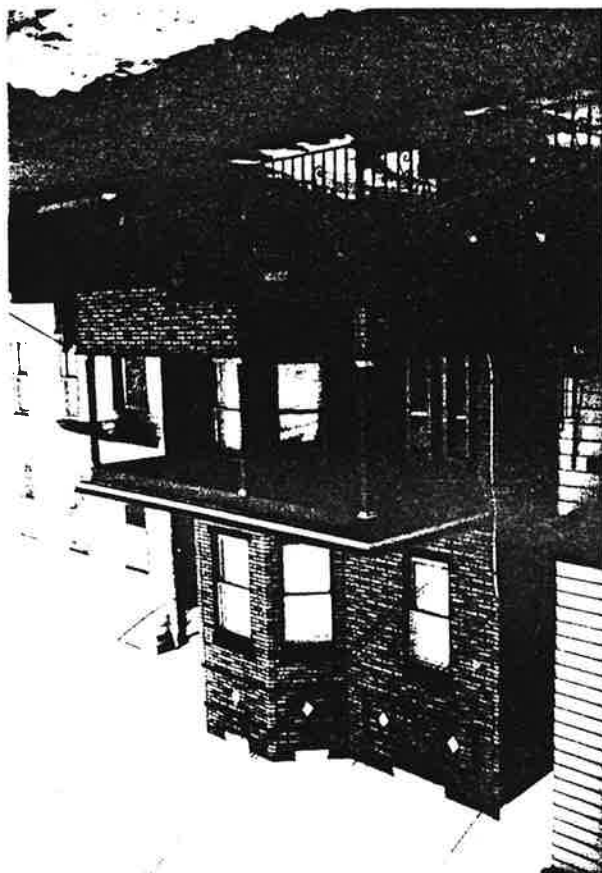
Site No. 0906-81 loc
 29 Beach Street
 Jersey City, N.J.
 Photo No. No. 211
 Map No. 2

2.	29 Beach Street Block/848	Btwn. 1896 1928 (G.M. Hopkins Map 1928)	N	G R		Greek Revival/Italianate; recessed rectangular plan with side entry, projecting right side bay and 1st story porch; 2 stories with basement approximately 2 bays; wood framed building resurfaced with asphalt fiberglass siding; 1/1 wood double hung sash windows; stone and wooden stoop leading up to double wooden entry door set in wood framing; 3 wooden posts support porch roof; shed roof; no visible cornice, moderate alterations.

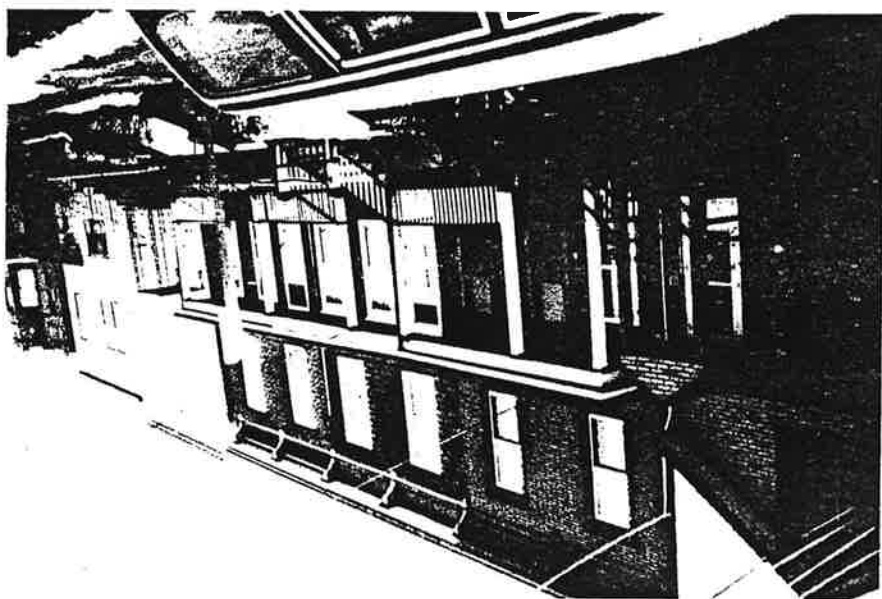
Site No. 0906-81 loc
 19-29 Beach Street
 Jersey City, N.J.
 Photo No. No. 211
 Map No. 1

1.	19-29 Beach Street Block/848	Btwn. 1873 1887 (L.D. Fowler Map except #29 1896 1928 (G.M. Hopkins Map 1928)	N	F/ R G		Greek Revival/Italianate row; recessed rectangular plans with side entries, 2 stories, some with basement; approximately 2 bays; wood framed buildings; 1/1 wood double hung sash windows on all buildings; some casement windows at basement level; shed roof with architraved wood cornice; brackets on cornice and rectangular panels on frieze on Nos. 21, 21A, 23; #19 #21 #23 resurfaced with asphalt/fiberglass siding; aluminum siding on Nos. 27 and 29, wood shingle siding on #21A, continuous bracketed roof cornice and plain porch cornice on #21 and #23, some with wooden proches, others concrete leading up to single wooden entry door fronted by aluminum siding, moderate to major alterations.	Contact 211/10

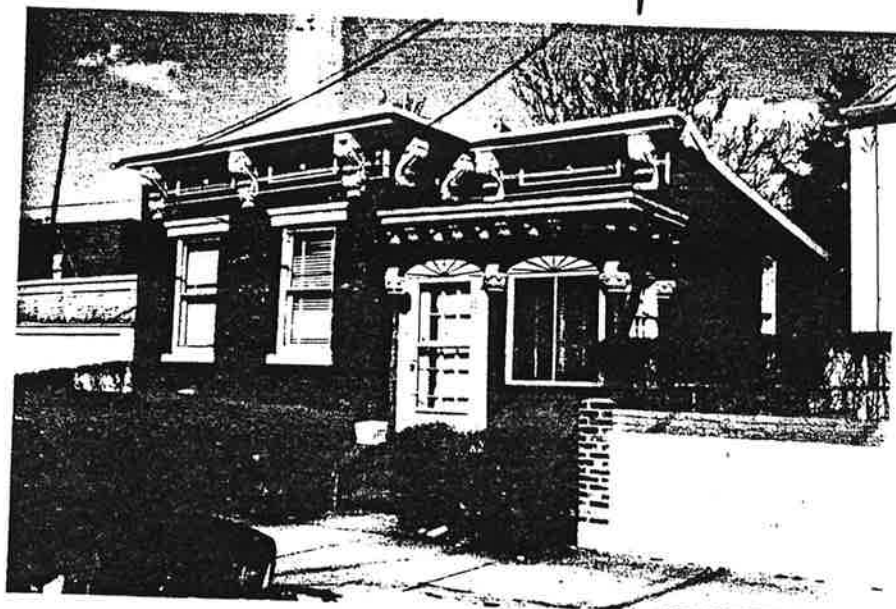
Site No. 0906-D1 bec
28 Beach Street
Jersey City, N. J.
Photo Neg. No. $2\frac{11}{12}$
Map No. 3

1.	28 Beach Street Block/850	Btwn. 1887- 1896 (SAn- born 1896)	P	G	R	Eclectic Greek Revival recessed square plan with small entry way (right side); brick building; 1 story approximately 4 bays; 1/1 wood double hung sash windows and lighted single paned windows on building next to entry; shed roof with brick chimney; architraved wooden cornice with heavy decorative brackets adorned with acanthus leaves; architraved window heads, dentiled cornice with grotesque, stone sills; thin columns with exotic capitals, small brick stoop leads up to single wooden multi-lighted door with aluminum storm door in front; this building is unusually adorned, no visible alterations.	Contact 211/12
.	48 Beach Street Block/849	Btwn. 1896- 1928 (G.M. Hopkins Map 1928)	P	G	R	Italianate with Greek Revival elements; recessed rectangular plan with side and central entry; 3 stories; 2 bays; brick exterior; 1/1 wood/double hung sash windows and multi-lighted picture windows with iron bars in front (1st sotry); shed roof with brick chimneys, architraved wood cornice with modillions and dentils; temple-like adornment on projecting bay; stone pilasters with Ionic capitals separate windows on projecting bay windows iron fire escape extend from third to 2nd story; single wooden entry door with trasom window above (left side); double doors form central entry; brick facing on 1st story facade appears to be not original minor alterations.	Contact 211/13

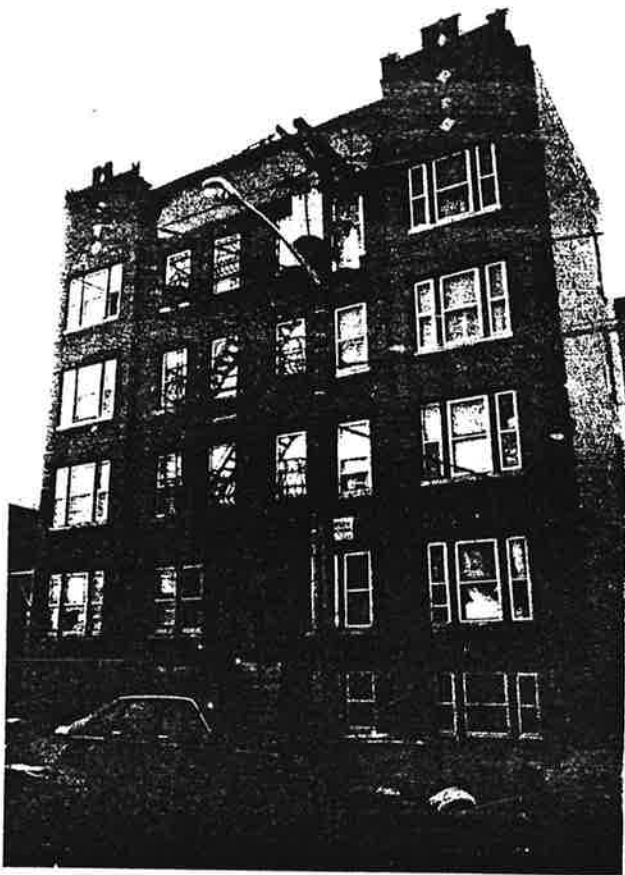
Site No. 0906-D1 Area
251 Beacon Avenue
Jersey City, New Jersey
Photo Neg. No. 186/6
Map No. 1

MAP #	ADDRESS/LOCATION : PROPERTY NAME	DATE	Signifi- cance to D/S	Condition	USE	DESCRIPTION: Style, Ext. Wall Fabric, Fenestration, Form, Roof, Major Features, Alterations, Stories, etc.	NEGATIVE FILE #
1	251 Beacon Avenue Block 694	Btwn. 1887- 1928 (G.M. Hopkins Map 1928)	N	G	R2	Early 20th Century Apartment Building, recessed rectangular plan with central entry, brick exterior; 4 stories with basement; approximately 6 bays; 1/1 wood double hung sash windows on facade and side of building; flat roof with brick parapets; building composed of 3 basic portions, the central portion housing 4 bays; each flooding portion houses a set of three windows per story; stone sills; iron fire escape suspended from buildings; facade sunken basement entry on left side of building; entry consist of double wooden doors with transom in front, no visible alterations.	Contact 186/6

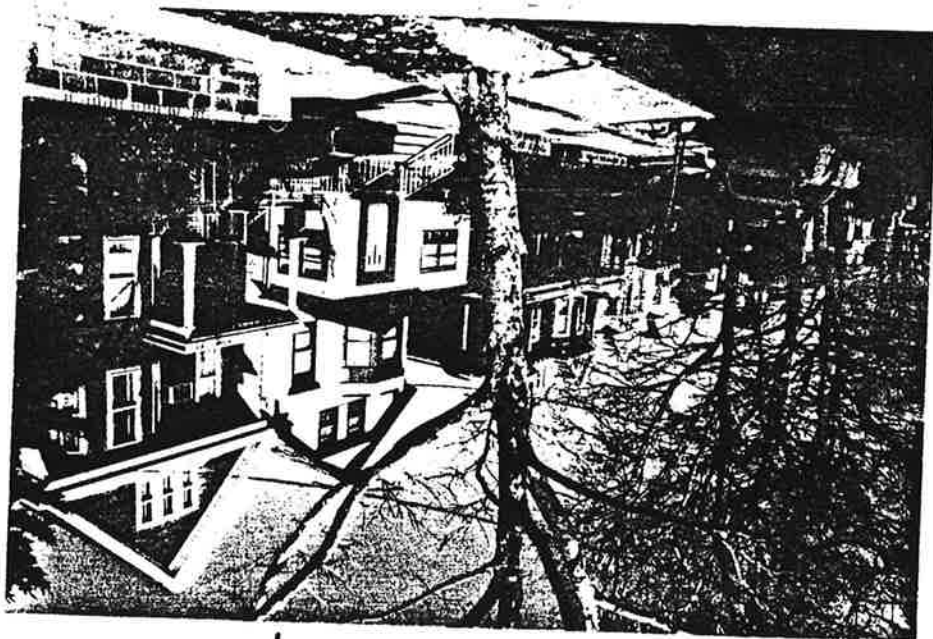
Site No. 0906-81 ear
 90-28 Carlton Avenue
 Jersey City, N.J.
 Photo Neg. No. 188/21
 Map No. 1

MAP #	ADDRESS/LOCATION : PROPERTY NAME	DATE	Signifi- cance to D/S	Condition	USE	DESCRIPTION: Style, Ext. Wall Fabric, Fenestration, Form, Roof, Major Features, Alterations, Stories, etc.	NEGATIVE FILE #
1	20-28 Carlton Avenue Block/848 Streetscaping of Carlton Ave.	Btwn. 1896- 1928 (G.M. Hopkins Map 1928) except #22 Btwn. 1887- 1896 (San- born 1896)	P	G	R	Victorian/Queen Anne, recessed rectangular plans, some of irregular shapes with projecting porches; each building is approximately 2 or 2 1/2 stories, wood framed buildings some with clapboard, wood shingles, others resurfaced with asphalt/fiberglass siding; some buildings have gabled roofs, others shed roofs, some with parapets, many built with architaved wood cornices atop and supported by brackets, each building composed of approximately 2 bays, some projecting outward as is 1st story porches, wooden stoops, some with railings and newels, alterations on this row range from minor to moderate.	Contact 188/21

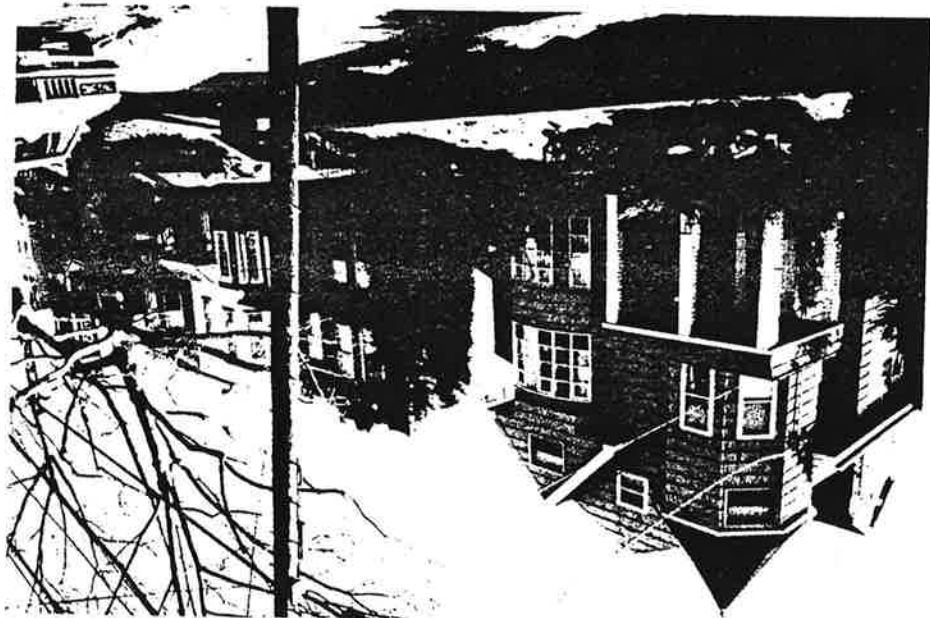
Site No. 0906-B1ear
 21-31 Carlton
 Avenue
 Jersey City, N.J.
 1881
 Map No. 3

MAP #	ADDRESS/LOCATION : PROPERTY NAME	DATE	Signifi- cance to D/S	Condition	USE	DESCRIPTION: Style, Ext. Wall Fabric, Fenestration, Form, Roof, Major Features, Alterations, Stories, etc.	NEGATIVE FILE #
3	21-31 Carlton Avenue Block/846	Btwn. 1896- 1928 (G.M. Hopkins Map 1928) except #29 Btwn. 1887- 1896	N	G	R	Streetscape of Queen Anne style (#21) and Queen Anne Variants (#23-#31); all buildings are set back and conform to a rectangular plan with side entries; #21 is 2 1/2 stories, #23-#29 stories each with 2 bays; #31 is 3 stories and houses flats; 1st story projecting porches on all buildidngs; all buildings are wood framed construction and have been resurfaced on the exterior with either aluminum or asphalt siding; large multi-lighted picture bay windows on #21 which also has gabled and bent roofs with dormers and pediments, shed roofs on all other buildidngs; 1/1 wood double hung sash window dominant window type on all buildings; wooden stoops some with replacement iron railings on porches; resurfacing of exteriors and replacement of new features such as aluminum windows and iron posts alter greatly the appearances of these buildings.	Contact 188/20

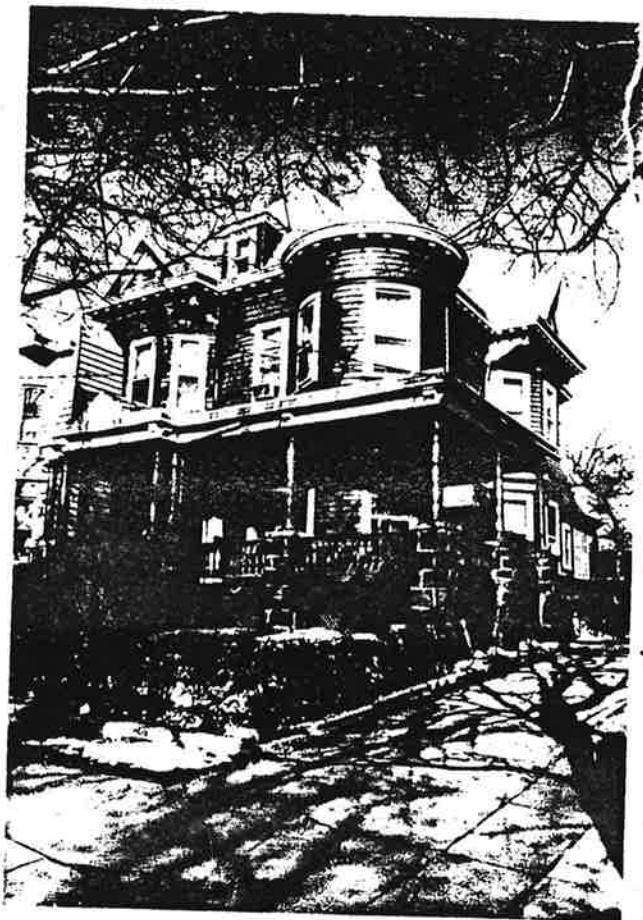
Site No. 0906-D1 car
26 Carlton Avenue
Jersey City, N. J.
Photo Neg. No. ¹⁸⁹/₂
Map No. 5

MAP #	ADDRESS/LOCATION : PROPERTY NAME	DATE	Signifi- cance to D/S	Condition	USE	DESCRIPTION: Style, Ext. Wall Fabric, Fenestration, Form, Roof, Major Features, Alterations, Stories, etc.	NEGATIVE FILE #
5	26 Carlton Avenue Block/848	Btwn 1896- 1928 (G.M. Hopkins Map 1928)	P	G	R	Queen Anne, recessed rectangular plan with rounded corner tower, projecting facade bay and projecting 1st story porch, wood shingles siding on buildings woodframes construction; cross/gabled roof with triangular pediments atop projecting bays; 2 1/2 bays; 2 1/2 stories, the equivalent of 4 bays on facade; 1/1 wood double hung sash windows on building round 1/1 wood double hung sash window set in gabled dormer, architraved modillioned wood cornice atop large wood brackets support projecting gables; architraved 1st story porch roof with modillions supported by wooden Doric columns, columns sit on stone and concrete bases, wood railings and newels on wooden porch; triangular pediment atop porch roof just above wood and stone stoop; double wooden entry doors with transom window above wood finial tops tent roof of rounded corner bay; no visible alterations to this building which is a fair example of this style.	Contact 189/2

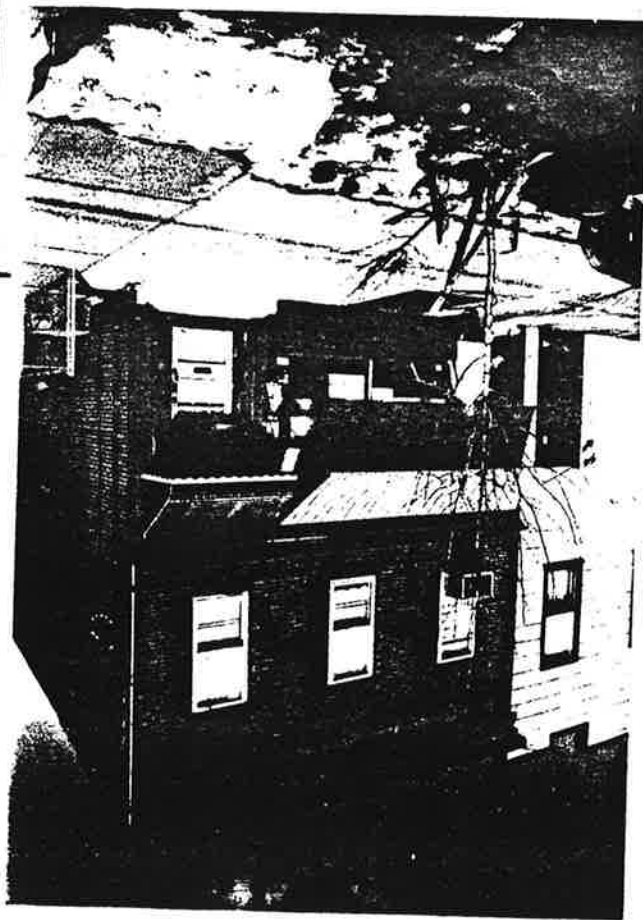
Site No. 0906-D1 ca
 46 Carlton Avenue
 Jersey City, N.J.
 Photo Neg. No. 189
 Map No. 7

MAP #	ADDRESS/LOCATION : PROPERTY NAME	DATE	Signifi- cance to D/S	Condition	USE	DESCRIPTION: Style, Ext. Wall Fabric, Fenestration, Form, Roof, Major Features, Alterations, Stories, etc.	NEGATIVE FILE #
7	46 Carlton Avenue Block/848	Ante 1873 (G.M. Hopkins Map 1873	N	F	C/ R	Italianate/Greek Revival; recessed rectangular plan with side entries 2 stories, 3 bays wood framed building resurfaced with asphalt/fiberglass siding; 1/1 wood double hung sash windows on 2nd story; large picture windows at 1st story level; shed roof with architaved wood cornice; a second modillioned cornice exist just above 1st story level; canvas and aluminum canopy hanging from facade of building; entry doors are single wooden entry doors, one with nine window lights, the other having numerous panels; brick facing on 1st story; excepting resurfacing no other alterations.	Contact 189/4
8	49 Carlton Avenue Block/845	Btwn. 1873 1887 (L.D. Fowler Map 1887)		G	C/ R	Italianate/Greek Revival; recessed rectangular plan with side and corner entry; wood shingle siding; 1/1 wood double hung sash windows on 2nd story; 2 single paned windows in sets three flanked by 1/1 types; shed roof with architaved cornice with elaborate scroll brackets, aluminum canopy above large display windows (left side of bldg.) of 1st story, corner entry consist of an aluminum storm door fronting a single wooden entry door with a large glass panel inset; side entry door consist of multi-lighted double wooden entry doors with transom window above small concrete stoops fronting each entry.	Contact

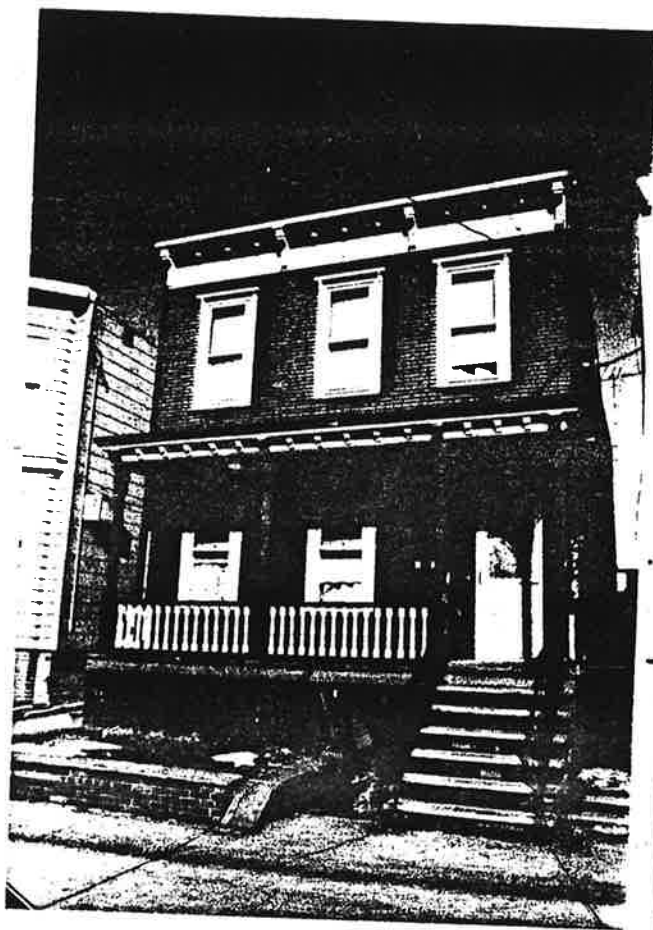
Site No. 0906-D1 car
 54 Carlton Avenue
 Jersey City, N.J.
 Photo Neg. No. 189/7
 Map No. 9

MAP #	ADDRESS/LOCATION : PROPERTY NAME	DATE	Signifi- cance to D/S	Condition	USE	DESCRIPTION: Style, Ext. Wall Fabric, Fenestration, Form, Roof, Major Features, Alterations, Stories, etc.	NEGATIVE FILE #
9	54 Carlton Avenue Block/847	Btwn. 1887 1896 (San born 1896)	N	G	R	Italianate/Greek Revival recessed rectangular plans with side entry; resurfaced wood framed building with asphalt/fiberglass siding; 2 stories, 3 bays, shed roof with architraved wood cornice with modillions and brackets; a second cornice of same design on porch roof of 1st story; 5 1/1 wood double hung sash windows on buildings facade, architraved window heads above each window, 4 rounded posts on porch supporting porch roof, wood railings and rounded newels on porch; brick stoop with iron railings lead up to single wooden entry door fronted by aluminum storm door; basement entry with sunken concrete stoop aside brick stoop small brick retaining wall in front, excepting resurfacing no other major alterations.	Contact 189/7

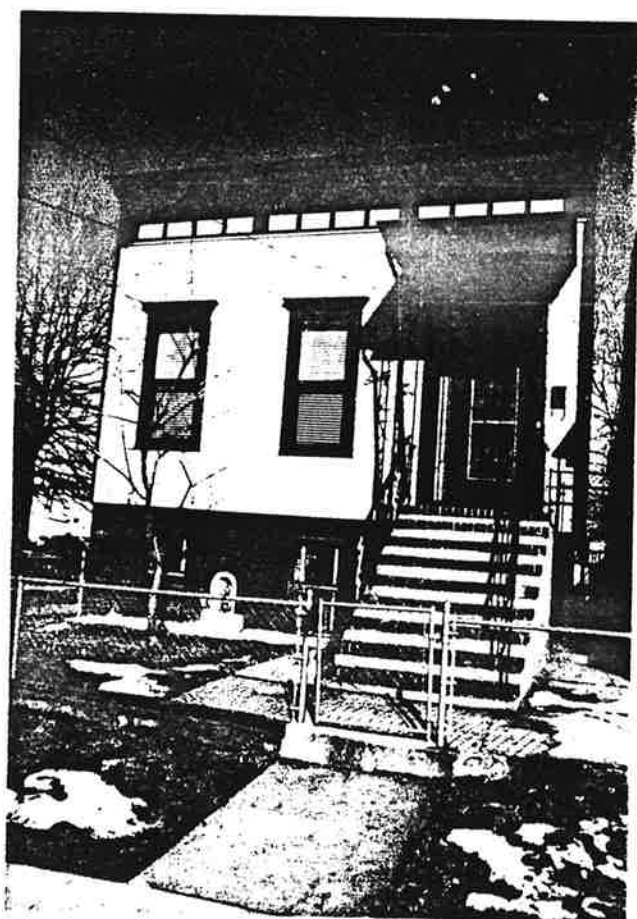
Site No. 0906-D1 car
 62 Carlton Avenue
 Jersey City, N.J.
 Photo Neg. No. 189/8
 Map No. 10

10	62 Carlton Avenue Block/847	Btwn. 1887- 1896 (San- born 1896)	N	G	R	Italianate/Greek Revival recessed rectangular plan with side entry; brick exterior resurfaced with aluminum siding; 1 story with basement; 2 windowed bays, the third housing entry door; shed roof with architraved wood cornice adorned with modillions, brackets and dentilled frieze, cornice on small porch roof done in similar design; architraved window heads; iron posts and railings on brick stoop (replacement); excepting resurfacing, no other major alterations.	Contact 189/8

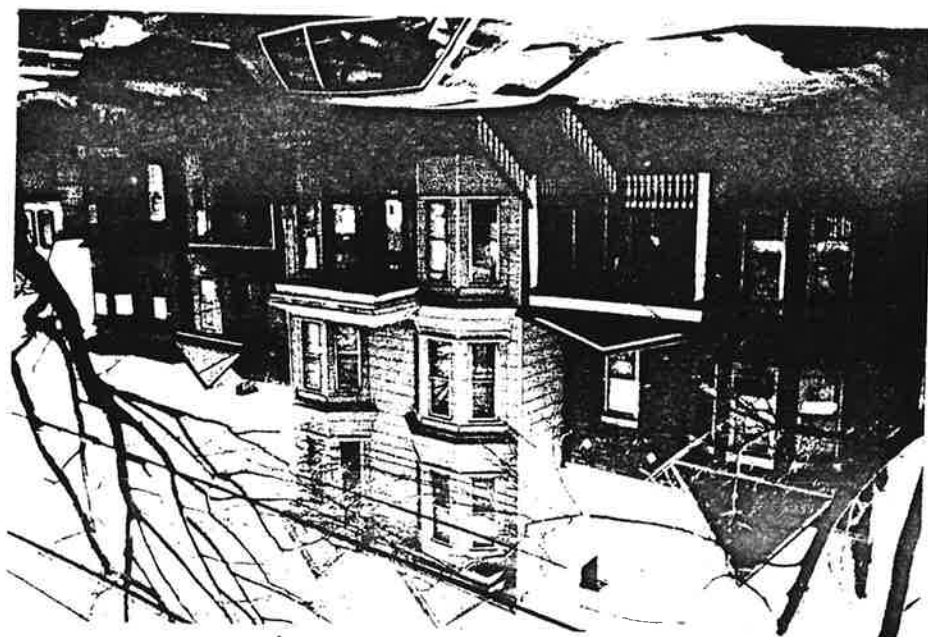
Site No. 0906-B/ear
 65 Carleton Avenue
 Green City, N.D.
 Photo No. No. 189/10
 Map No. 12

MAP #	ADDRESS/LOCATION : PROPERTY NAME	DATE	Signifi- cance to D/S	Condition	USE	DESCRIPTION: Style, Ext. Wall Fabric, Fenestration, Form, Roof, Major Features, Alterations, Stories, etc.	NEGATIVE FILE #
11	65 Carlton Avenue Block/845	Btwn. 1896 1928 (G.M. Hopkins Map 1928)	P Theme	E	R2	Italianate, recessed rectangular plan with central entry; 3 stories with basement; 2 projecting bays; 1/1 wood double hung sash windows, polychromatic brick exterior; shed roof with extending eaves; 2 large brackets in center of building at roof, dentiled moldings and garland moldings on frieze, stone lintels with keystone, stone sills; single wooden entry door with transom window above; scroll like keystone on overdoor; concrete stoop with wrought iron railings and fence in front; building is in excellent condition, no visible alterations.	
12	69-75 Carlton Avenue Block/845	Btwn. 1896- 1928 (G.M. Hopkins Map 1928)	N	F	R	Queen Anne; recessed rectangular plans with side entries; projecting porches; 2 stories with basement; 2 bays (#69); 3 stories with basement, 2 projecting bays (#71); 2 stories, with basements, 2 bays (#73 and #75); all wood framed buildings; all resurfaced with aluminum siding (#73 and #75) or asphalt fiberglass siding (#69 and #73); 1/1 wood double hung sash windows on all buildings, casement windows at basement levels, shed roofs some with triangular pediments (#69, #71, #73) brick chimneys atop all buildings; temple like porch on #69; 2 Doric (wood) support pedimented gable porch roof on #69 along with wood railings and newels (rounded) brick and concrete stoops on Nos. 71-75 iron posts with like railings on porches; small roofs on porches, the exteriors of all buildings are resurfaced and therefore altered somewhat.

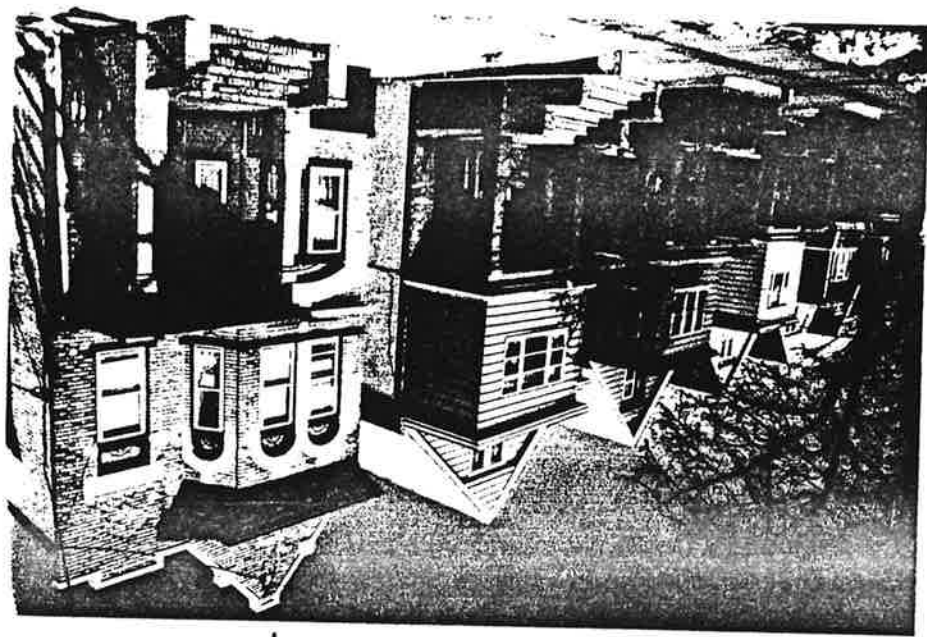
Site No. 0906-81 aa
 114-124 Carlton
 Avenue
 Jersey City, N.J.
 State No. 18
 Map No. 14

14.	114-124 Carlton Avenue Block/943	Btwn. 1896- 1928 (G.M. Hopkins Map 1928)	P	G	R	Queen Anne; recessed rectangular plans with projecting porches and side entries; brick exteriors, all except #114 have a front attic; 1/1 wood and aluminum windows (replacements); all have gabled roofs except #114 which has a shed roof with brick parapet; 2nd and attic stories of Numbers 116-124 are covered with aluminum siding; the sides of Numbers 116-124 are covered with concrete; architraved wooden cornice on all buildings; cornice on #114 is modillioned, rounded window sections above some windows on #114 filled with stained glass; brick and concrete stoops with like piers supporting porch roofs on all buildings, brick water table on all buildings; entries consist of single paneled wooden doors; no major alterations on buildings.	Contact 189/16

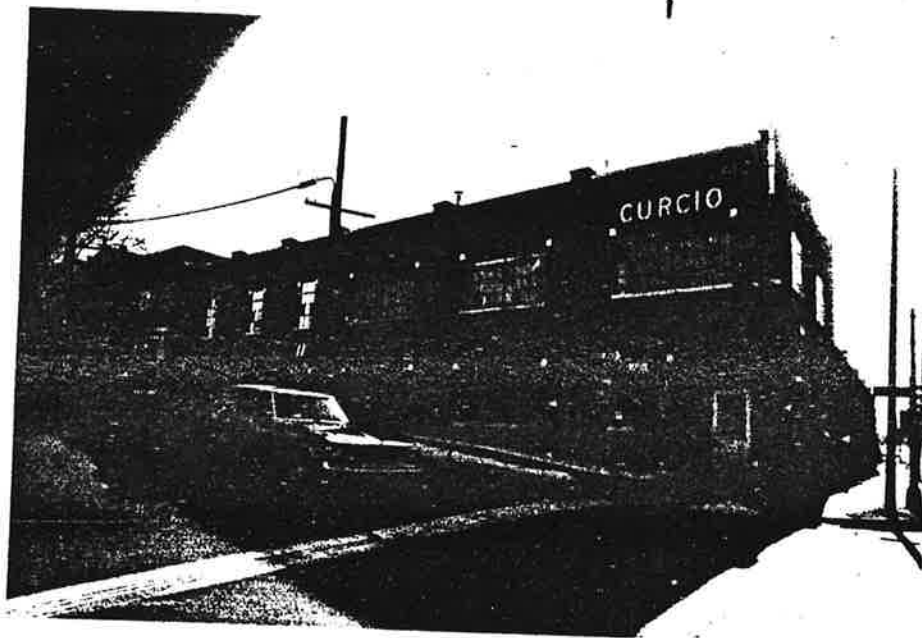
Site No. 0906-D/ear
173 Carlton
Avenue
Jersey City, N. J.
Photo Neg. No. 190
Map No. 17
3

MAP #	ADDRESS/LOCATION : PROPERTY NAME	DATE	Signifi- cance to D/S	Condition	USE	DESCRIPTION: Style, Ext. Wall Fabric, Fenestration, Form, Roof, Major Features, Alterations, Stories, etc.	NEGATIVE FILE #
17	173 Carlton Avenue Block	Btwn. 1896- 1928 (G.M. Hopkins Map 1928)				Utilitarian; recessed rectangular plan with side entry; 2 stories; 6 bays; 7 bays (Tonnele Avenue side)m brucj exteriors, flat roof with brick parapet, multi-lighted industrial windows on 2nd story of building only; white stone symmetrically placed above window bays; entry consist of single steel and glass door with transom window above, letters reading "Curcio" situated atop windows above entry; no visible alterations.	Contact 190/3

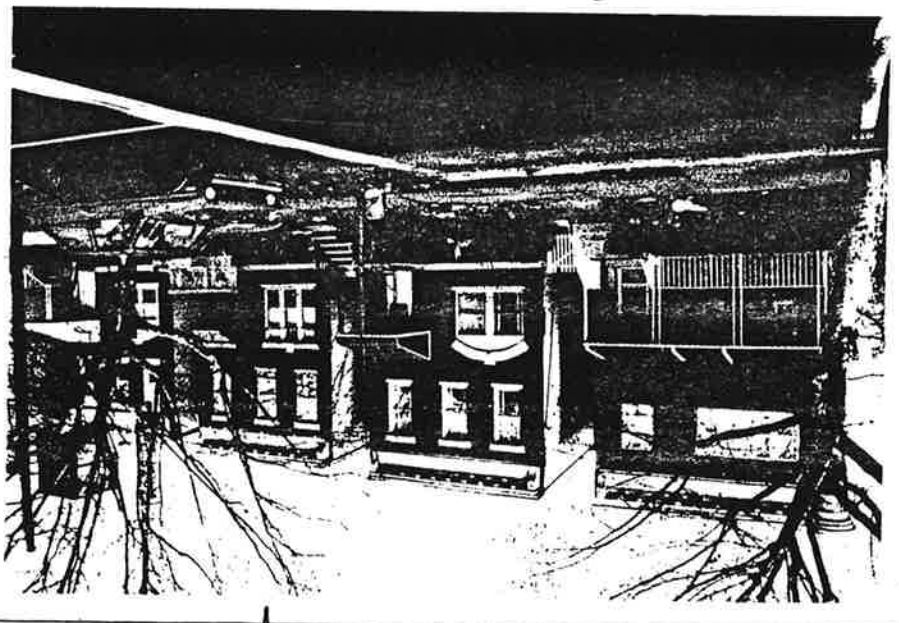
Site No. 0906-81 JFK
 31 85-3191 9. F.
 Kennedy Blvd.
 Jersey City, N.J.
 Photo Neg. No. 186/17
 Map No. 7

7.	3185-3139 J.F. Kennedy Boulevard Block: 953 4 unattached buildings	Btwn. 1896 1928 (G.M. Hopkins Map 1928)	P Theme	F	R	Greek Revival; recessed rectangular plans with side entry; brick exteriors; 1/1 wood double hung sash windows; shed roof with architraved wood cornices, modillions on cornices, relief molding on wooden friezes; stone lintels, stone sills; segmental brick arch with keystone atop pair of windows on #3187; stone water tables on buildings #3187, #3189 and #3191; #3185 a rounded cornice on left corner of building; replacement windows on #3185; concrete stoops; entry doors consist of wooden doors fronted by aluminum storm doors except on #3185; major alterations on #3185 minor alterations on remaining buildings.	Contact: 186/7

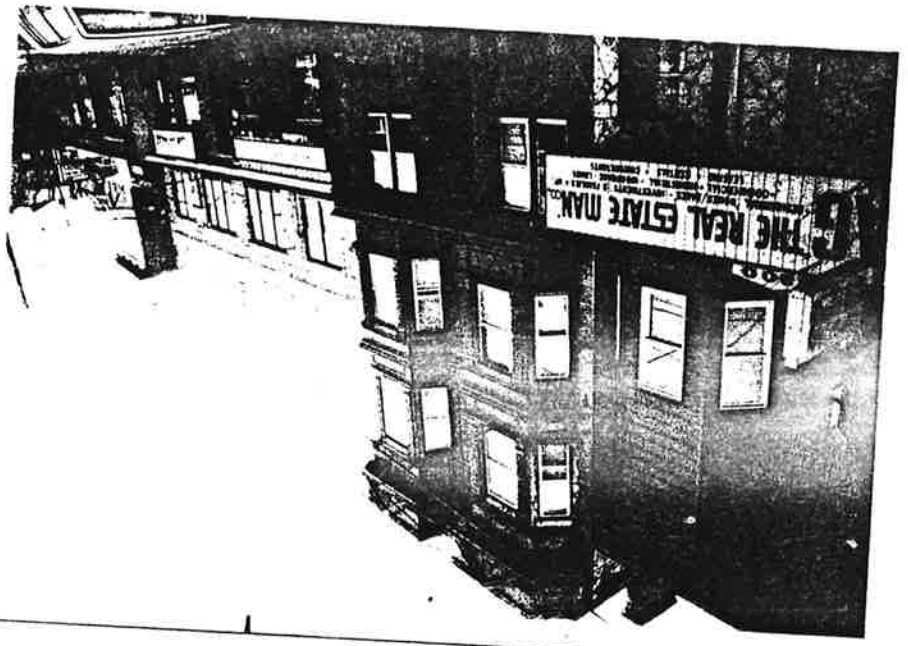
Site No. 0906-81 Jfk
 3198 J.F. Kennedy Blvd.
 Jersey City, N.J.
 Photo Neg. No. 187/10
 Map No. 8a

MAP #	ADDRESS/LOCATION : PROPERTY NAME	DATE	Signifi- cance to D/S	Condition	USE	DESCRIPTION: Style, Ext. Wall Fabric, Fenestration, Form, Roof, Major Features, Alterations, Stories, etc.	NEGATIVE FILE #
8a.	3198-3190 J.F. Kennedy Blvd. Block: 842	#3190 Ante 1873, #3192 Btwn. 1873-1887 (L.D. Fowler Map 1887) #3194 3198 Btwn 1896 1928 (G.M. Hopkins Map 1928)	N	H/G	C/R	#3198: Italianate; recessed rectangular plan with central entry and projecting bays on 2-3rd stories; wood and brick exteriors, stuccoed 1st story of buildings facade; architraved wood cornices on 2nd-3rd stories of building; fluted pilasters between windows; modillioned and dentiled 2nd story cornice with pediment (triangular) formation atop; floral relief moldings set into tympanums above both projecting bays; raised panels below each window; relief molding set in center of building between bays; cornice above 1st story has large heavy brackets for support; arched entryway made by shaping of stucco to voussoirs with keystone; 4-step concrete stoop in front; basement entry with sunken stoop in front; 1st story severely altered.	Contact: 187/10,9

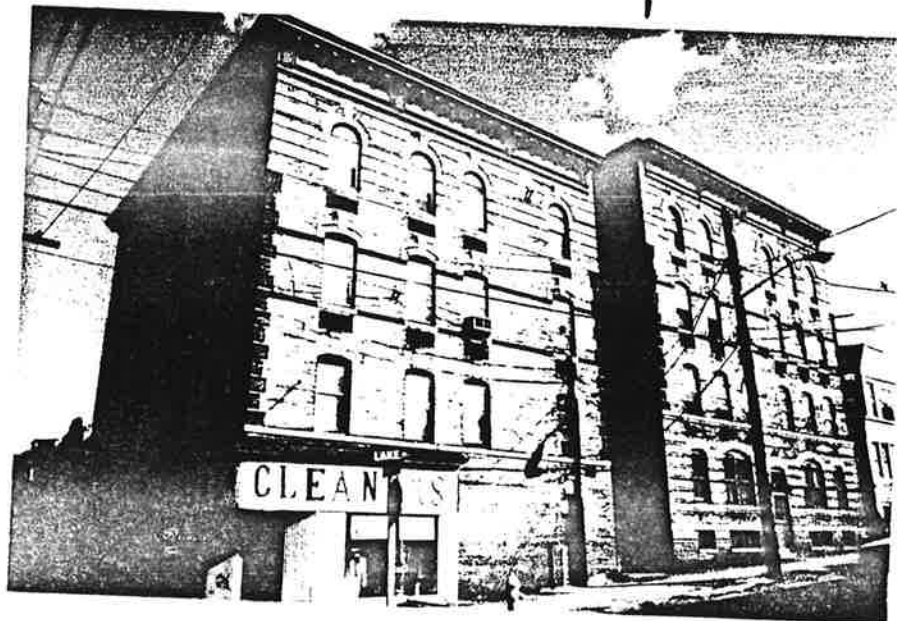
Site No. 0906-D1 jfk
3236-3234 J. A. Kennedy
Jersey City, N. J. Blvd.
Photo Neg. No. 188/5
Map No. 14

MAP #	ADDRESS/LOCATION : PROPERTY NAME	DATE	Signifi- cance to D/S	Condition	USE	DESCRIPTION: Style, Ext. Wall Fabric, Fenestration, Form, Roof, Major Features, Alterations, Stories, etc.	NEGATIVE FILE #
14	3236-3234 J.F. Kennedy Blvd. Block: 843 2 buildings	Btwn. 1887- 1896 (San- born 1896)	N	F	C/R	Italianate/Queen Anne; recessed rectangular plans with central and side entries; 2-3 stories #3236 is 3 stories with 4 bays, #3234 is 2 stories with approximately 4 bays; brick exterior with polychromatic brick finish (facade) fiberglass siding (#3234) wood framed exterior with asphalt/fiberglass siding; 1/1 wood double hung sash windows; on both buildings; shed roof on #3236; shed with small tent roof on #3234; 2nd story of #3234 projects outward from building; iron fire escape hangs from facade of #3236; tavern situated on 1st story of #3236, large display windows with two entries on 1st story; bar entry recessed and not visible in photo, side entry also recessed and set in arched entryway; 2 entries on 1st story of #3234 as well, one a single wooden door, the other constructed of glass and steel; excepting the resurfacing of #3234 which is moderate, minor alterations exist.	Contact: 188/5

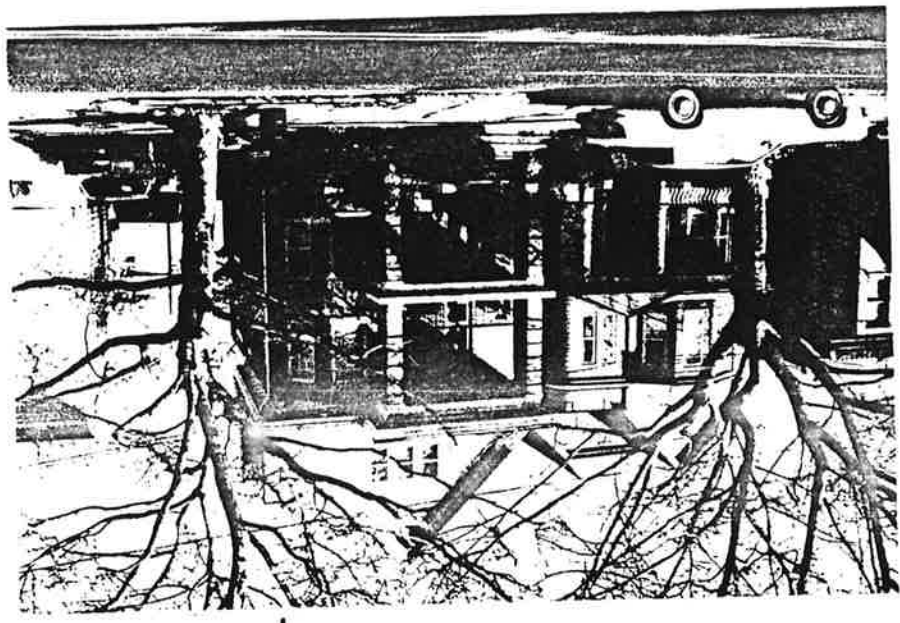
Site No. 0906-B1 gk
 3285-3289 Kennedy
 Blvd.
 Jersey City, N.J.
 State Reg. No. 219
 Map No. 19

19.	3285-3289 J.F. Kennedy Blvd. Block: 941 Row of three houses	Btwn. 1896- 1928 (G.M. Hopkins Map 1928)	N	G	C/R	Queen Anne row; recessed rectangular plans with side entries, 3 stories approximately 2 bays, brick exteriors; 1/1 wood double hung sash windows on all buildings; projecting bay windows on all buildings except #3285 which has a replacement facade in a modern style; shed roofs with brick parapets atop buildings; curvilinear brick gables are still visible atop #3285; projecting bay window on side of 3285; stone lintels, stone sills; concrete and brick stoops lead up to single wooden entry doors; brick or stucco like facade in geometric design on #3285; brick piers support the porch roofs of #'s 3287 and #3289; concave tiles on overhangs #3289 facade; entries consist of single steel and glass door (#3285), double wooden doors with sidelights (#3287) and a single wooden entry door (#3289) with an enclosed 1st story entryway or porch; alterations range from moderate to extensive on these three unattached buildings.	Contact: 210/6

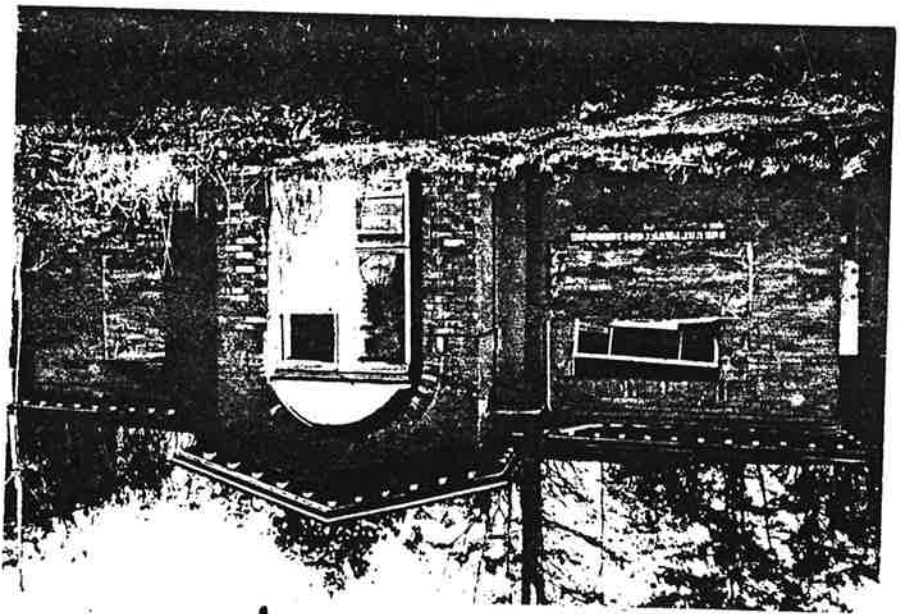
Site No. 0906-DI/Neuman
House of Reverend No 2
Fordhaus Avenue
near Summit Ave.
Jersey City, N.J.
Photo Neg. No. 164/9
Map. No. 1

MAP #	ADDRESS/LOCATION : PROPERTY NAME	DATE	Signifi- cance to D/S	Condition	USE	DESCRIPTION: Style, Ext. Wall Fabric, Fenestration, Form, Roof, Major Features, Alterations, Stories, etc.	NEGATIVE FILE #
	Maintenance House of Reservoir No. 2 Laidlaw Avenue near Summit Avenue Jersey City, New Jersey. U= Utility V= Vacant	1955 (San born)	N	P	U / V	Romanesque; recessed rectangular plan with central entry and projecting 1st story pavillion; brick exterior; rectangular window openings on each flank- ing bay of pavillion (boarded up); low pitched roof with wooden cornice; modillions adorn cornice; segmental brick semi- circular arch above entry; entry consist of double wooden doors with architraved overdoor (in disrepair); moderate alterations.	164/9

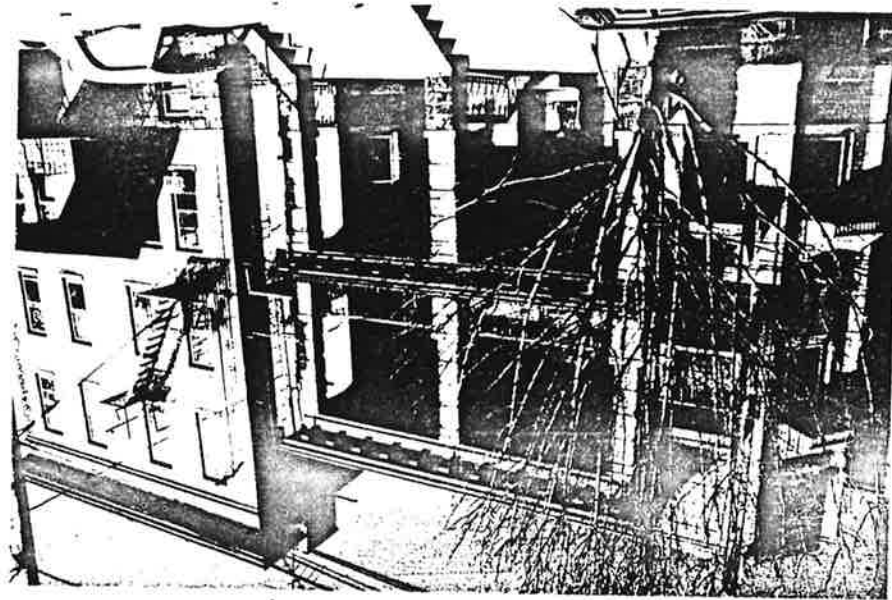
Site No. 0906-B1a
 114-110 Lake Street
 Jersey City, N.J. 07310
 Map No. 4

AP #	ADDRESS/LOCATION : PROPERTY NAME	DATE	Signifi- cance to D/S	Condition	USE	DESCRIPTION: Style, Ext. Wall Fabric, Fenestration, Form, Roof, Major Features, Alterations, Stories, etc.	NEGATIVE FILE #
4	114-110 Lake Street Block/945 #114 #112 are attached #110 unattached	Btwn. 1896- 1928 (G.M. Hopkins Map 1928)	N	G	R	a) 114-112 - Greek Revival/Italianate recessed rectangular plans with side entries, 2 stories with basements, projecting side bays as well as projecting varandah and porch; brick exterior, 1/1 wood double hung sash windows, casement windows at basement level, architraved wooden cornice with modillions on both varandah and porch roof brick piers support such roofs; stone sills; stone water tables; stone foundation and stone bases support piers; concrete stoops with iron railings entry doors consist of single wooden entry door with transom light above, aluminum awnings above windows; iron railings on varandah, no visible alterations; apartments in both buildings. b) 110 - Italianate; recessed rectangular plan with central entry; 3 stories, 4 bays, brick exteriors; 1/1 wood double hung sash windows, shed roof with brick chimney, extended architraved wood cornice with brackets, stone lintels and sills, iron fire escape spanning 2nd to 3rd stories. aluminum awning above entry; stone water table; concrete stoop with iron railings lead to single wooden entry door; iron railings on stoop, basement entry at bottom of concrete stoop. rusticated stone foundation, no major alterations	Contact 188/1

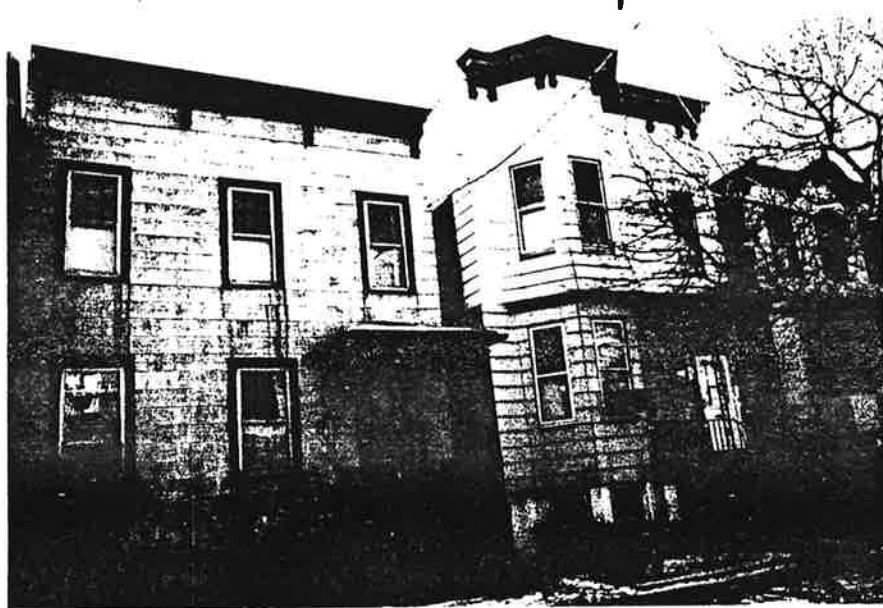
Site No. 0906-D1 la
113-115 Lake Street
Jersey City, N. J.
Photo Neg. No. 187 ¹⁸⁸/₃
Map No. 5

5.	113-115 Lake Street Block/947	#113 Btwn. 1887- 1896 (San- born 1896) #115 Btwn. 1896 1928 (G.M. Hopkins Map 1928	N	F	R	#113) Greek Revival; recessed rectangular plan with side entry; wood framed building; 3 stories with basement, 3 bays 6/1 wood double hung sash window set in wood framing; small casement window at basement level, plain wooden cornice with brackets; small porch roof supported by wooden posts; single wooden entry door; stoop appears to be a replacement, minor alterations. #115) Italianate; recessed rectangular plan with side entry; 2 stories with basement, approximately 2 bays projecting bay (left side); 1/1 wood double hung sash windows same type at basement level; shed roof with architaved wooden cornice with brackets and modillions, building resurfaced with aluminum siding (facade) and asphalt/fiberglass siding (side), brick and concrete stoop with iron railings lead up to single wooden entry door with aluminum storm door and side lights; basement entry below stoop, moderate alterations.	Contact 188/3

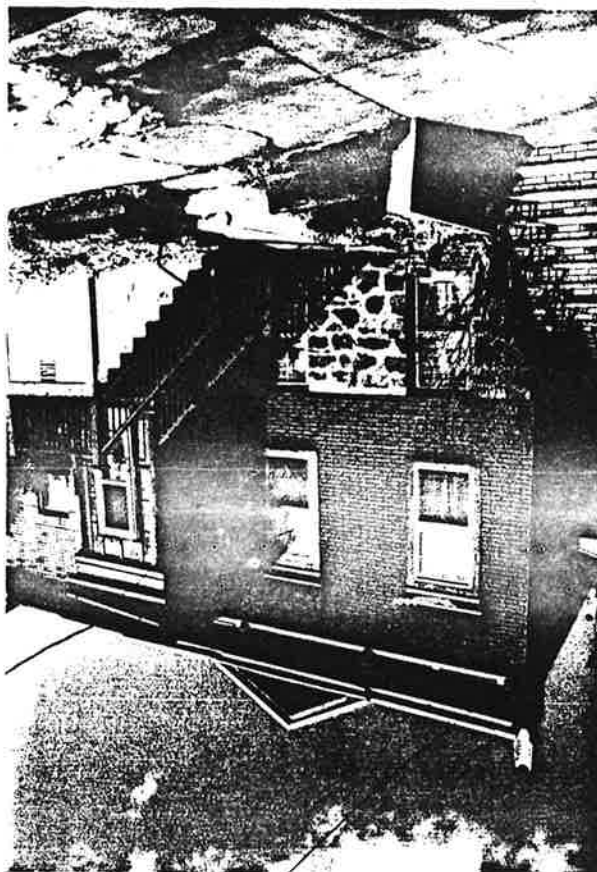
Site No. 0906-B1a
134 Lake Street
Jersey City, N.J.
Photo Neg. No. 187
Map No. 8

8.	134 Lake Street Block/945	Btwn. 1896- 1928 (G.M. Hopkins Map 1928)				Queen Anne recessed rectangular plan with side entry 1 story with basement; 3 bays; wood framed building with stone and concrete foundation shed roof with architraved wood cornice with brackets and triangular pediment; 1/1 wood double hing sash windows on 1st and basement stories, multi-lighted windows on projecting porch entryway; window heads above 1st story windows; wooden Doric columns flank single wppden entry door with aluminum storm door in front wooden stoop with like railings and newels lead up to entry resurfacing of building; only alteration to building.	Contact 187/20

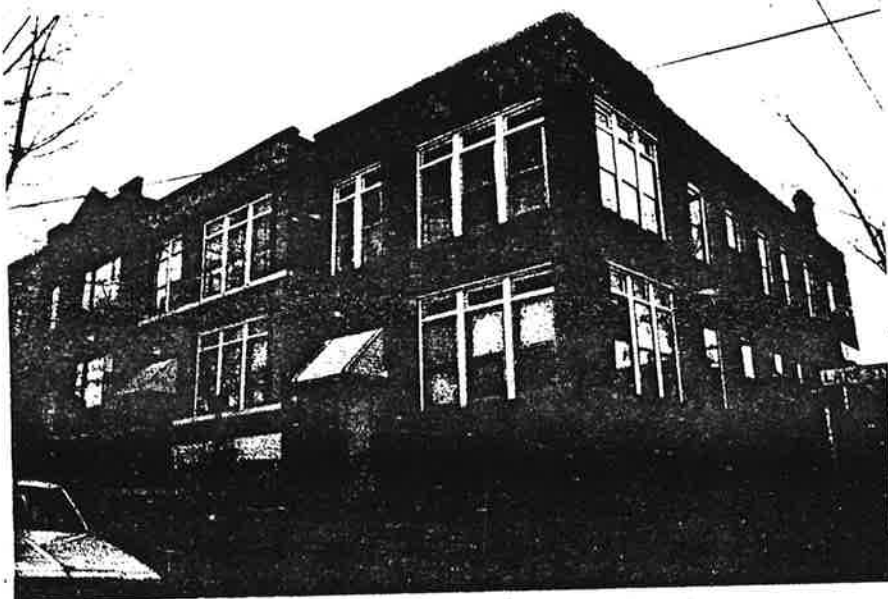
Site No. 0906-D1 la
139-135 Lake Street
Jersey City, N.J.
Photo Neg. No. 68
Map No. 9

MAP #	ADDRESS/LOCATION : PROPERTY NAME	DATE	Signifi- cance to D/S	Condition	USE	DESCRIPTION: Style, Ext. Wall Fabric, Fenestration, Form, Roof, Major Features, Alterations, Stories, etc.	NEGATIVE FILE #
9.	139=135 Lake Street	Btwn. 1896 1928 (G.M. Hopkins Map 1928)				Early 20th Century Buildings; recessed rectangular plans with side entries; 2 stories with basements approximately 2 bays on facade and 7 bays on side; polychromatic brick facades, plain brick on sides of building; brick facing is evident on foundation of # 135; iron railings on stoops in front buildings, flat roofs with brick chimneys; single wooden entry doors some with sidelights and transom windows above, no major alterations.	Contact 187/9

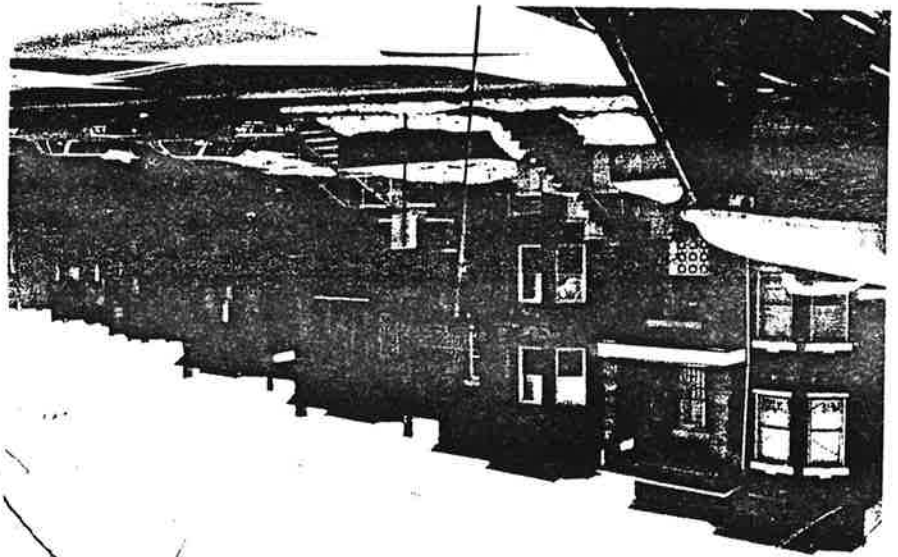
Site No. 0906-81 man
 217-229 Manhattan
 Avenue
 Jersey City, N.J.
 Photo Neg. No. 210/6
 Map No. 7

7.	217-229 Manhattan Avenue Block/941 Eight individual buildings	Btwn. 1896- 1928 (G.M. Hopkins Map 1928)	P	G	R	Italianate; recessed rectangular plans with side entry. 2 stories, approximately 2 bays, one a projecting bay on left side of all buildings; #217-#223 have projecting porch and verandah brick buildings all; 1/1 wood double hung sash windows, some buildings have replacement 1/1 aluminum double hung sash windows, shed roofs with architraved wood cornice with modillions, dentiled moldings on frieze, architraved dentiled cornice atop verandah roof; polychromatic brick finish stone lintels some with keystone; stone sills, casement windows at basement level; concrete and brick stoops, some with iron railings lead up to double wooden entry doors some with transom window above, asphalt/fiberglass siding on #227 only major alteration other than replacement stoops.	Contact 210/16

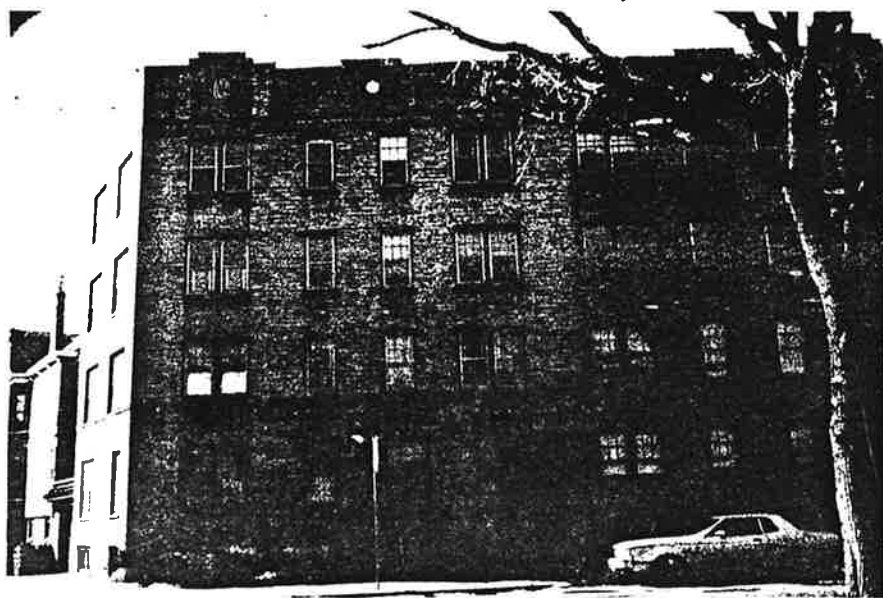
Site No. 0906-D1 san
1-5 Sanford Place
Jersey City, N. J.
Photo Neg. No. 211/7
Map No. 1

MAP #	ADDRESS/LOCATION : PROPERTY NAME	DATE	Signifi- cance to D/S	Condition	USE	DESCRIPTION: Style, Ext. Wall Fabric, Fenestration, Form, Roof, Major Features, Alterations, Stories, etc.	NEGATIVE FILE #
1	1-5 Sanford Place Block/848 "Pershing Manor Apartments"	After 1928	N	E	R2	Early 20th Century Apartment Building; irregular triangular type plan; 5 stories with basement, brick exteriors, approximately 8 bays on Sanford Place side 2 bays facing Summit Avenue; a polychromatic finish to exterior; 6/1 wood double hung sash windows on building; casement windows at basement level; flat roof with brick parapet, brick belt course surrounds building between 1st and 2nd stories, metal fire escape hanging from facade of building; entry consist of double steel and glass doors with transom window above; no visible alterations	Contact 211/7
2	9 Sanford Place Block/848	Btwn. 1896 1928 G.M. Hopkins (1928)	N	G	R2	Queen Anne recessed rectangular plan with central entry; brick exterior; 3 story, 2 projecting bays; bowed bays; 3 1/1 wood double hung sash windows on each bay of each story; shed roof with architaved wood cornice with double brackets; triangular pediments atop each projecting bay; triangular pediment atop porch roof; brick piers support porch pediment; concrete stoop with iron railings lead up to single wooden entry door with many window lights; stone foundation on building.	Contact 211/8

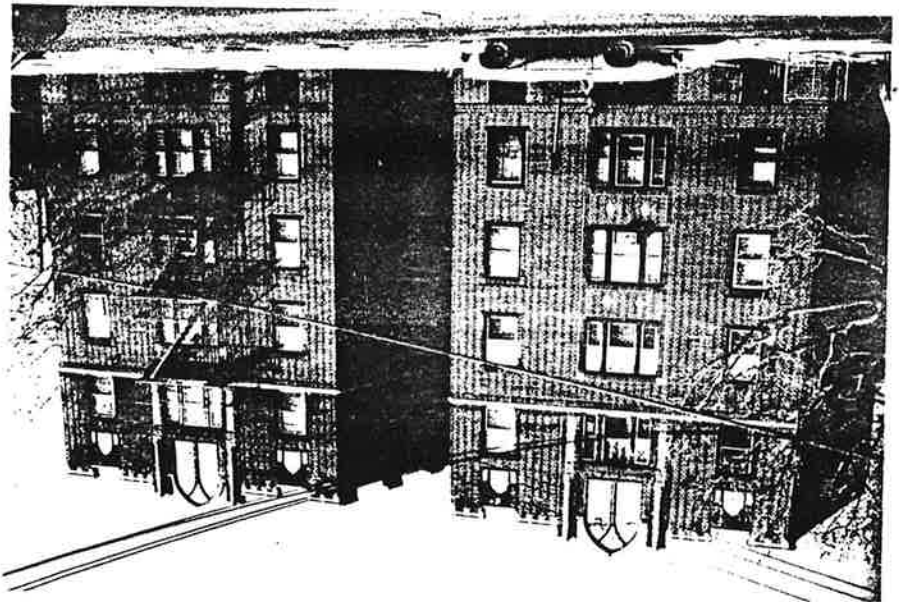
Site No. 0906-D1 000
 12-14 Sanford Place
 Jersey City, N.J.
 Clark Mfg. Co.
 Map No. 3

AP #	ADDRESS/LOCATION : PROPERTY NAME	DATE	Signifi- cance to D/S	Condition	USE	DESCRIPTION: Style, Ext. Wall Fabric, Fenestration, Form, Roof, Major Features, Alterations, Stories, etc.	NEGATIVE FILE #
3	12-14 Sanford Place Block/851 " Sanford Court Apartments"	Btwn. 1896 1928 (G.M. Hopkins Map 1928)	N	F	R	Early 20th Century Apartment Building; irregular shaped plan; brick exteriors; 4 stories with basement; approximately 3 bays per quad or section of buildings facade; brick parapets atop flat roof atop building 1/1 and 3/1 wood double hung sash windows; concrete Gothic panels set above central bays of right and left section of the Sanford Place facade; white stone in <u>shape</u> of diamonds on exterior of building; small basement windows entry is recessed deep in the center of Sanford Place facade, no visible alterations entry not visible in photo.	Contact 211/9
