Beach Street in Sparrow Hill Neighborhood of Survey Area
(Ward D) 0906-D1 bec NJHSI:0906, Jersey City, Hudson County

NEW JERSEY OFFICE OF CULTURAL AND ENVIRONMENTAL SERVICES
HISTORIC PRESERVATION SECTION
DISTRICT/STREETSCAPE CONTINUATION SHEET

District/Streetscape Continuation Page # 1 Inventory # 0906-D1-bea

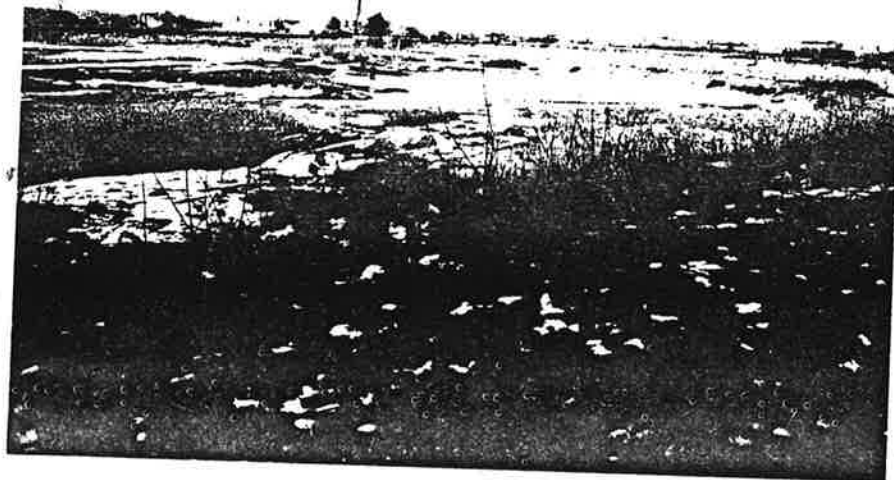
Site No. 0906-D1 spr
Reservoir No 2
at Spruce and
Collard
Jersey City, N.J.
Photo Neg. 186/16
Map No. 1

MAP #	ADDRESS/LOCATION : PROPERTY NAME	DATE	Signifi- cance to D/S	Condition	USE	DESCRIPTION: Style, Ext. Wall Fabric, Fenestration, Form, Roof, Major Features, Alterations, Stories, etc.	NEGATIVE FILE #
1	Jersey City Reservoir - Number 2 at Spruce Street and Collard Street looking southeast - Block 844 1/2 1 Jersey City Water works In= Infrastructure originally known as Reservoir No. 1	Ante 1873 1851- 1854 (Shaw)	P	F	In	Municipal Reservoir, oval shaped, walled in with stone and cement, reservoir has a 52,436,074 gallon capacity, a brick garage is situated to the south-west corner of reservoir (corner of Laidlaw Avenue and Collard Street), in the same corner exist a brick maintenance house, eastern side of reservoir has small brick gatehouse (at corner of Laidlaw and Summit Avenues).	Contact 186/16
2	7 Spruce Street Block/841	Btwn. 1896 1928 (G.M. Hopkins Map 1928)	N	G	R	Early 20th Century brick building; recessed rectangular plan with side entry; 2 stories with basement approximately 2 bays; brick exteriors, shed roof with brick parapets, 10 6/1 wood double hung sash windows on buildings facade casement windows at basement level; stone sills; brick arch with stone keystone above entry; brick stoop leads up to double wooden entry doors; no visible alter-ations.	Contact 186/14

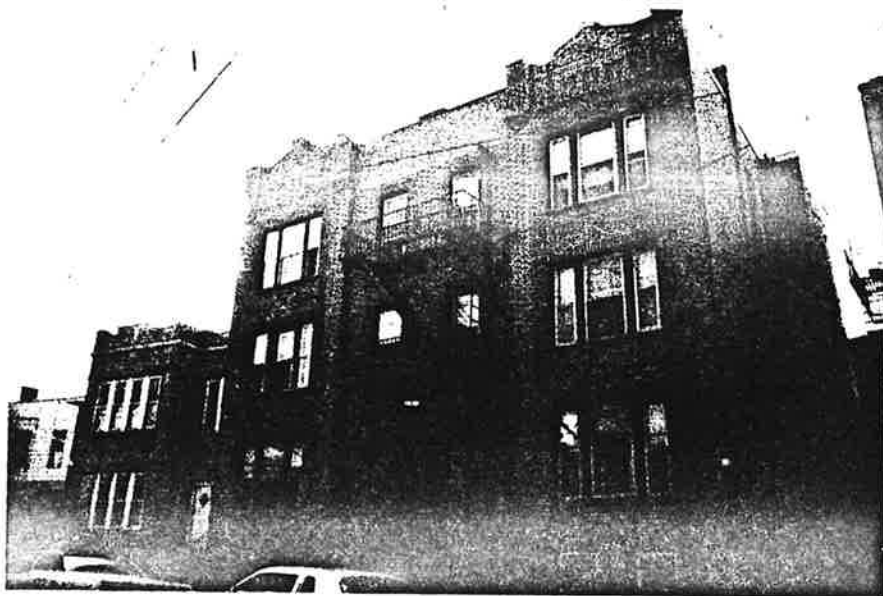
Site No. 0906-D1 spr
11-9 Spruce Street
Jersey City, N.J.
Photo Neg. No. 186/13
Map No. 3

LAP #	ADDRESS/LOCATION : PROPERTY NAME	DATE	Signifi- cance to D/S	Condition	USE	DESCRIPTION: Style, Ext. Wall Fabric, Fenestration, Form, Roof, Major Features, Alterations, Stories, etc.	NEGATIVE FILE #
3	11-9 Spruce Street Block/841	Btwn. 1896 1928 (G.M. Hopkins Map 1928)	N	G	R2	Early 20th Century Apartment Building; recessed rectangular plan with central entry; brick exterior approximately 4 bays on buildings facade, extreme end bays house a set of three windows all windows are 1/1 wood double hung sash types 3 stories with basement, flat roof with brick parapets, a polychromatic brick facade, iron fire escape on front of building, entry consist of double wooden entry doors with multi-lights and transom window above, no visible alterations.	Contact 186/13
4	26 Spruce Street Block/953	Btwn. 1896 1928 (G.M. Hopkins Map 1928)	P	F	R	Italianate, recessed rectangular plan with side entry, brick building; 2 stories, 3 bays; 3 bays on of building; 1/1 wood double hung sash windows on building, some windows appear to have been replaced by aluminum type windows; shed roof with architaved wood cornice with modillions and brackets; stone lintels and sills; entryway appears to be a later edition to buildings facade surfaced with aluminum housing 2 windows, paneled single wooden entry door with aluminum awning above, entryway is situated on left side of building, concrete stoop in front	Contact 186/18

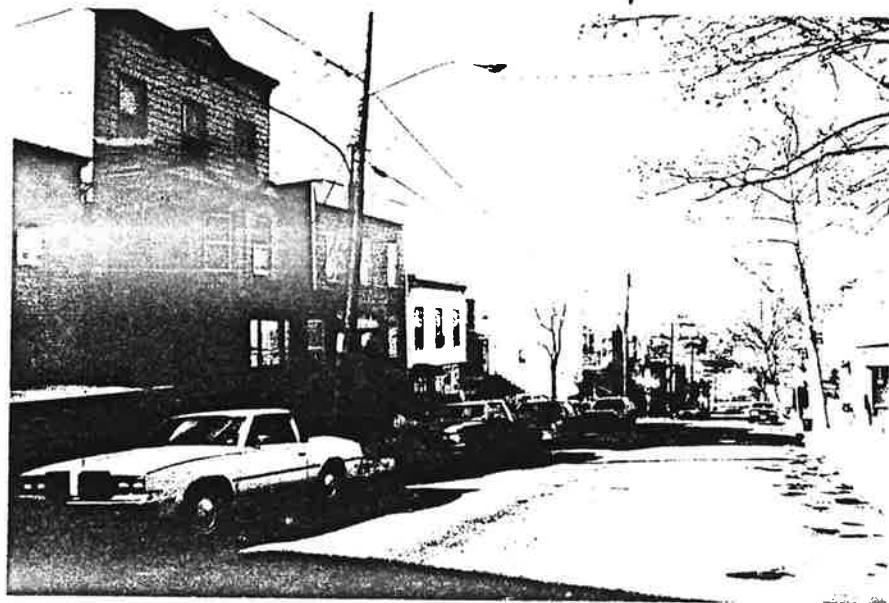
Site No. 0906-D1 spr
27-33 Spruce Street
Jersey City, N.J.
Photo Neg. No. ¹⁸/₁₈
Map No. 5

MAP #	ADDRESS/LOCATION : PROPERTY NAME	DATE	Signifi- cance to D/S	Condition	USE	DESCRIPTION: Style, Ext. Wall Fabric, Fenestration, Form, Roof, Major Features, Alterations, Stories, etc.	NEGATIVE FILE #
5	27-33 Spruce Street Block/955 Streetscape 4 individual unattached buildings	Btwn. 1887- 1896 (San- born 1896)	N	G	R	Italianate; recessed rectangular plans; most with side entries; each approximately 2 stories. 3 bays each, many resurfaced with aluminum siding upon wood framed exteriors; shed roofs all, #27 has small triangular pediment atop and on overdoors as well as above projecting bay window; 1/1 wood double hung sash windows, on all buildings; #27 has elevated 1st and 2nd story due to extremely high above ground basement which is raised approximately 1 story off the ground, single wooden entry doors on each building; extensive alterations.	Contact 187/1
6	38 1/2 Spruce Street Block/953	1800 Btwn. 1873- 1887 L.D. Fowler Map 1887)	P	E	R	Colonial Revival recessed rectangular plan with side entry; 2 stories 2 bays; stone exterior; hip roof covered with fish scale type tiles; 2 pedimented dormer windows of differing sizes on roof; windows are of 1/1 wood double hung sash type; gabled entryway housing single wooden door appears to be a later addition; a small window opening just below left side dormer appears to have been removed from use; however, framing remains, this building is situated in the rear of lot behind an newer later building; this building is unusual in this neighborhood and is one of few examples of the earliest types of buildings in this area of the city; building from exterior appears to be in very good shape.	Contact 187/2

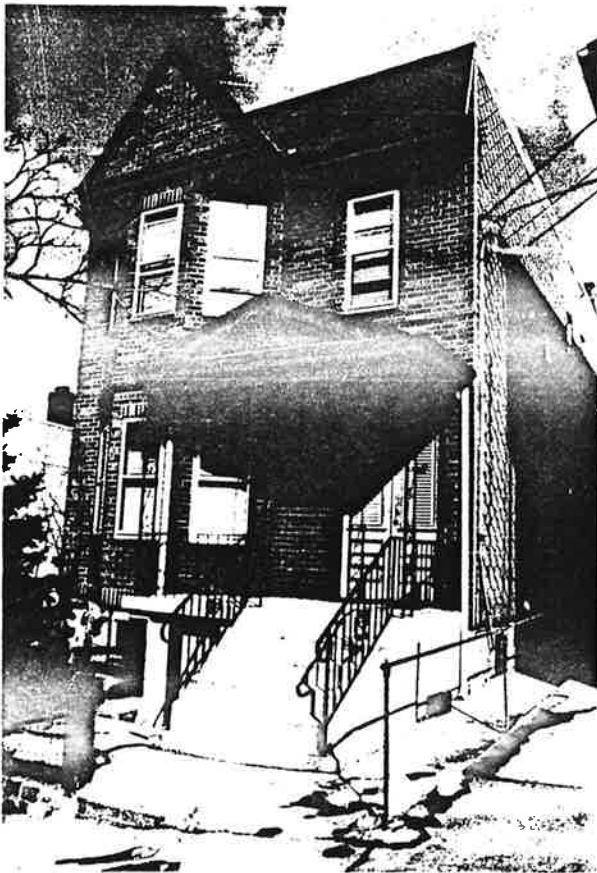
Site No. 0906-D1 spr
50 Spruce Street
Jersey City, N.J.
Photo Neg. No. ¹⁸⁷/₃
Map No. 7

AP #	ADDRESS/LOCATION : PROPERTY NAME	DATE	Signifi- cance to D/S	Condition	USE	DESCRIPTION: Style, Ext. Wall Fabric, Fenestration, Form, Roof, Major Features, Alterations, Stories, etc.	NEGATIVE FILE #
7	50 Spruce Street Block/953	Btwn. 1896 1928 (G.M. Hopkins Map 1928)				Queen Anne; recessed rectangular plan, 2 stories 2 bays wood framed exterior with asphalt/fiberglass siding, shed roof with triangular pediment above projecting bay window on left side of building; raking wood cornice with modillions, small vergeboards at corners of projecting bay windows, 1/1 wood double hung sash windows, triangular pediment and architraved cornice on porch roof; roof supported by iron posts and railings; double wooden entry doors each with a long slim glass panel, concrete stoop in front, moderate alterations.	Contact 187/3

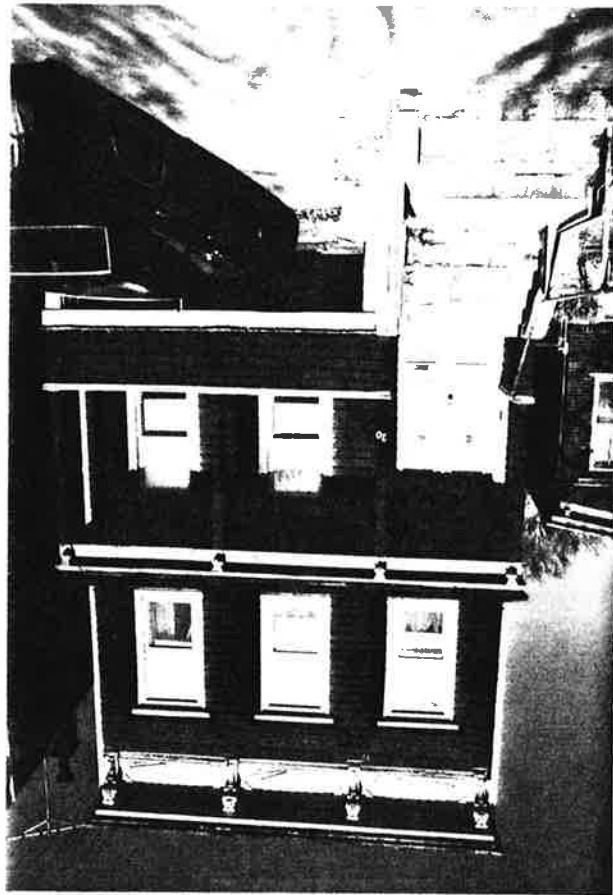
Site No. 0906 81A
 20 Tray Street
 Jersey City, N.J.
 Great N.Y. No. 188/11
 May No. 5

5.	20 Troy Street Block/846	Btwn. 1887- 1896 (San- born 1896)	P Theme	G	R	Italianate; recessed rectangular plan with side entry; wood framed building wood shingle siding; 5 1/1 wood double hung sash windows on facade; shed roof with architaved wooden cornice; 4 decorative wood brackets, fan-like molding on frieze all windows in wood framing; wooden window heads; small architaved cornice atop porch roof supported by 4 wooden posts; concrete stoop and wooden porch; paired entry doors with molded panels and transom window above; stoop appears to be a replacement; no other visible alterations.	Contact 188/11

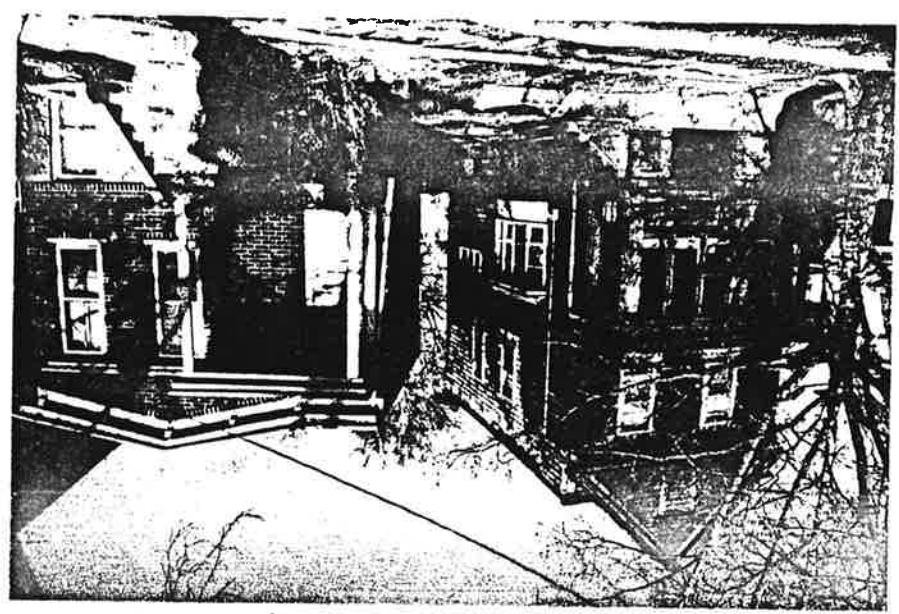
Site No. 0906 B1 ft
 24-22 Tray Street
 Jersey City, N.J.
 Photo No. 188/9
 May No. 7

6.	24-22 Troy Street Block/846	Btwn. 1896- 1928 (G.M. Hopkins Map 1928)	P Theme	G	R	a) #24 Victorian/Queen Anne; recessed rectangular plan with side entry; 2 stories; 2 bays; wood framed exterior with wood shingle siding; shed roof with triangular pediment atop facade; raking wood cornice, triangular pediment atop closed window of set into pediment, 1/1 wood double hung sash windows; large multi-lighted display bay window at side of building; brick and concrete foundation; corbel brackets support pediment; small fluted pilasters t side of pediment forming edges of cornice; concrete and wood stoop with iron railings lead up to single wooden door entry with transom above; no visible alterations.	Contact 188/10

6.	24-22 Troy Street Block/846		P Theme	G	R	b) #22 - Greek Revival; recessed rectangular plan with side entries; brick exterior; long 2/2 wood double hung sash windows; 1 story with basement; approximately 3 bays; shed roof with small gable architaved wood cornice with modillions; architaved window heads; wooden sills; architaved cornice atop porch roof supported by posts; paneled wooden door with transom window above, concrete stoop in front no visible alterations but moderate deterioration.	Contact 188/10
