NEW JERSEY OFFICE OF CULTURAL AND ENVIRONMENTAL SERVICES
 HISTORIC PRESERVATION SECTION
 DISTRICT/STREETSCAPE CONTINUATION SHEET

N.J. HISTORIC SITES INVENTORY

Date 3/85District/Streetscape Continuation Page # 1. Inventory # 0906-D2 ab

Abbott Street in Waverly Neighborhood of Survey Area
 (used D2) USHSI # 0906-D2 ab, Jersey City, Hudson Co.
 Page 1 of 1 photo pages.

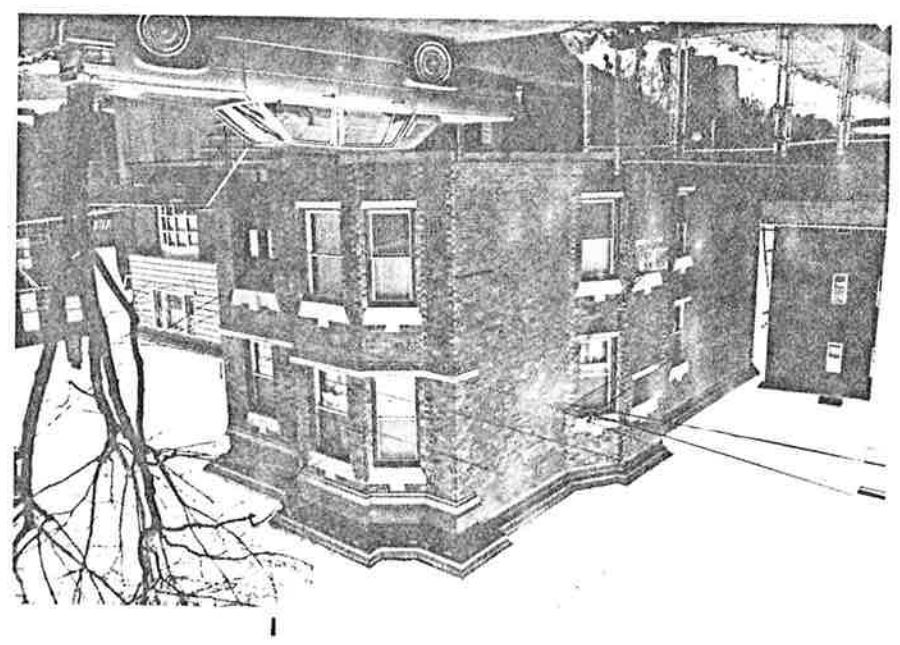
Site No. 0906-D2 ab
 11 Abbott Street
 Jersey City, N.J.
 Photo Neg. No. 182/15
 Map No. 1
 (bet. 1908-1919)

MAP #	ADDRESS/LOCATION : PROPERTY NAME	DATE	Signifi- cance to D/S	Condition	USE	DESCRIPTION: Style, Ext. Wall Fabric, Fenestration, Form, Roof, Major Features, Alterations, Stories, etc.	NEGATIVE FILE #
1.	11 Abbett Street Block: 726 (Contact: 182/15)	Between 1908- 1919	P It. Brick Theme	G/E	R ¹	Italianate Variant, 2 story, brick, 1 main entry, irregular rectangular plan. Window and portal heads stone with keystones; rectangular windows with 1/1 sash and stone sills; tripartite projecting bay rises the height of the building; continuous bracketed cornice.	Contact: 182/15

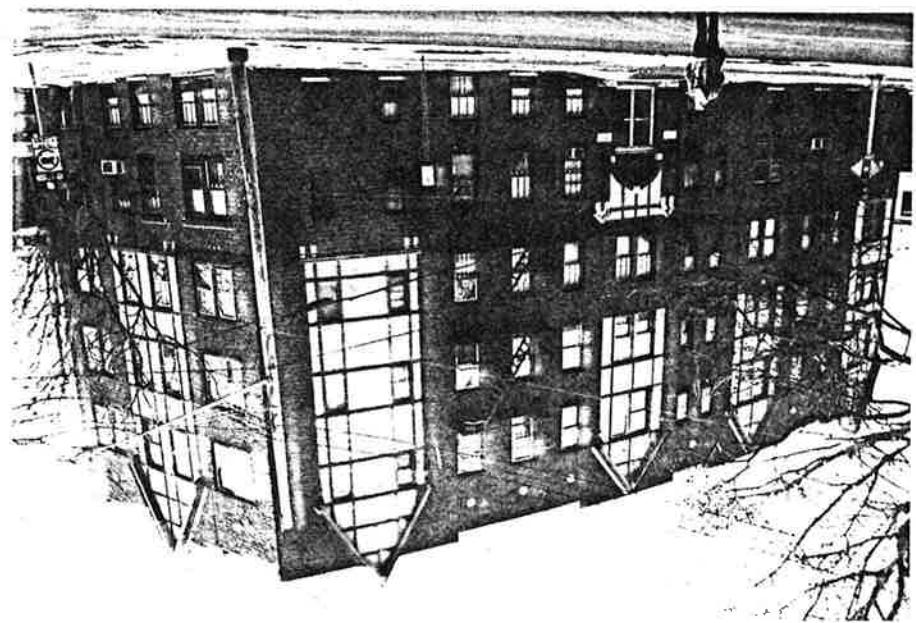
Site No. 0906-D2 bal
502 Baldwin Ave.
Jersey City, N.J.
Photo Neg. No. 181/11
Map No. 1
(after 1928)

MAP #	ADDRESS/LOCATION : PROPERTY NAME	DATE	Signifi- cance to D/S	Condition	USE	DESCRIPTION: Style, Ext. Wall Fabric, Fenestration, Form, Roof, Major Features, Alterations, Stories, etc.	NEGATIVE FILE #
1.	502 Baldwin Avenue Block: 709 $\frac{1}{2}$ (Contact: 181/11)	After 1928	P Apt. Theme	E	R ²	Tudor apartment house, 4 stories with basement, 12 bays, brick, 1 main entry, irregular U shaped plan. Main entry with pointed arch and brick and stucco surround; rectangular windows with varying sash; irregular fenestration; brick and stucco end sections (stories 2-4) and 2 unsymmetrically placed brick and stucco center sections (stories 3-4), all terminating in gable roof ends; brick parapet.	Contact: 181/11

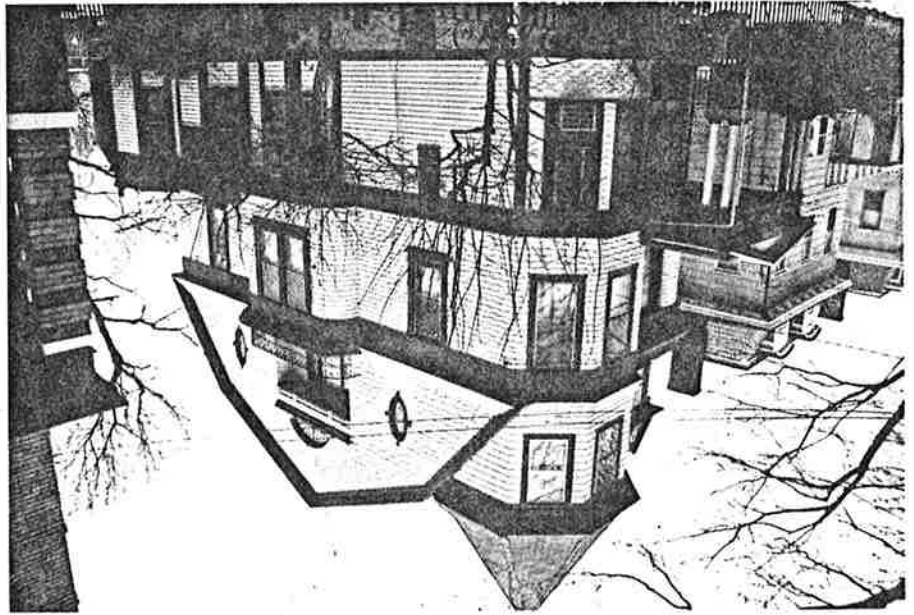
74 Boorem Avenue
 Photo Neg. No. 182/10

5.	74 Booream Avenue Block: 719 (Contact: 182/9,10)	Between 1896- 1908	P Queen Anne Theme	E	R ¹	Queen Anne, 3 stories, frame, 1 main entry, irregular rectangular plan with rear extensions. Gable roofed porch with wreath and swag decorated frieze carried by 2 sets of 3 columns set before main entry; rectangular windows with 1/1 sash; tower with tent roof with octagonal base to right of entry; gable roofed dormer set into pitched roof of front facade; gambrel roof end on side elevation. Continuous frieze at top of 2nd story has been covered over or replaced by modern siding.	Contact: 182/9,10

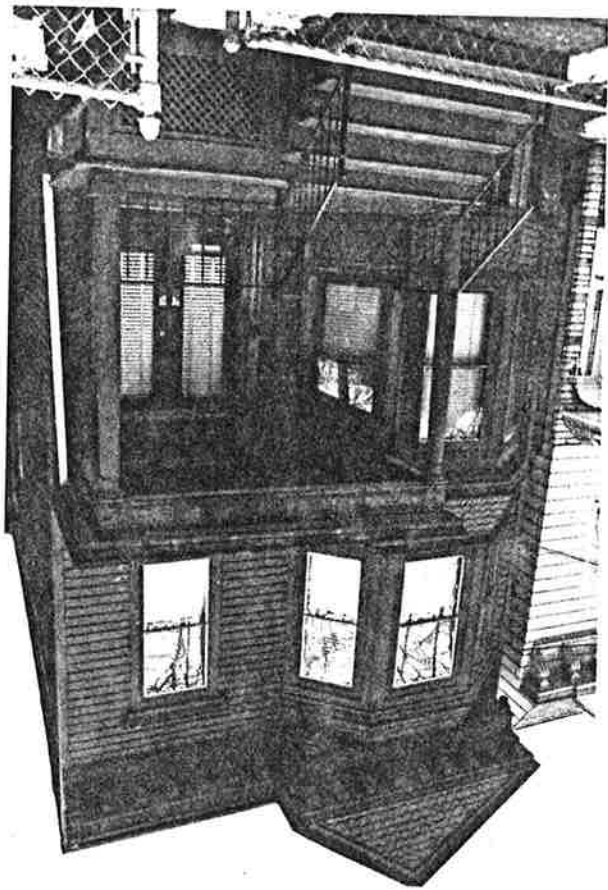
Site No. 0906-D2 door
90 Booram Avenue
Jersey City, N.J.
Photo Neg. No. 182/14
Map No. 7
(bat. 1896-1908)

MAP #	ADDRESS/LOCATION : PROPERTY NAME	DATE	Signifi- cance to D/S	Condition	USE	DESCRIPTION: Style, Ext. Wall Fabric, Fenestration, Form, Roof, Major Features, Alterations, Stories, etc.	NEGATIVE FILE #
7.	90 Booream Avenue Block: 719 (Contact: 182/14)	Between 1896- 1908	Y Queen Anne Theme	G/E	R ¹	Queen Anne Variant, 2 stories, frame, 1 main entry, irregular rectangular plan. Wooden porch with dentils and plain frieze set on columns before entry; 2 story tripartite projecting bay topped by pediment; single window with cornice head above entry; rectangular windows with wood enframements and 1/1 sash; small colonnettes between windows of projecting bay; bracketed cornice with dentils and frieze decorated with rinceau design in relief; pendants beneath pediment; fish scale shingles on projecting bay and pediment. Modern metal railings on porch and stairs.	Contact: 182/14

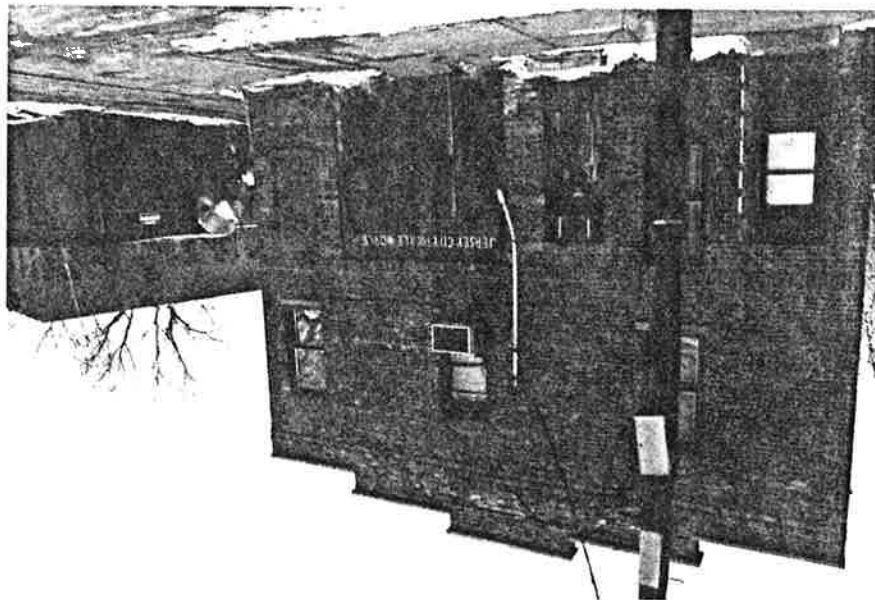
Site No. 0906-D2 jef
 116 Jefferson Avenue
 Jersey City, N.J.
 Wreck
 Jersey City Pickle
 Photo Neg. No. 181/15
 Map No. 4
 (bet. 1908-1919)
 facade bet. 1919-1923

MAP #	ADDRESS/LOCATION : PROPERTY NAME	DATE	Signifi- cance to D/S	Condition	USE	DESCRIPTION: Style, Ext. Wall Fabric, Fenestration, Form, Roof, Major Features, Alterations, Stories, etc.	NEGATIVE FILE #
4.	116 Jefferson Avenue Jersey City Pickle Works Block: 705 (Contact: 181/15)	Between 1908- 1919; Facade between 1919- 1928	P Industrial Theme	F	C	Early Industrial style, 2 stories, brick, L shaped plan. <u>Ground Story</u> : Main entry plus garage entrance; rectangular windows with stone sills; 1 entry and 1 window boarded up. <u>2nd Story</u> : Rectangular windows with 1/1 sash, stone sills, and brick lintels. Building terminates in brick stepped parapet.	Contact: 181/15

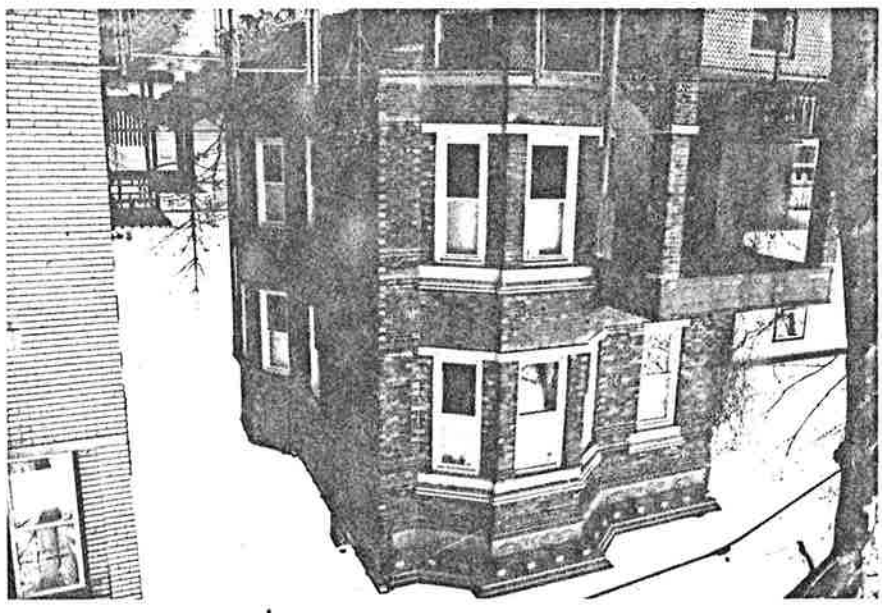
Site No. 0906 - D2 Ric
 3 Lienau Place
 Jersey City, N.J.
 Photo Neg. No. 207/17
 Map No. 1
 (bet. 1908 - 1919)

1.	3 Lienau Place Block: 708 (Contact: 207/17)	Between 1908- 1919	P It. Brick Theme	G/F	R ¹	Italianate Variant, 2 stories, brick, 1 main entry, irregular rectangular plan, set back. Front porch set on brick piers; tripartite projecting bay rises the height of the building; rectangular windows with 1/1 sash; windows of bay have continuous stone sills and cornice window heads with plain frieze; matching single window above entry; bracketed cornice with decorative frieze. Porch and stoop area have been altered.	Contact: 207/17

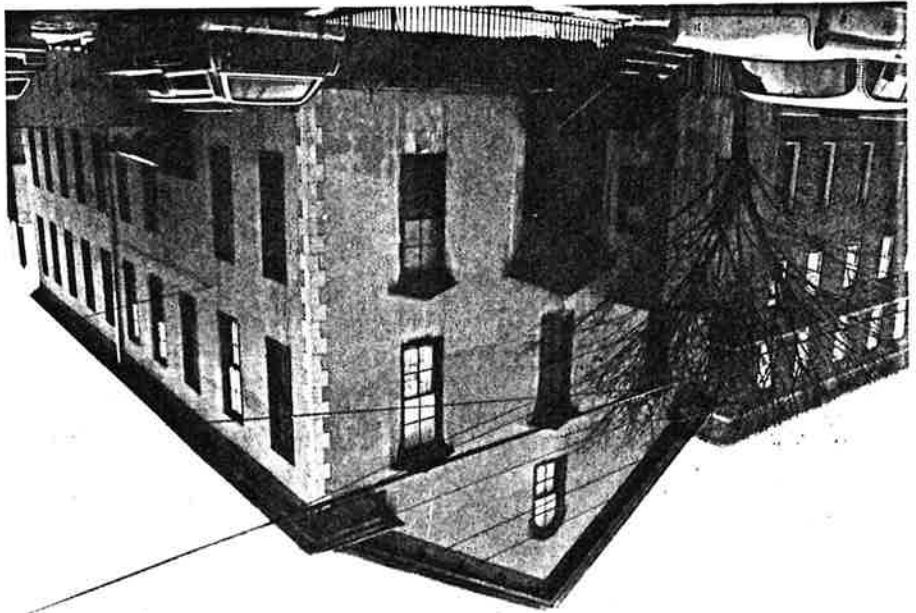
Site No. 0906-D2 fer
119 Ferry Street
St. Nicholas R.C.
Sisters' House
Jersey City, N.J.
Photo Neg. No. 183/14
Map No. 1
(bet. 1896-1908)

MAP #	ADDRESS/LOCATION : PROPERTY NAME	DATE	Signifi- cance to D/S	Condition	USE	DESCRIPTION: Style, Ext. Wall Fabric, Fenestration, Form, Roof, Major Features, Alterations, Stories, etc.	NEGATIVE FILE #
1.	119 Ferry Street St. Nicholas R.C. Sisters' House Block: 726 (contact: 183/14)	Between 1896- 1908	Y Complex (See D-5)	G	O	Italianate, 2½ stories, 3 bays, 1 main entry, stucco over frame, rectangular plan with 1 story front extension. Main entry with panelled wooden surround and pedimented portal head; 2nd-3rd story windows with decorated pedimented heads; ½ story window with round arched label head; all windows with 4/4 sash; quoins at corners of building ; gable roof with end facing street; continuous bracketed cornice. Front extension not original.	Contact: 183/14

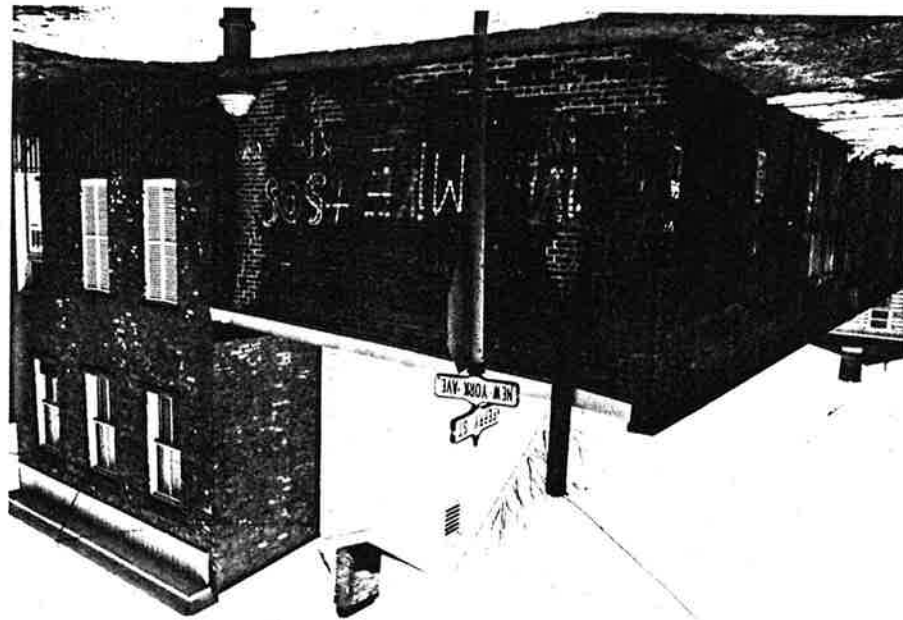
Site No. 0906-D2 ny
 123 New York Ave.
 Jersey City, N.J.
 Photo Neg. No. 184/1
 Map No. 1
 (frame section below
 1873, brick section
 bldg. 1887-1896)

1.	123 New York Avenue Block: 737 (Contact 184/1)	Frame Section Before 1873; Brick Section Between 1887- 1896	P It. Brick Theme	G/E	R ¹	Italianate, 2 stories, 3 bays, brick front section attached to frame building, 1 main entry, rectangular plan with rear extension. Main entry with transom and modern door; rectangular windows with 2/2 sash and stone lintels and sills; modern replacement cornice. Brick section with flat roof; frame section with variant gable roof. Property listed on 1873 map as belonging to M. Messmann.	Contact: 184/1

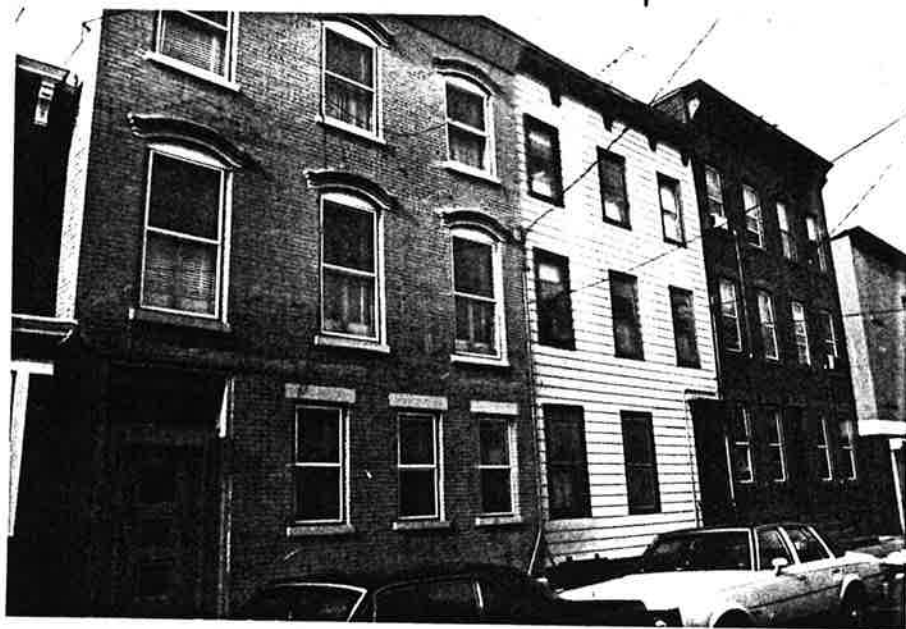
Site No. 0906-D2 ny
143 New York Ave.
Jersey City, N. J.
Photo Neg. No. 185/11
Map No. 5
(c. 1875)

5.	143 New York Avenue Block: 737 (Contact: 185/11)	c.1875	P It. Brick Theme	G/F	R ²	Italianate, 3 stories, 3 bays, brick, 1 main entry, rectangular plan with rear extension. Replacement door with transom; rectangular windows with 1/1 sash, stone sills and lintels; decorated segmentally arched window heads on 2nd-3rd stories. Cornice covered over with modern siding.	Contact: 185/11

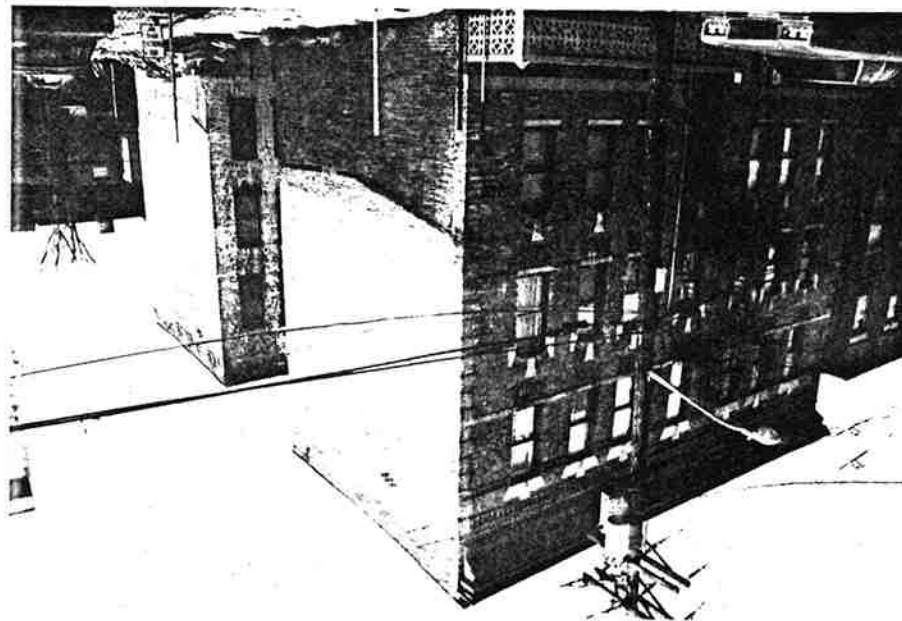
Site No. 0906-D2 ny
 156 New York Avenue
 Jersey City, N.J.
 Photo Neg. No. 185/14
 Map No. 8
 (before 1873)

8.	156 New York Avenue Block: 738 (Contact: 185/14)	Before 1873	P It. Brick Theme	G/E	R ²	Italianate, 3 stories, 3 bays, brick, 1 main entry, rectangular plan with rear extension. Replacement entry door with transom; rectangular windows with stone lintels and sills; cornice with ornate foliate brackets and plain frieze. Property listed on 1873 map as belonging to A. Gow.	Contact: 185/14

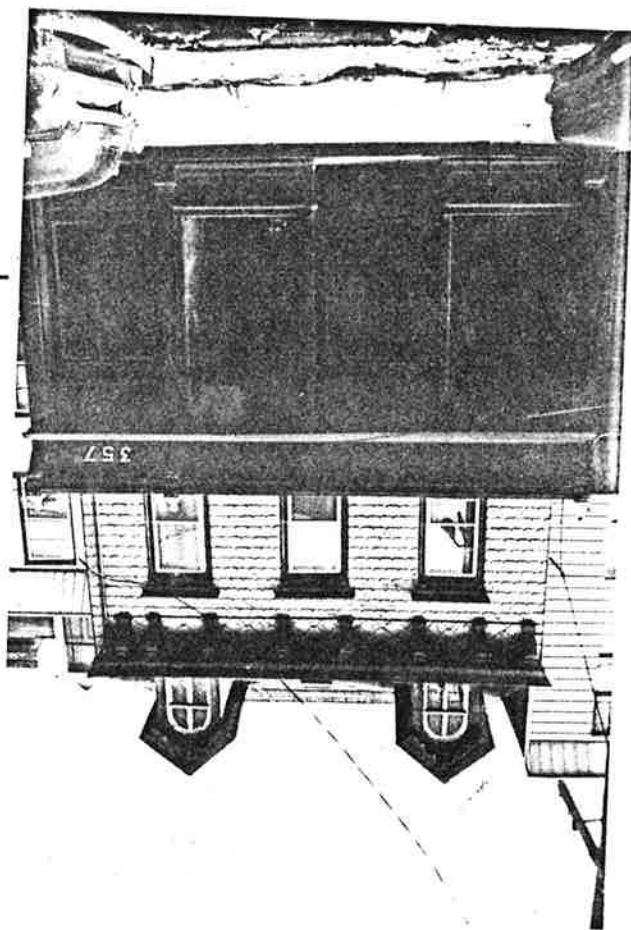
Site No. 0906-D2 pad
 357 Palisade Avenue
 Jersey City, N. J.
 Photo Neg. No. 185/15
 Map No. 13
 (bet. 1873 - 1887)

13.	357 Palisade Avenue Block: 738 (Contact: 185/15)	Between 1873- 1887	P It. Wood Theme	E	C	Italianate Variant, 2½ stories, 3 bays, frame, multiple entries, rectangular plan with rear extensions. <u>Ground Story</u> : Old store front with panelled base, fluted pilasters, and cornice with modillions, brackets topped by finials, and swag decorated frieze bearing words "Breher Bros." <u>2nd Story</u> : Rectangular windows with 1/1 sash and bracket supported cornice window heads; decorative shingling; bracketed cornice. Gable roofed dormers with scalloped vergeboards and round headed windows with 2/2 sash set into gable roof.	Contact: 185/15

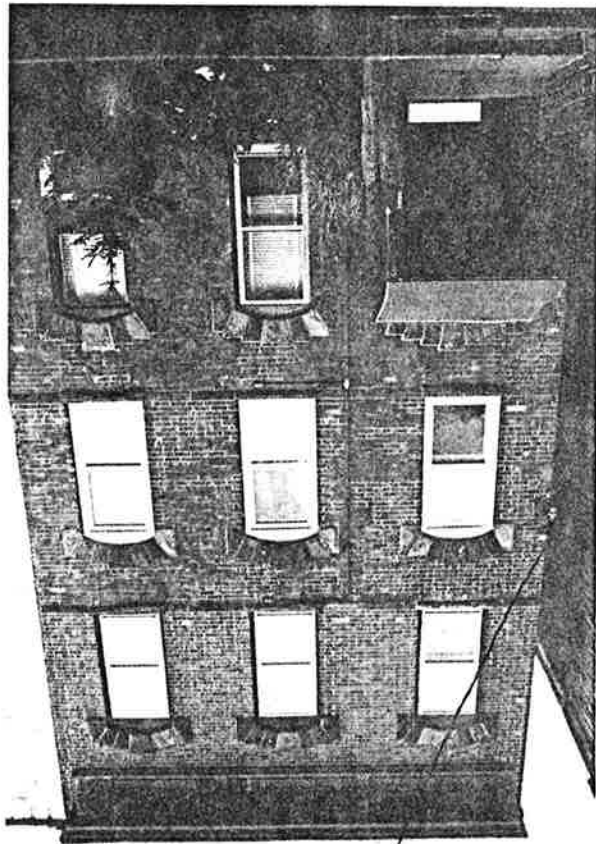
Site No. 0906-D2 pass
 52 Prospect Street
 Jersey City, N.J.
 Photo Neg. No. 179/14
 Map No. 1
 (bat. 1887-1896)

1.	52 Prospect Street Block: 714 (Contact: 179/17)	Between 1887- 1896	P It. Brick Theme	F	R ²	Italianate Variant, 3 stories, 3 bays, brick, 1 of twin houses, rectangular plan with rear extension; 1 main entry. Stone, segmentally arched portal and window heads with rusticated voussoirs; rectangular windows with 1/1 sash; stone belt courses form lintels; bracketed cornice with modillions and panelled frieze. Metal awning intrudes upon portal head; all stonework is deteriorating.	Contact: 179/17

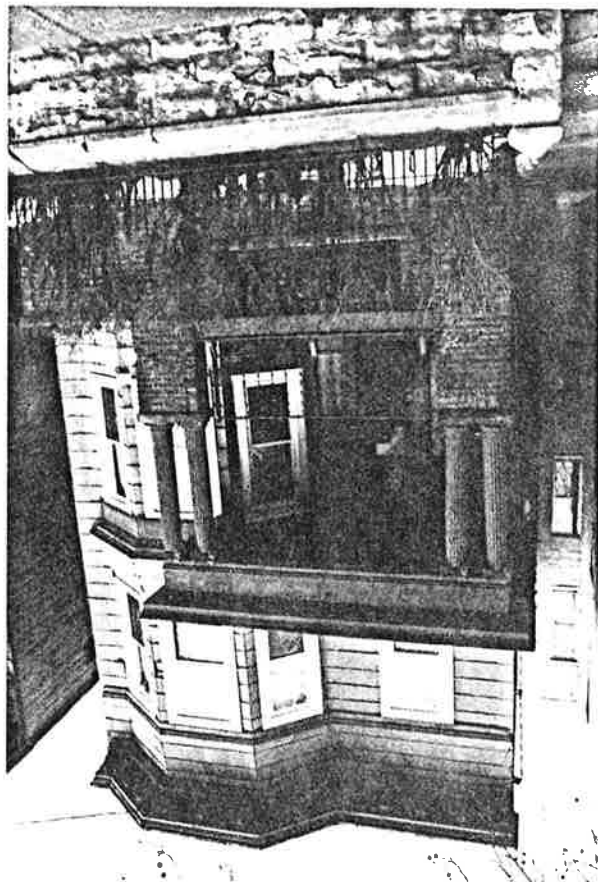
Site No. 0906-D2 pass
 56 Prospect Street
 Jersey City, N.J.
 Photo Neg. No. 179/15
 Map No. 2
 (bat. 1896-1908)

2.	56 Prospect Street Block: 714 (Contact: 179/15)	Between 1896- 1908	P It. Wood Theme	G/F	R ¹	Italianate Variant, 2 stories, frame, 1 main entry, rectangular plan. Wooden porch with dentils, plain frieze, and paired fluted columns with Ionic capitals set on brick piers; tripartite projecting bay extends height of building; rectangular windows with 1/1 sash and wooden enframements; bracketed cornice with dentils. Stone work on porch deteriorating.	Contact: 179/15

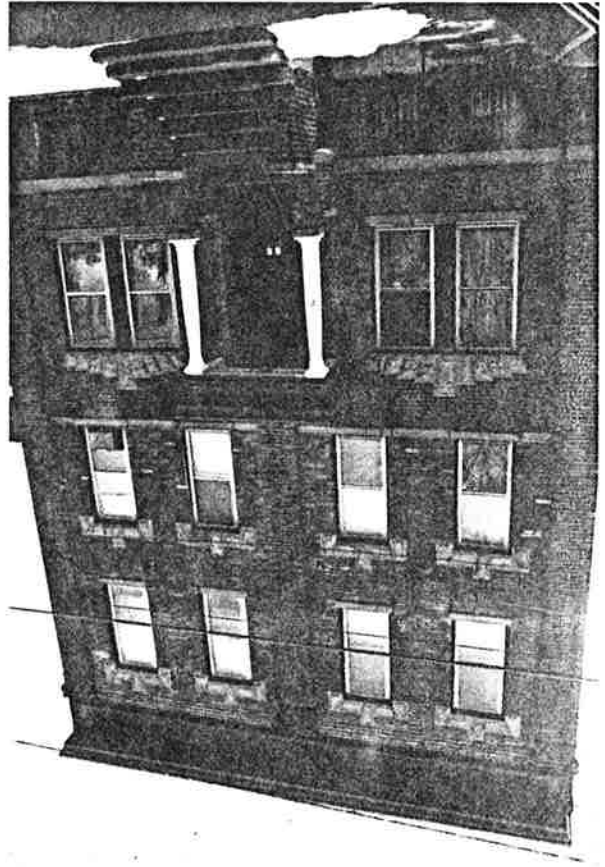
Site No. 0906-D2 pros
 81 Prospect Street
 Jersey City, N.J.
 Photo Neg. No. 179/9
 Map No. 5
 (bar. 1908-1919)

5.	81 Prospect Street Block: 709 (Contact: 179/9)	Between 1908- 1919	P Geo. Revival Theme	G	R ²	Georgian Revival, 3 stories, 4 bays, brick, 1 main entry, rectangular plan. <u>Ground Story:</u> Small porch with decorated frieze carried on columns is set before main entry; double windows with stone lintels with rusticated voussoirs. <u>2nd-3rd Stories:</u> Windows with rusticated stone label lintels with keystones. All windows rectangular with 1/1 sash and stone sills; corner and center pilasters with ornate capitals; bracketed cornice with decorated frieze matching that of porch.	Contact: 179/9

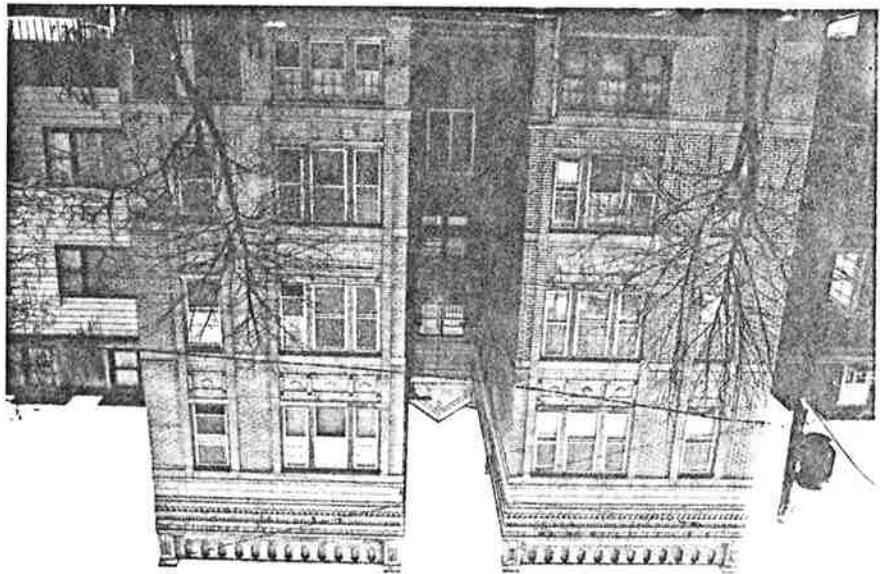
Site No. 0906-D2 trav
45-47 Ravine Ave.
Jersey City, N. J.
Photo Neg. No. 184/16
Map No. 3
(bet. 1908-1919)

MAP #	ADDRESS/LOCATION : PROPERTY NAME	DATE	Signifi- cance to D/S	Condition	USE	DESCRIPTION: Style, Ext. Wall Fabric, Fenestration, Form, Roof, Major Features, Alterations, Stories, etc.	NEGATIVE FILE #
3.	45-47 Ravine Avenue Block: 719 (Contact: 184/16)	Between 1908- 1919	P Apt. Theme	G/E	R ²	Decorated Brick, 3 story with basement, 5 bays, brick, multiple entrances, irregular rectangular plan with entrance court and side light well courts. Double windows topped by pediment in recessed entry area; tripartite window and single window to either side of entry area; windows with 9/1 sash; basement windows 6/1 sash; decorative brickwork panelling of facade; decorative brick work bands surmounted by brick parapet with blind arcade.	Contact: 184/16

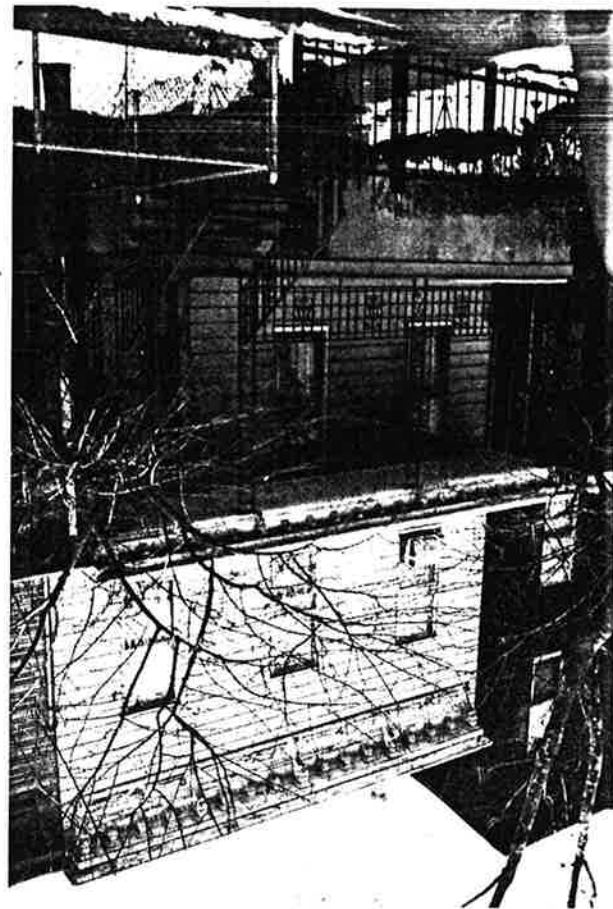
Site No. 0906-D2 ne
 99 Reservoir Avenue
 Jersey City, N.J.
 Photo Neg. No. 209/6
 Map No. 12
 (bet. 1887-1896)

12.	99 Reservoir Avenue Block: 710 (Contact: 209/6)	Between 1887- 1896	P It. Wood Theme	G/E	R ¹	Italianate, 2 stories, 3 bays, frame, 1 main entry, rectangular plan. Porch with bracketed cornice extends across ground story; rectangular windows with 1/1 sash; bracketed cornice with modillions and a frieze with decorative panelling. Building has been resurfaced; original porch supports and railings have been replaced with modern metal ones; window trim has been removed.	Contact: 209/6

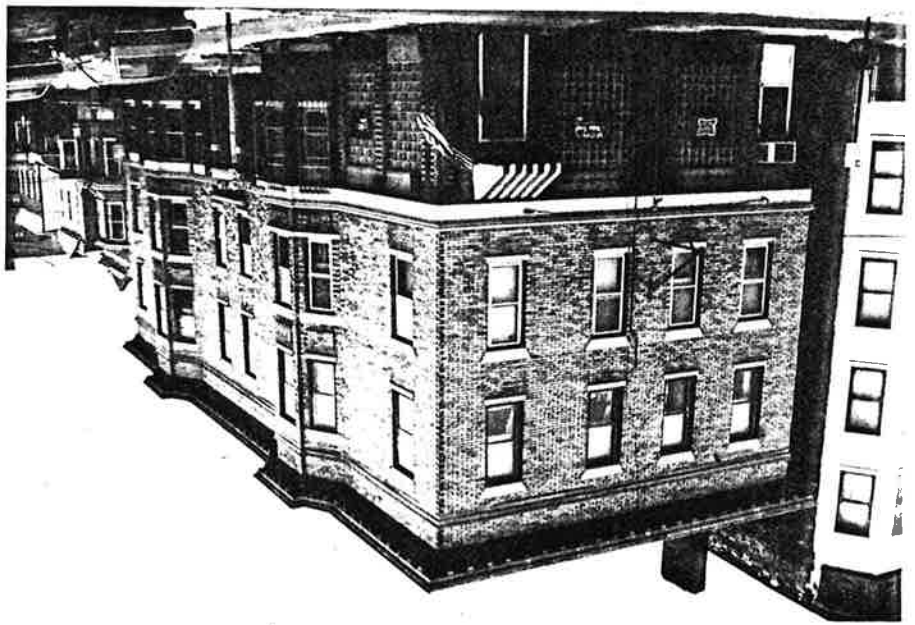
Site No. 0906-D2 res
 112-116 Reservoir Ave.
 Tenney City, N.J.
 Photo Neg. No. 209 1/2
 Map No. 15
 (bet. 1896-1908)

15.	112-116 Reservoir Avenue Block: 715 (Contact: 209/2)	Between 1896- 1908	P Geo. Revival Theme	G/E C/R	R2	Georgian Revival Variant, 3 stories, brick, multiple entries, rectangular plan. Bar occupies portion of ground story; main entry with stone head; 2 tripartite projecting bays rise height of building; rectangular windows with 1/1 sash, stone lintels and sills; bracketed cornice.	Contact: 209/2

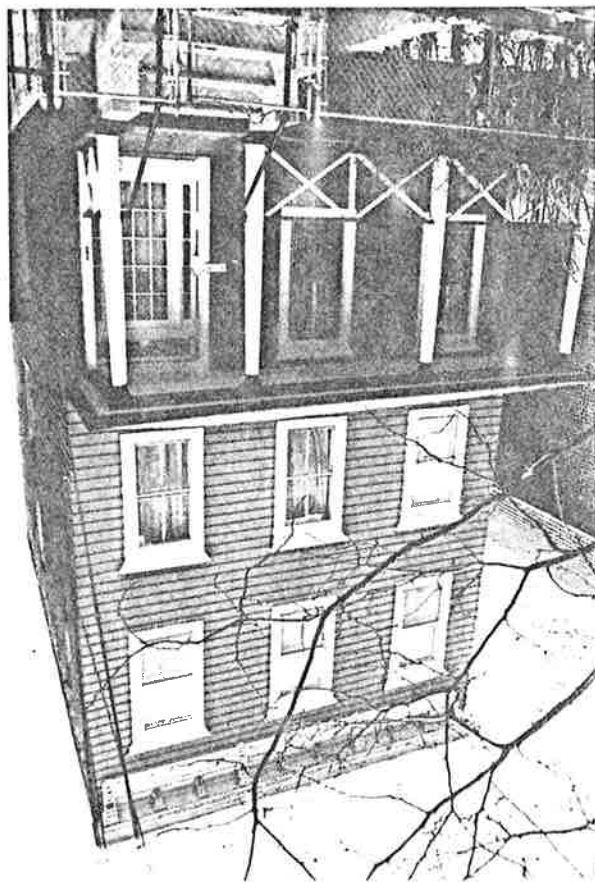
Site No. 0906 - D2 Sher
26 Sherman Avenue
Waverly City, N.Y.
Photo Neg. No. 184/18
Map No. 1
(before 1873)

MAP #	ADDRESS/LOCATION : PROPERTY NAME	DATE	Signifi- cance to D/S	Condition	USE	DESCRIPTION: Style, Ext. Wall Fabric, Fenestration, Form, Roof, Major Features, Alterations, Stories, etc.	NEGATIVE FILE #
1.	26 Sherman Avenue Block: 736 (Contact: 184/18)	Before 1873	P It. Wood Theme	E	R2	Italianate, 3 stories, 3 bays, frame, 1 main entry, rectangular plan with rear and side extensions. Front porch carried on columns; main entry with multi-paned door, sidelights, and transom; rectangular windows with 2/2 sash and broad wooden enframements and cornice window heads; cornice with ornate brackets and modillions and a panelled frieze. Modern concrete steps lead to front porch.	Contact: 184/18

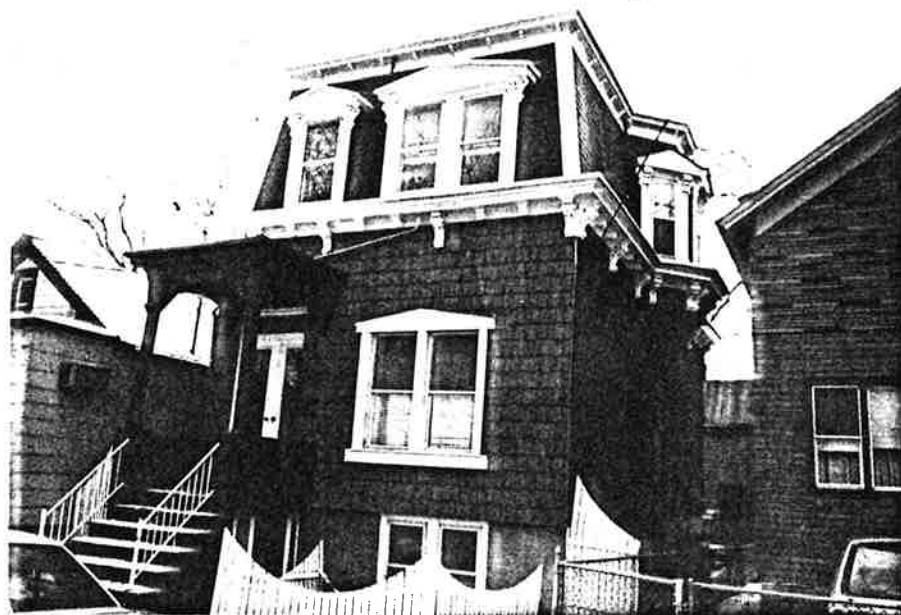
Site No. 0906-D2 wa
101 Waverly Street
Jersey City, N. J.
Photo Neg. No. 207/
15
Map No. 7
(bet. 1873-1887)

MAP #	ADDRESS/LOCATION : PROPERTY NAME	DATE	Signifi- cance to D/S	Condition	USE	DESCRIPTION: Style, Ext. Wall Fabric, Fenestration, Form, Roof, Major Features, Alterations, Stories, etc.	NEGATIVE FILE #
7.	101 Waverly Street Block: 705 (Contact: 207/15)	Between 1873- 1887	P Second Empire Theme.	E	R ¹	Second Empire, 2 stories with basement, 2 bays, frame, rectangular plan with rear extension. Single main entry prefaced by bracketed porch carried on posts; double windows with pediment on ground story; continuous bracketed cornice with modillions surmounted by mansard roof topped by continuous bracketed cornice; a single and a double windowed dormer, both with pediments supported by ornate brackets, are set into the mansard roof. Stoop area is not original. All windows with 1/1 sash.	Contact: 207/15,14

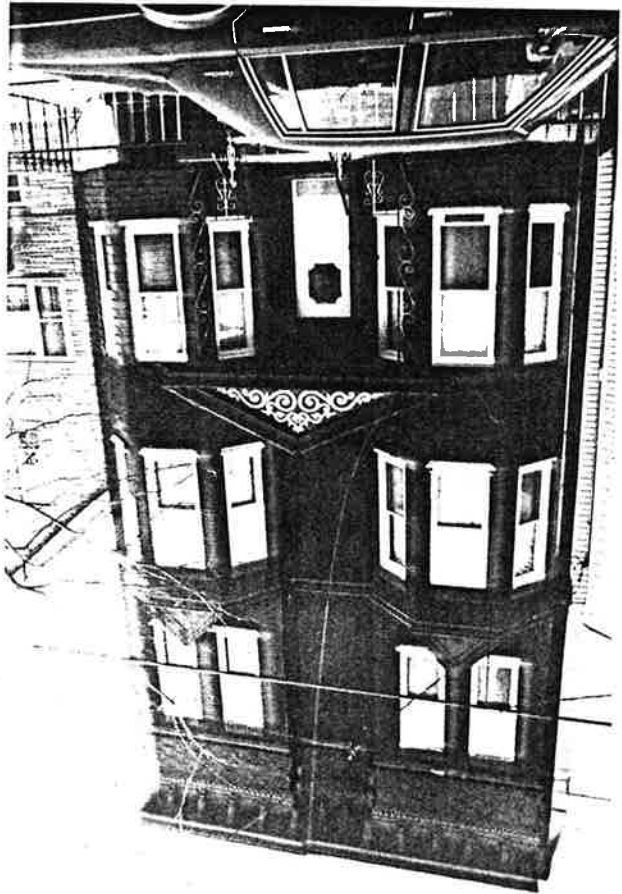
Site No. 0906-D2 web
78 Webster Avenue
Jersey City, N.J.
Photo Neg. No. 185/3
Map No. 9
(bet. 1887-1896)

9.	78 Webster Avenue Block: 737 (Contact: 185/3)	Between 1887- 1896	P It. Wood Theme	G/ER ²		Italianate Variant, 3 stories, frame, 1 main entry, rectangular plan. Gable roofed porch with relief decoration in the tympanum and modern scrolled iron posts set before main entry; 2 tripartite projecting bays rise to top of 2nd story; central 2nd story window of bays topped by pediment; rectangular windows with 1/1 sash; bracketed cornice with decorated panelled frieze. Building has been resurfaced.	Contact: 185/3
