Bleeker Street in Western Slope Neighborhood of Survey
 Area (ward B) 0906-B3 bl, N.Y. 45 I. 0906 Jersey City,
 Hudson County

NEW JERSEY OFFICE OF CULTURAL AND ENVIRONMENTAL SERVICES
 HISTORIC PRESERVATION SECTION
 DISTRICT/STREETSCAPE CONTINUATION SHEET

N.J. HISTORIC SITES INVENTORY

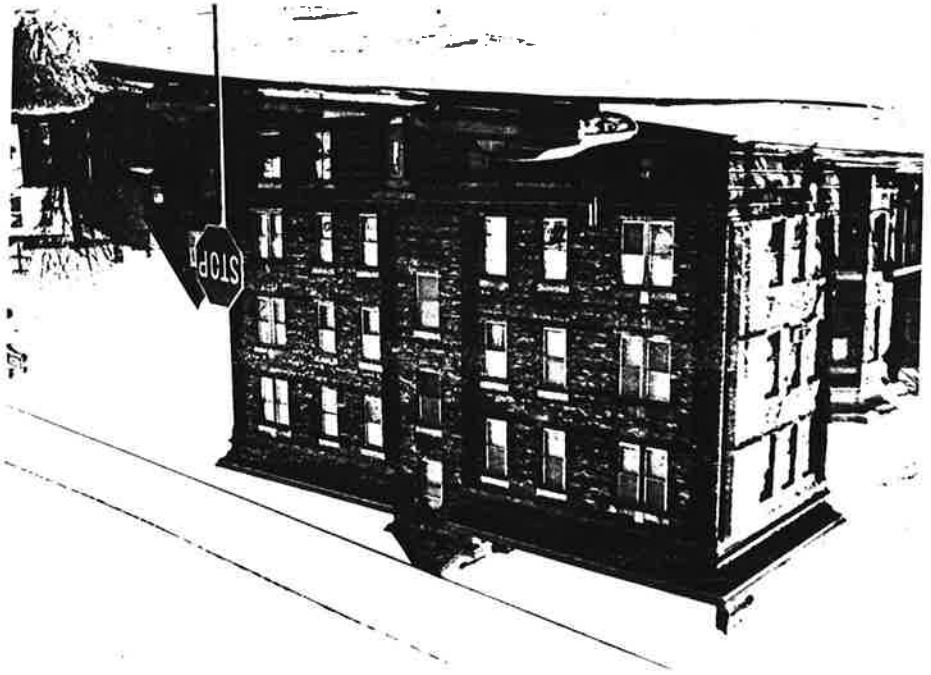
Site No. 0906-8386
 151 Bleeker Street
 Gurray City, N.Y.
 Photo Neg. No. 212/10
 Map No. 1

1.	151 Bleecker Street Block/920	Btwn. 1896 1928 (G.M. Hopkins 1928)	P	E	R2	Italianate; recessed rectangular plan with central entry; 3 story brick building with basement level; 1/1 wood double hung sash windows on building; 1 casement window at basement level; flat roof with pediment atop; brick chimney atop roof; architraved wooden cornice; molded frieze; stone lintels and sills, some keystones on lintels; polychromatic brick exterior; brick bands surrounding basement level differs from that of successive stories; brick pilasters on facade and corners of building; single wooden entry door with stone overdoor above entry; no visible alterations.	Contact 212/10

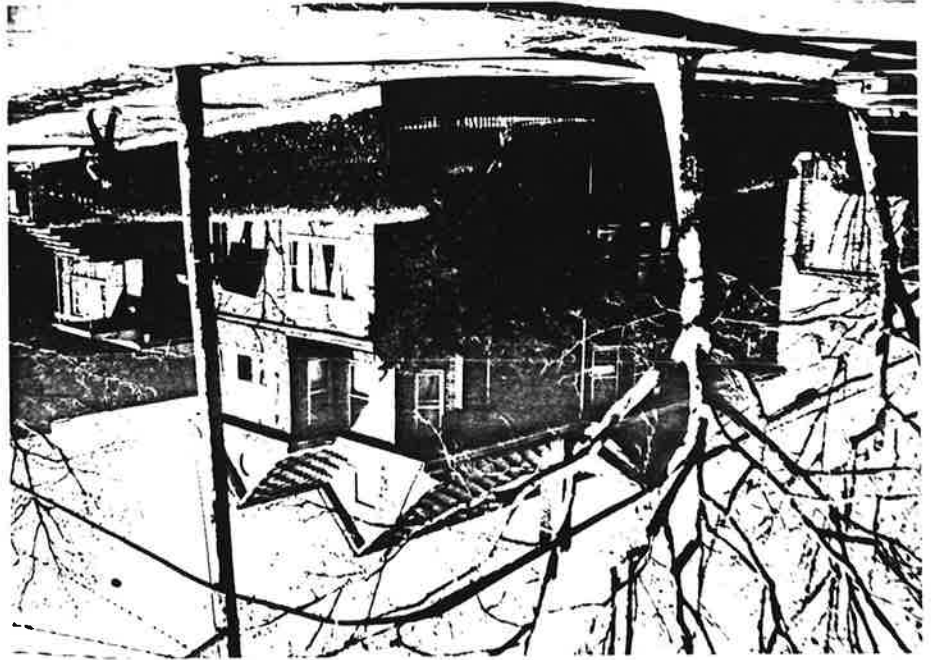
Site No. 0906-8386
 146-148 Bleeker Street
 Gurray City, N.Y.
 Photo Neg. No. 212/11
 Map No. 2

2.	146-148 Bleecker Street Block/915	Btwn. 1896 1928 (G.M. Hopkins 1982)	P	G	R	Victorian/Queen Anne; recessed rectangular plan with side entry; 2 1/2 story wood framed building now resurfaced with asphalt/fiberglass siding; 1/1 wood double hung sash windows; projecting bays on facade and side of building; cross-gabled roof covered with asphalt/fiberglass roofing tiles; circular windows set into gables topping projecting bays; architraved wooden cornices; brick chimneys single wooden entry door with aluminum storm door in front; aluminum awning above entry; iron fence and hedges surround lot; exterior resurfacing constitutes a moderate alteration.	Contact 212/11

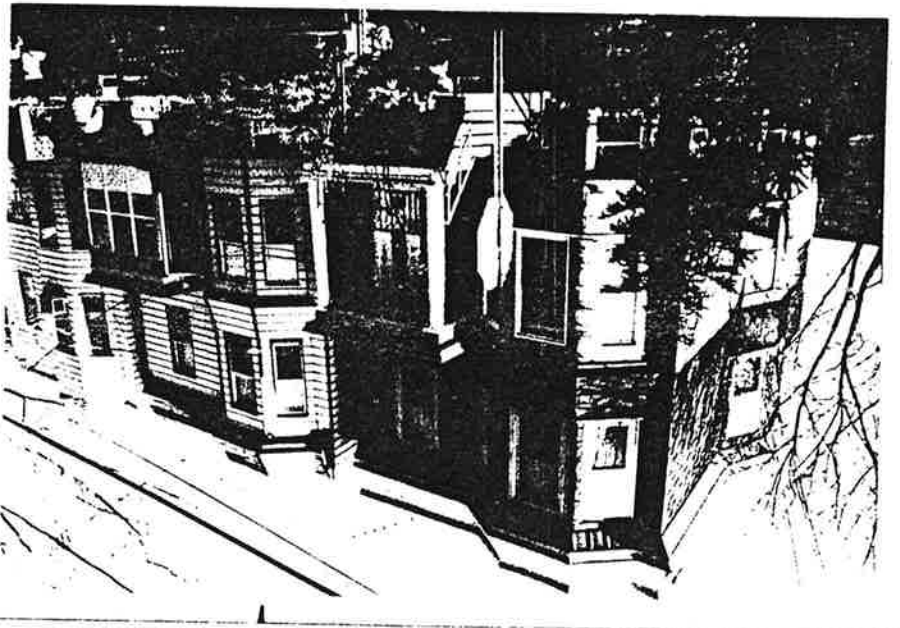
Site No. 0906-B3 col
1-5 Columbia Ave.
Jersey City, N.J.
Photo Neg. No. 191 2
Map No. 1

AP #	ADDRESS/LOCATION : PROPERTY NAME	DATE	Signifi- cance to D/S	Condition	USE	DESCRIPTION: Style, Ext. Wall Fabric, Fenestration, Form, Roof, Major Features, Alterations, Stories, etc.	NEGATIVE FILE #
1	1-5 Columbia Avenue Block/930	Btwn 1986- 1928 (G.M. Hopkins Map 1928)		F/B	R	Greek Revival/Queen Anne recessed rectangular plan with side entry; 2 stories with basement approximately 2 bays, on (left side) projects outward, slightly projecting bay (side of building), front porch projects or extends outward from #s 1 and #3 shed roof with brick chimneys, 1/1 wood double hung sash windows on all buildings; asphalt/fiberglass on aluminum siding exist on both sides of building, bracketed wood cornice on #3, cornices of other buildings concealed stone or brick foundations on all three buildings; 2 Doric wooden columns support porch roof on #1, enclosed stoop on #3; wooden stoop on #1; concrete porch on #3, brick stoop on #5; double wooden entry doors with transom on #1 single wooden doors on #3 and #5; buildings severely altered.	Contact 191/21

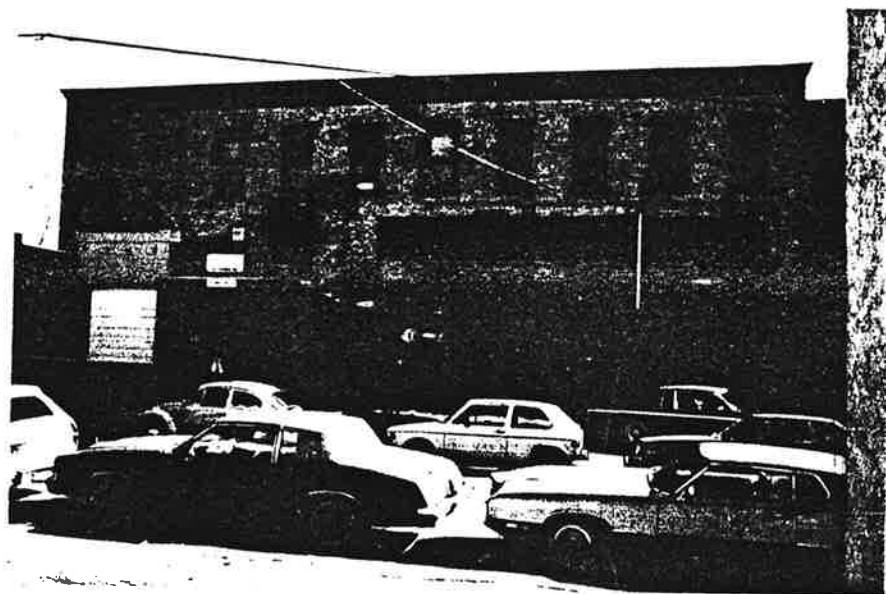
Site No. 0906-D3co
 40-48 Columbia
 Avenue
 Jersey City, N.J.
 Photo Neg. No. $\frac{212}{4}$
 Map No. 3

3.	40-48 Columbia Avenue Block/924 Building serves as a plumbing supply warehouse	Btwn 1873- 1887 (L.D. Fowler Map 1887.)	N	F	C	Greek Revival (Industrial) recessed rectangular plans with side entries; 2 stories; 10 bays; 6 bays (side) brick exterior; projecting entryway in front of building; 1 story rear addition to building in rear; architaved wooden cornice with brackets; 1/1 wood double hung sash windows, some on 1st story are concreted up; stone foundation to building, truck loading entry far left of building; single wooden entry door at side of 1st story entryway addition to building; single wooden door with iron windows walk on 2nd story, minor alterations such as addition of truck loading entry and entry-way.	Contact 212/4

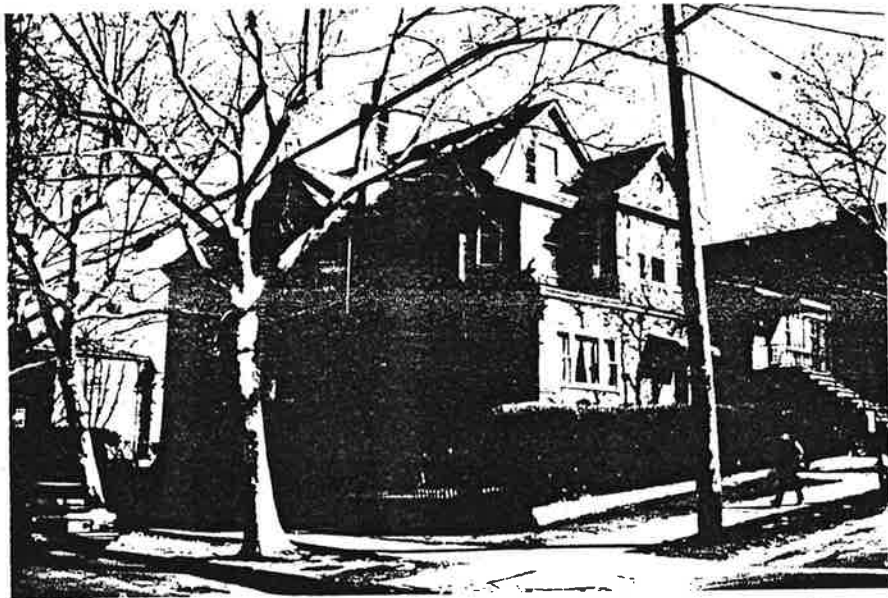
Page 9 of 16
 Site No. 0906-D3 col
 141-48 Columbia Ave.
 Jersey City, N.J.
 Photo Reg. No. 212
 Map No. 15

15.	146-148 Columbia Avenue Block 915	#146 Btwn 1873 1887 (L.D. Fowler Map 1887 #148 Btwn 1887- 1896 (San- born 1896)		G	R	Queen Anne; recessed rectangular plan with side entry; 2 1/2 stories wood frame building now resur- faced with asphalt/fiberglass siding 1/1 wood double hung sash windows on this irregular shaped building with cross and multi gabled roof, oriels, picture and smaller 1/1 windows on building; casement windows at basement level; brick foundation; gabled roof has brick chimney atop; architaved cornice on building below gables; entry consist of single wooden entry door with aluminum awning above; residing only moderate alteration visible on building.	Contact 212/11

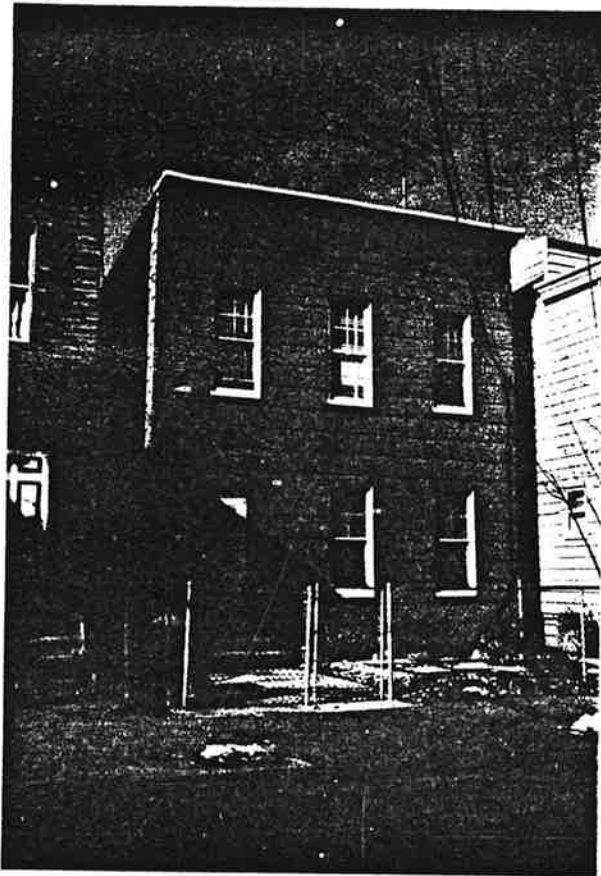
Site No. 0906-D3 col
159 Columbia
Avenue
Jersey City, N.J.
Photo Neg. No. 212
Map No. 17

AP #	ADDRESS/LOCATION : PROPERTY NAME	DATE	Signifi- cance to D/S	Condition	USE	DESCRIPTION: Style, Ext. Wall Fabric, Fenestration, Form, Roof, Major Features, Alterations, Stories, etc.	NEGATIVE FILE #
17	159 Columbia Avenue Block 916	Btwn 1873- 1887 (L.D. Fowler Map 1887)				Greek Revival, recessed rectangular plan with side entry; wood framed, resurfaced with vinyl siding 4/1 wood double hung sash windows, 2 stories with basement, 3 bays; architraved wood cornice with wooden brackets; single wooden entry door with aluminum storm door in front; casement windows at basement level; moderate alterations, exterior resurfacing.	Contact 212/14
18	165 Columbia Ave. Block 916	Btwn 1873- 1887 (L.D. Fowler Map 1887)		F	R	Greek Revival, recessed rectangular plan with side entry 1 story with basement; 3 bays; shed roof with brick Chimney architraved wood cornice with brackets and modillions architraved cornice atop slightly projecting porch roof; type of window undercernable from photo, aluminum awnings above 1st story windows; single wooden entry door with aluminum porch roof supported by iron posts; iron railings and fencing in front.	Contact 212/15

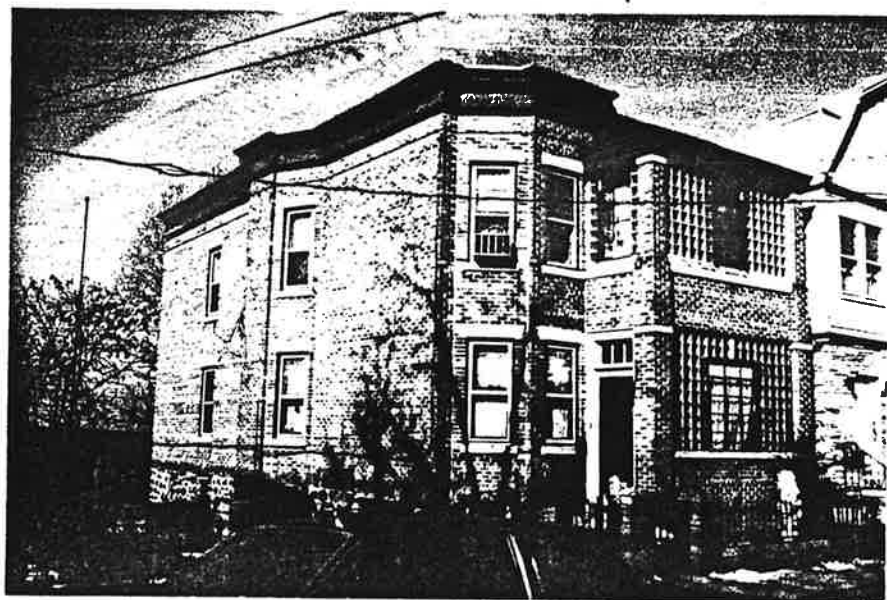
Site No. 0906-D3 col
 175 Columbia Avenue
 Jersey City, N.J.
 Photo Neg. No. 212
 Map No. 20

20.	175 Columbia Avenue Block 916	Btwn 1896 1928 (G.M. Hopkins Map 1928)			G R	Italianate recessed irregular rectangular plan, 2 stories with basement; approximately 4 bays; brick exterior; 1/1 wood double hung sash windows, glass block window lights set into projecting bay; casement windows at basement level; shed roof with architraved wood cornice; stone lintels and sills, stone and concrete foundation; entry set into side of projecting bay, 3 transom lights above door; brick and concrete stoop; iron fencing set into brick and concrete piers and retaining wall; no visible alterations.

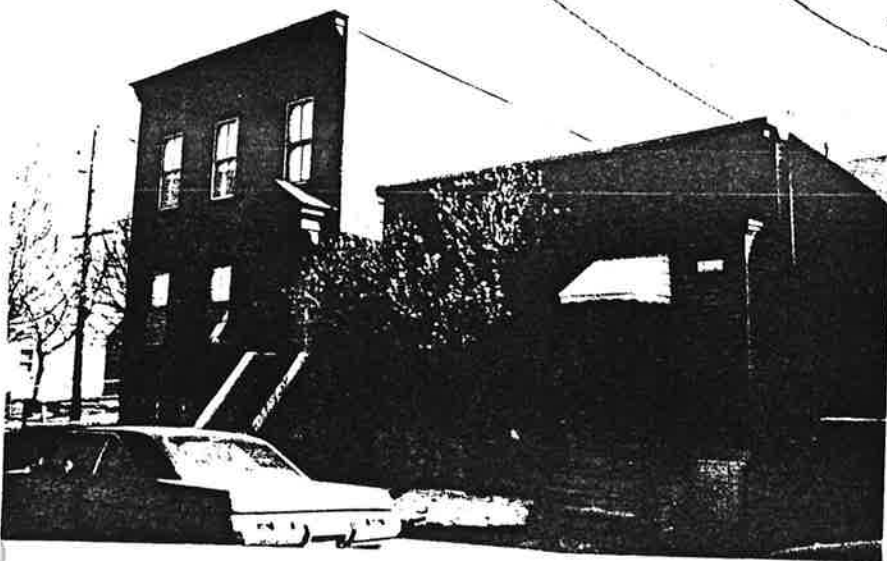
Site No. 0906-D3 col
 292-294 Columbia
 Avenue
 Jersey City, N.J.
 Photo Neg. No. 212
 Map No. 28

28.	292-294 Columbia Avenue Block 907 2 individual buildings	Btwn 1896- 1928 (G.M. Hopkins Map 1928)	N	E	R	Greek Revival; recessed rectangular plans with side entries; #244 is a 2 stories; 3 bays with 2/2 wood double hung sash windows wood framed resurfaced with asphalt/fiberglass siding; shed roof with wooden cornice with brackets triangular pediment with brackets form overdoor of #294; replacement concrete stoop; single wooden entry door; #292 is a single story building resurfaced with asphalt/fiberglass siding; 2 bays; single wooden entry door; aluminum awning above entry; 4 step concrete stoop, plain wooden cornice atop; both buildings severely altered.	Contact 212/26

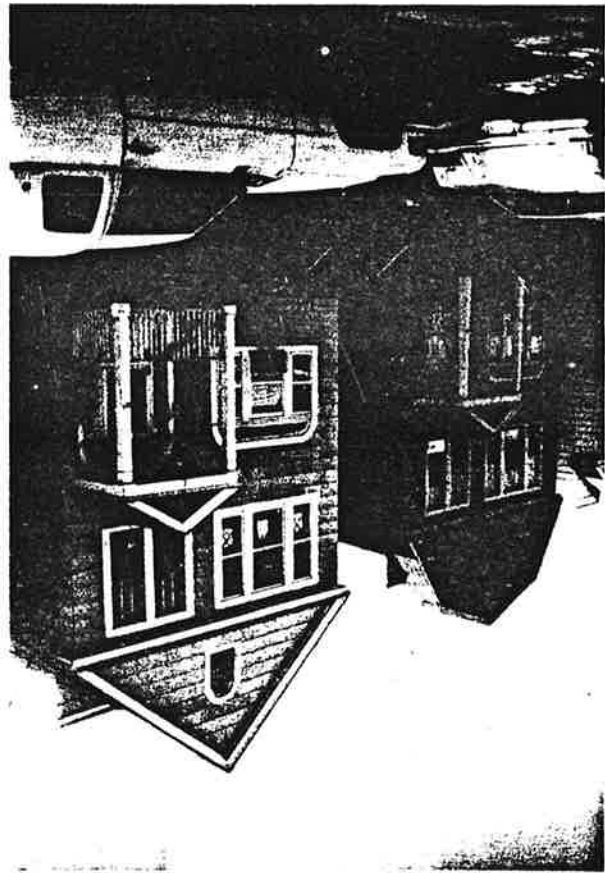
Site No. 8906-8302
 324-326 Columbia
 Avenue
 Jersey City, N.J.
 Photo May No. 213/27
 Map No. 29

29.	324-326 Columbia Avenue Block 2 individual buildings	After 1928	N	G	R	Queen Anne; recessed rectanuglar plans with side entries; wood framed buildings with brick foundations; one resurfaced with asphalt/fiberglass siding; the other with aluminum (#326) each 2 stories with basements; 2 bays; 1/1 wood double hung sash windows; 1st story windows in a set of 3 with a rounded window strip above, shed roof with gambrel pediment (#324) and triangular pediment (#326); raking wood cornices atop each; temple-like porch roofs supported by wooden posts; concrete stoops with iron railings lead up to single wooden entry doors flanked by sidelights; resurfacing constitutes extensive alterations.	Contact 212/27

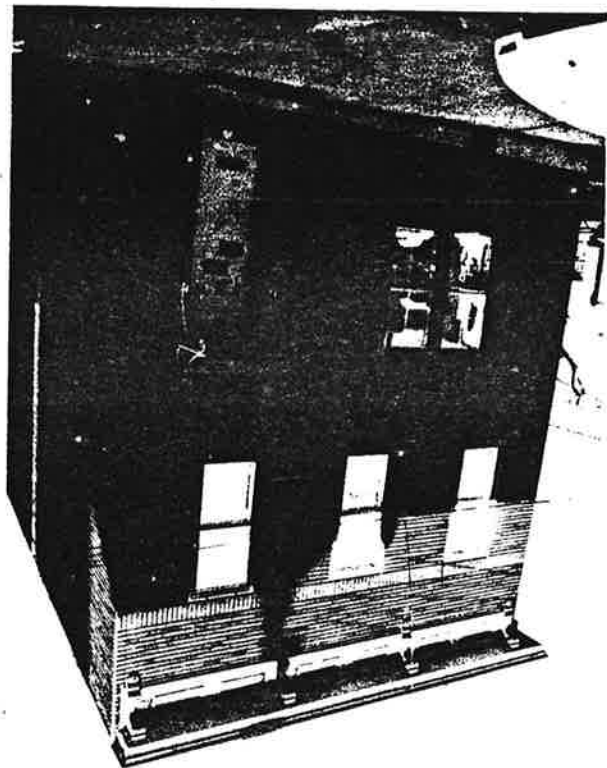
Site No. 0906-B3 con
256 Congress Street
Jersey City, N.J.
Photo Neg. No. 194/10
Map No. 1

MAP #	ADDRESS/LOCATION : PROPERTY NAME	DATE	Signifi- cance to D/S	Condition	USE	DESCRIPTION: Style, Ext. Wall Fabric, Fenestration, Form, Roof, Major Features, Alterations, Stories, etc.	NEGATIVE FILE #
1.	256 Congress Street Block: 883	Btwn 1896- 1928 (G.M. Hopkins Map 1928)	N	G R		Greek Revival; recessed rectangular plan with side entry; wood framed building; 2 stories, 3 bays, 2/2 wood double hung sash window; shed roof with architraved and bracketed wood cornice, rectangular panels on frieze; facade resurfaced with asphalt/fiberglass siding; single wooden entry door with transom window above; aluminum awning added above entry door; minor alterations.	Contact: 194/10

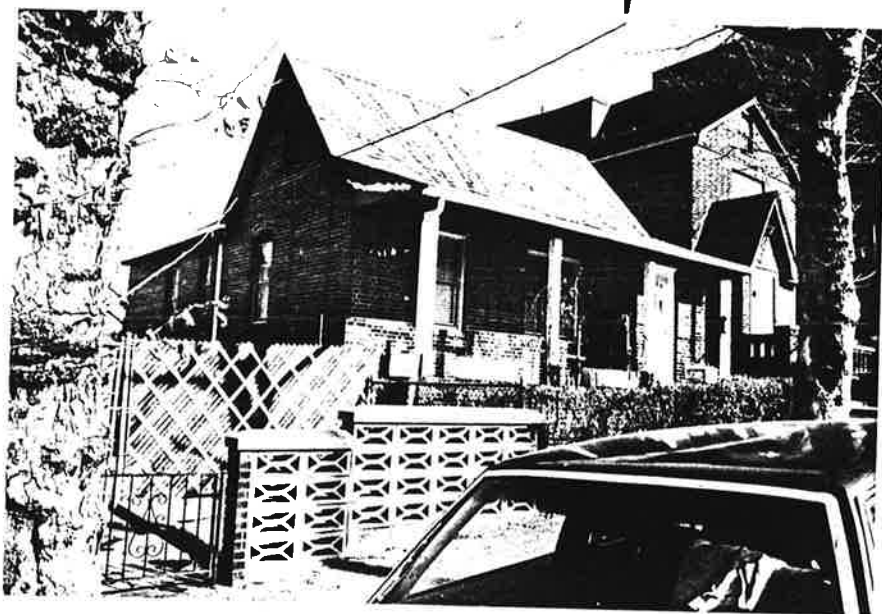
Site No. 0906-D3grc
150 Grace Street
Jersey City, N.J.
Photo Neg. No. 195⁵/₂
Map No. 5

MAP #	ADDRESS/LOCATION : PROPERTY NAME	DATE	Signifi- cance to D/S	Condition	USE	* DESCRIPTION: Style, Ext. Wall Fabric, Fenestration, Form, Roof, Major Features, Alterations, Stories, etc.	NEGATIVE FILE #
5.	150 Grace Street Block/894	After 1928	P	G	R	Folk House/Natinal; recessed rectangular plan; one and one half units deep with a hip on gable roof; brick building; 6/1 wood double hung sash windows; projecting right side entryway; 4 wooden posts support sloping porch roof; single wooden entry door; no major alterations.	Contact 195/2

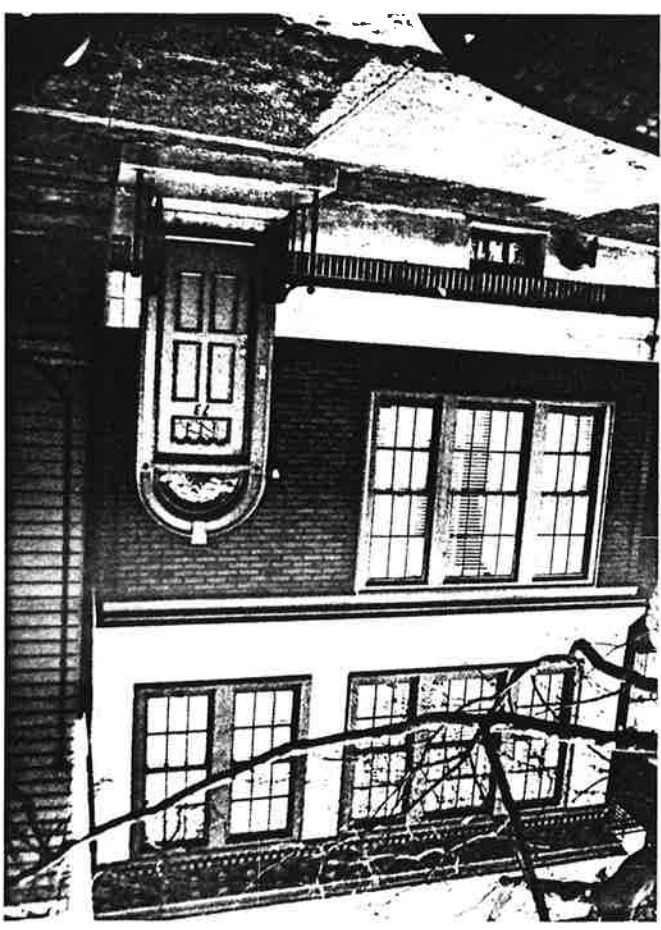
Site No. 0906-8380
 76 Hague Street
 Jersey City, N.J.
 Photo Neg. No. 1971
 Map No. 3

3.	76 Hague Street Block/898	Btwn 1896- 1928 (G. M. Hopkins Map 1928)	P	G	R	Italianate; recessed rectangular plan with central entry; 3 stories with basement, 4 bays (facade), approximately 6 bays on side of building, brick building; 1/1 wood double hung sash windows; small 1/1 wood double hung sash windows at basement level; shed roof with brick chimneys; architaved wood cornice with ornate wooden brackets; triangular pediment atop cornice; semicircular segmental window heads atoo 2nd story windows; segmental window heads on 2nd story window (facade); stone sills; stone foundation; brick and concrete stoop with iron railings lead up to single wooden entry door; triangular wood pediment above entr- door; no major alterations.	Contact 197/1

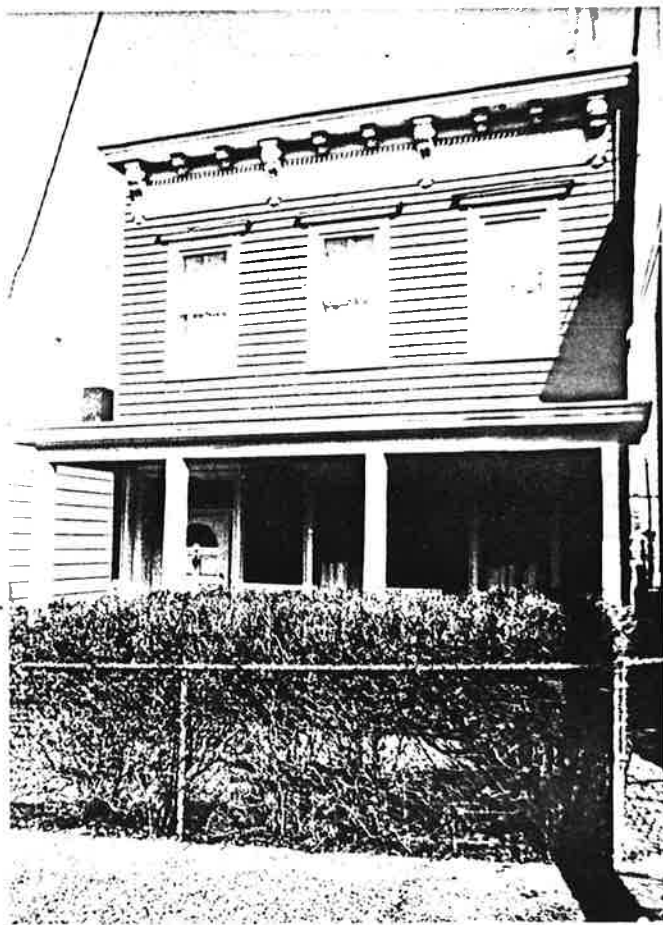
Site No. 0906-D3hag
112 Hague Street
Jersey City, N.J.
Photo Neg. No. 197/7
Map No. 8

MAP #	ADDRESS/LOCATION : PROPERTY NAME	DATE	Signifi- cance to D/S	Condition	USE	* DESCRIPTION: Style, Ext. Wall Fabric, Fenestration, Form, Roof, Major Features, Alterations, Stories, etc.	NEGATIVE FILE #
8.	112 Hague Street	#110 After 1928 (G.M. Hopkins Map 1928) #112 Btwn 1873 1887 (L.D. Fowler Map 1887)	P	G	R	Italianate; recessed rectangular plan with side entry 2 stories; 3 bays; wood shingle exterior; 2/2 wood double hung sash windows; shed roof with architraved wood cornice with modillions; decorative corbel moldings on frieze; architraved wood window heads above windows; architraved wooden cornice above porch roof; porch roof supported by 4 wooden posts; paneled single wooden entry door with transom window above; door set in wood framing; no visible alterations.	Contact 197/7

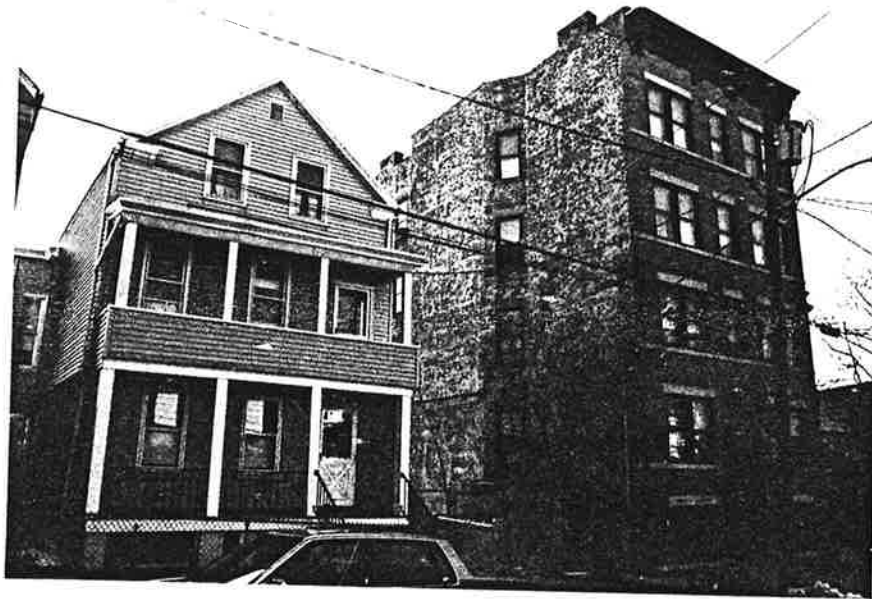
Page 1 of 2
Site No. 0906-D3.hut
257-261 Hutton
Street
Jersey City, N.J.
Photo Neg. No. 191/14
Map No. 1

1.	257-261 Hutton Street Block/935	#257 Ante 1873 (G.M. Hopkins Map 1893) #261 Btwn 1896- 1928 (G.M. Hopkins Map 1928)	N	G	R2	a) Early 20th Century Vernacular, recessed rectangular plan with side entry; 3 stories, 3 bays; wood framed building resurfaced with aluminum siding; 1/1 aluminum replacement buildings; slim 1/1 wood double hung sash windows on projecting side bay; gabled roof with raking cornice; architraved cornice atop porch roof supported by 4 wooden posts; same type of posts support porch roof; casement windows at basement level; wooden stoop and porch leading up to single wooden entry door with aluminum door in front; iron railings on stoop and po-ch; extensive alterations. b) (#261) Italianate; recessed rectangular plan with slightly projecting side bays; 4 stories with basement; brick exterior; shed roof with architraved wooden cornice; brick chimneys atop roof; double brackets and modillions on cornice; stone lintels and sills below 1/1 wood double hung sash windows; stone water table at basement level; brick pilasters with stone tops flank central entry; entry door not visible in photo; no visible alterations.	Contact 191/14

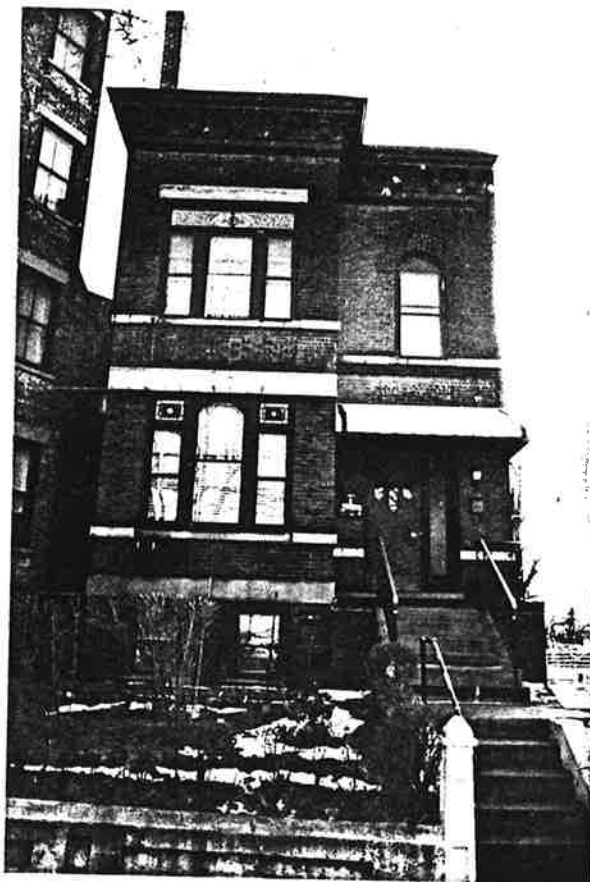
Site No. 0906-D3.hut
263 Hutton Street
Jersey City, N.J.
Photo Neg. No. 191/15
Map No. 2

2.	263 Hutton Street Block/935	Btwn 1896 1928 (G.M. Hopkins Map 1928)		G	R	Italianate; recessed rectangular plan with side entry; entire left side bay projects outward; 2 stories with basement; 1/1 wood double hung sash windows; 1st story bay windows set in a polladian style; small 1/1 wood double hung sash windows at basement level; shed roof with brick chimney architraved wood cornice with wooden modillions; stone lintels; stained glass panels above windows set inot projecting bay; stone belt courses and water table; concrete stoop with iron pipe railings lead up to single wooden entry door; transom window and aluminum awning above door, no visible alterations.	Contact 191/15

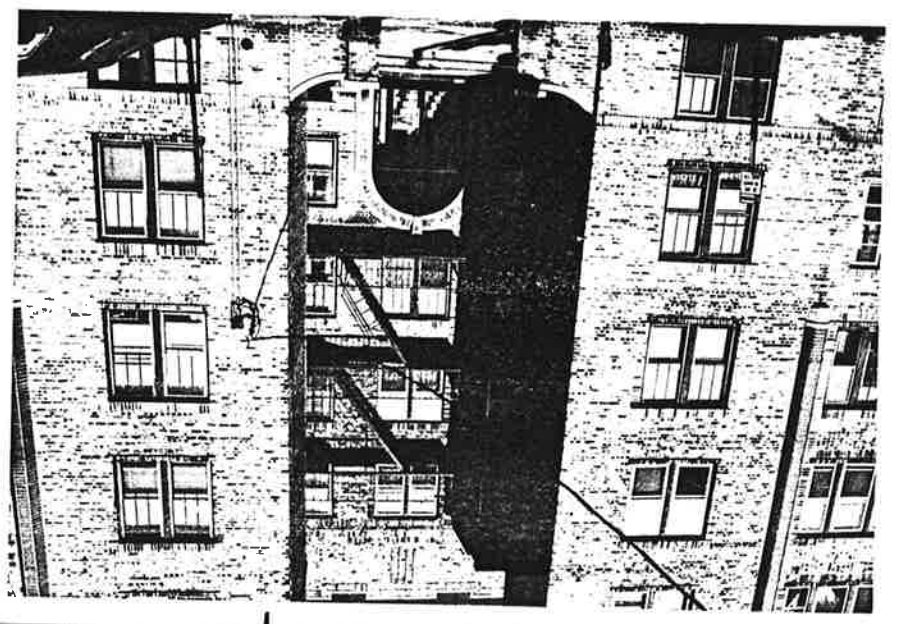
Site No. 0906-83 hut
 272 Sutton Street
 Jersey City, N.J.
 Photo Neg. No. 191/17
 Map No. 13
 (+16)
 (View of Entry)

3.	272 Hutton Street Block/934 (N.E. Corner of Liberty Ave.) "Park View Court Apartments"	Btwn 1896- 1928 (G. M. Hopkins Map 1928)		G	R	Early 20th Century Art Deco Apartment Building; irregular plan in the form of an "H"; 4 stories; 9 bay brick building with basement; 1/1, 2/1, 3/1 wood double hung sash windows ; flat roof with brick parapets; brick pilasters with stone capitals or crown flaning cnetral bay of each section; brick lintels and sills; poly-chromatic brick exterior; concrete stoop leading up to brick archway with stone keystone; steel and glass entry doors with semicircular light above; marble steps lead up to interior entry doors with glass panels set into each; brick enclosure in front recessed entry; iron fire escape suspended from facade of central bays of building; no visible alterations.	Contact

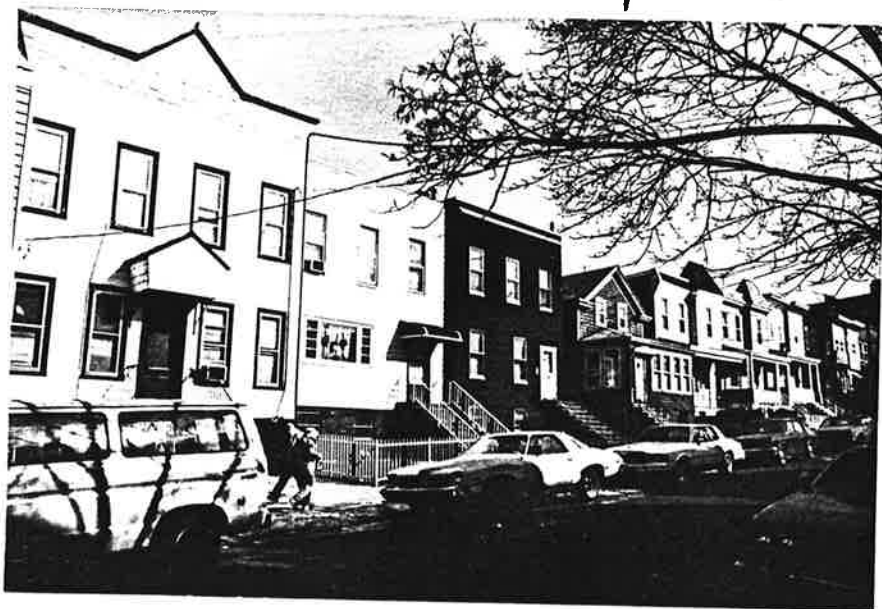
Site No. 0906-D3.rr
 114-94 Irving
 Street
 Jersey City, N.J.
 Photo Neg. No. 194/
 Map No. 6 23

6.	114-94 Irving Street Block/890	Btwn 1887- 1896 (San- born 1896) Except #114 Btwn 1896- 1928 (G.M. Hopkins 1928)	N	F	R	Queen Anne/Vernacular Styles; recessed rectangular plans with either central or side entries, each building, 2 stoires in height with basements, number of bays vary, some have 4 others 3 and still others only 2; 1/1 wood double hung sash windows, some have aluminum replacement windows; shed roofs, some with pediments (#114, #106, #104); all are resurfaced on their exteriors with either aluminum or vinyl siding; brick stoops with iron railings lead up to single wooden entry doors with aluminum storm doors in front; extensive alterations on all.	Contact 194/23

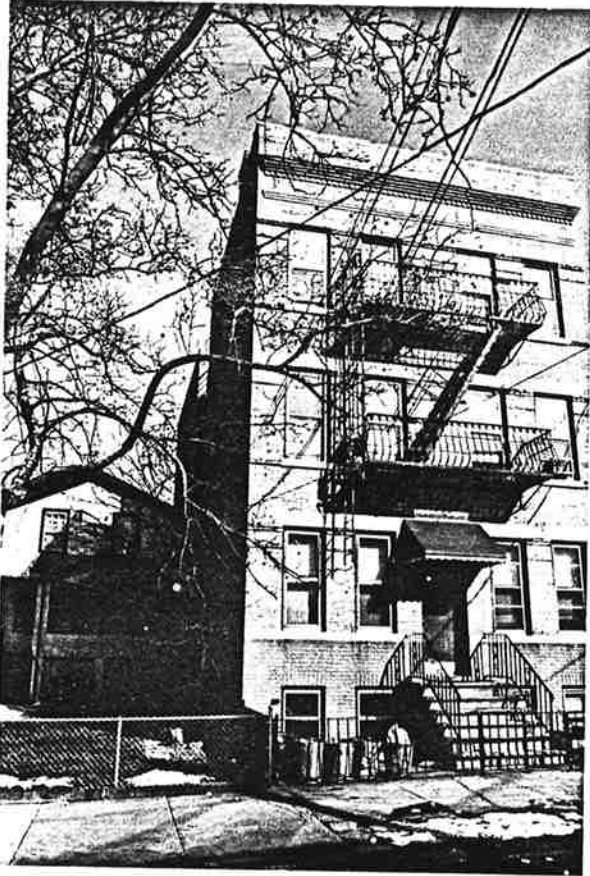
Site No. 0906-D3 in
122-124 Irving Street
Jersey City, N.J.
Photo Neg. 26.194/
Map No. 7 122

MAP #	ADDRESS/LOCATION : PROPERTY NAME	DATE	Signifi- cance to D/S	Condition	USE	DESCRIPTION: Style, Ext. Wall Fabric, Fenestration, Form, Roof, Major Features, Alterations, Stories, etc.	NEGATIVE FILE #
7.	122-124 Irving Street Block/890	Btwn 1896- 1928 (G. M. Hopkins 1928)	N	G	R2	Italianate Dumbell Apartment Building; recessed rectangular plan with central entry; 3 story with basement brick building, 4 bays; 1/1 wood double hung sash windows; flat roof with slight brick parapet brick moldings at roofline; stone lintels and sills, stone water table; concrete and brick stoop with iron railings lead up to single wooden entry door; aluminum awning exist above entry, brick chimney visible on roof; no visible alteration.	Contact 194/22

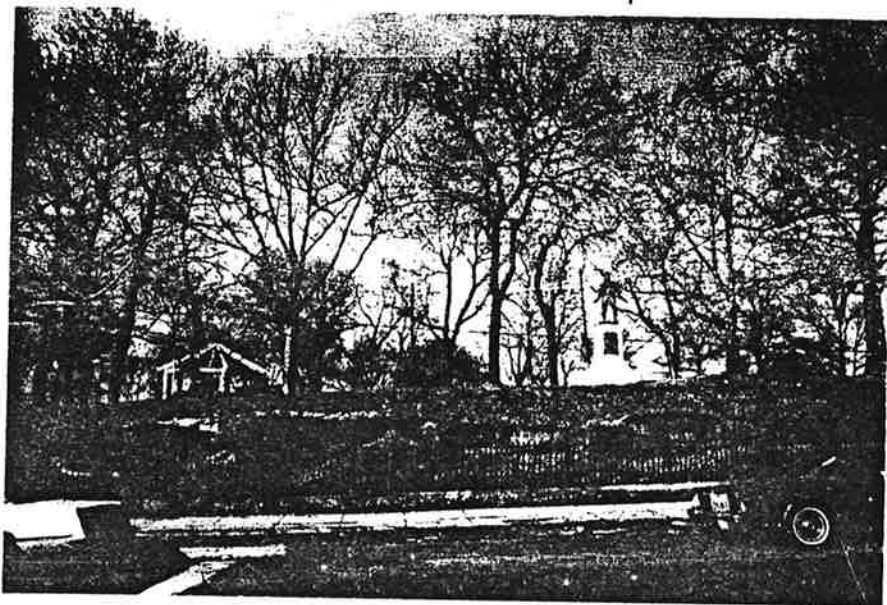
Site No. 0906-D3 jfk
 View of Leonard J.
 Gordon Park from
 Kennedy Blvd.
 Jersey City, NJ
 Photo Neg. No. 193
 Map No. 1

MAP #	ADDRESS/LOCATION : PROPERTY NAME	DATE	Signifi- cance to D/S	Condition	USE	DESCRIPTION: Style, Ext. Wall Fabric, Fenestration, Form, Roof, Major Features, Alterations, Stories, etc.	NEGATIVE FILE #
1 & 2	Leonard Gordon Park View from Kennedy Boulevard Block: 935 R= Recreational	Btwn. 1896 1928	P	G	R	Rhomboid Urban Park occupying almost entire block; park situated between Manhattan Ave. on the South Kennedy Blvd. on the East. Hutton St. on the North and Liberty Avenue on the West. A circular gazebo or bandstand exist almost in center of park. Statues of bear and bison situated near Manhattan Avenue. entrance (see photo No. 2); statue of militiaman visible from Kennedy Blvd. (see photo no.1); iron fencing anchored in concrete piers surround park.	Contact: 193/4

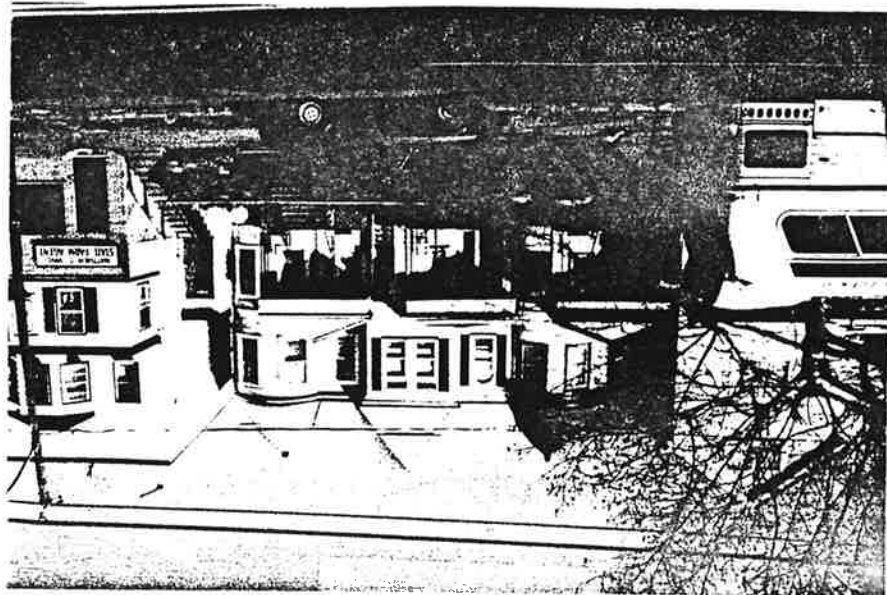
Site No. 0906-83 flr
 3451 J. F. Kennedy Blvd.
 Jersey City, N.J.
 Chateaux Map No. 8
 Map No. 8
 193-

8.	3457-3459½ J.F. Kennedy Boulevard Block: 924 3 rowhouses	Btwn. 1896 1928 (G.M. Hopkins 1928)	P	G	R	Queen Anne; recessed rectangular plans with projecting porches and projecting bays; 1/1 wood double hung sash windows, some replaced with aluminum in similar style; shed roofs, each with either a cone topped roof or a triangular pediment atop; pedimented porch roofs; iron posts support porch roof; wooden stoops on #'s 3457 and #3459; Brick stoop on #3459½; all three buildings resurfaced with aluminum siding; stoops lead up to single wooden entry doors with side lights; casement windows at basement level; exterior resurfacing only alteration to #3459.	Contact: 193/20

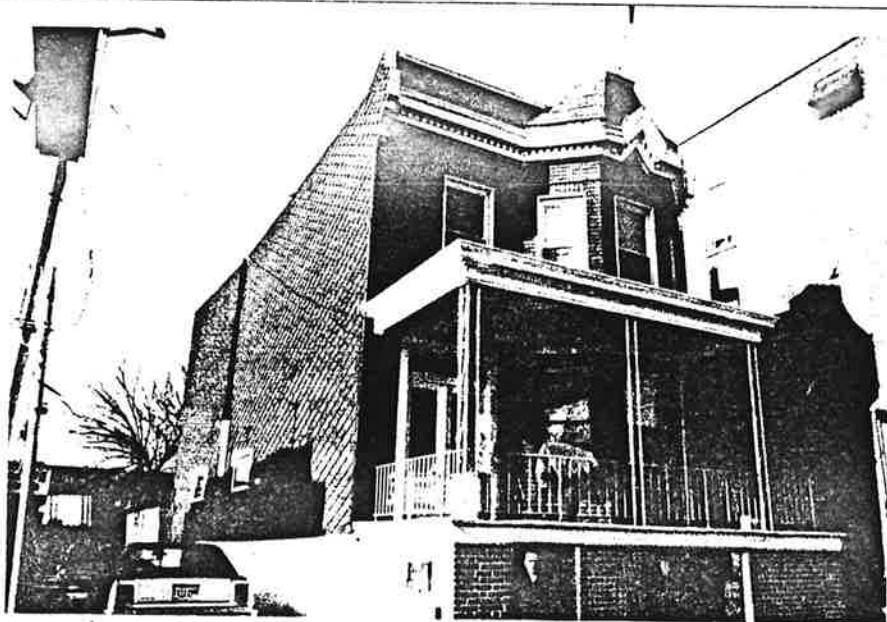
Site No. 0906-D3 jfk
3715 J. F. Kennedy
Blvd.
Jersey City, N.J.
Photo Neg. No. 191/6
Map No. 30

30.	3715 J.F. Kennedy Blvd. Block 898	Btwn. 1896 1928 G.M. Hopkins (1928)				Queen Anne; recessed rectangular plan with 2 side entries (one at basement level); 2 story with 2 bays (one projecting) and basement; shed roof with partial tent roof atop projecting bay; 1/1 wood double hung sash windows on building; large display windows (casement) at basement above with a 1/1 replacement aluminum window; 1st and 2nd stories of building resurfaced with asphalt/fiberglass siding; shed roof with architraved wood cornice with dentiled moldings; cornice forms a small pediment on projecting bay; architraved wood cornice on roof of building - 3 iron posts support porch roof; double wooden entry doors with transom window above; iron railing on porch (not original); extensive alterations.

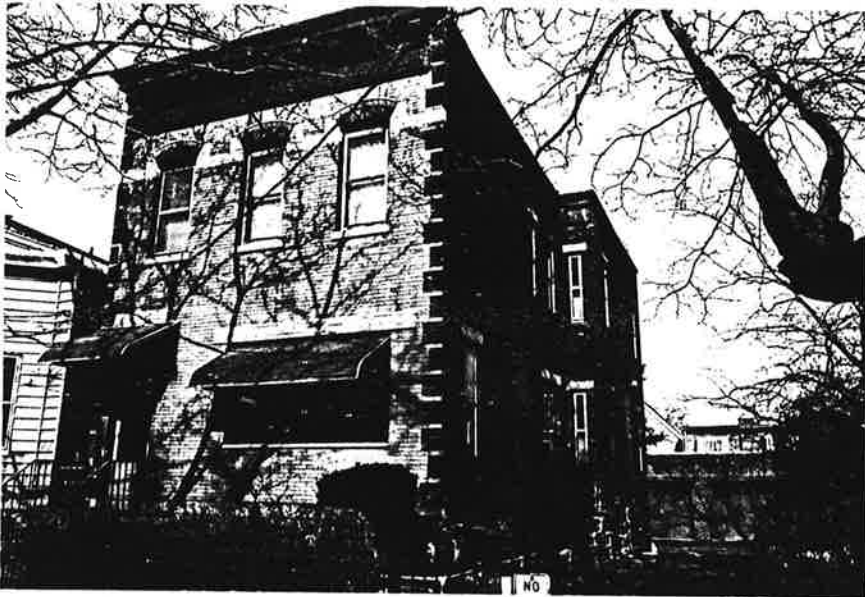
Site No. 0906-D3 leo
92 Leonard Street
Jersey City, N.J.
Photo Neg. No. 195₁₂
Map No. 3

3.	92 Leonard Street Block/896	Btwn 1896 1928 (G.M. Hopkins Map 1928)	P	E	R ²	Italianate; recessed rectangular plan with side entry rear portion of building projects outward slightly; brick exterior; 1/1 wood double hung sash windows; single paned window flanked by 2 1/1 types on 1st story; 3 bays with casement level; casement windows at basement level; shed roofs with architaved wooden cornice with modillions; dentils and garland relief moldings on frieze; segmental brick lintels; squared stone lintels and sills; darker colored brick at side intended to simulate quoins; stone foundation; brick and concrete stoop leads up to single wooden entry door with aluminum awning above; aluminum awning above 1st story facade windows; no visible alterations.	Contact 195/12

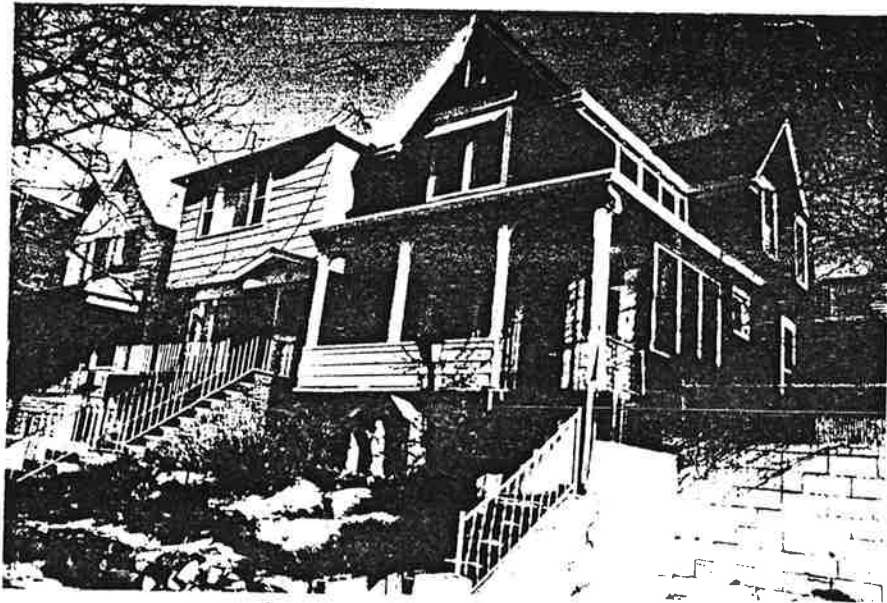
Site No. 0906-D3 lib
 526 Liberty Avenue
 Jersey City, NJ
 Photo Neg. No. 192
 Map No. 10 14

10.	526 Liberty Avenue Block: 916	Btwn 1896- 1928 (G.M. Hopkins Map 1928)				Shingle Style; recessed rectangular plan with side entry; 2 story wood framed building with cross gables; 1/1, 6/1 wood double hung sash windows, one small casement window on side of building, wood shingle on buildings exterior; architraved cornices on building; windows set in wood framing; concrete stoop in back leading up to wooden porch; single wooden entry door with aluminum storm door in front porch roof supported by 4 wooden posts; minor alterations; replacement railings and some use of aluminum siding.	Contact: 192/14

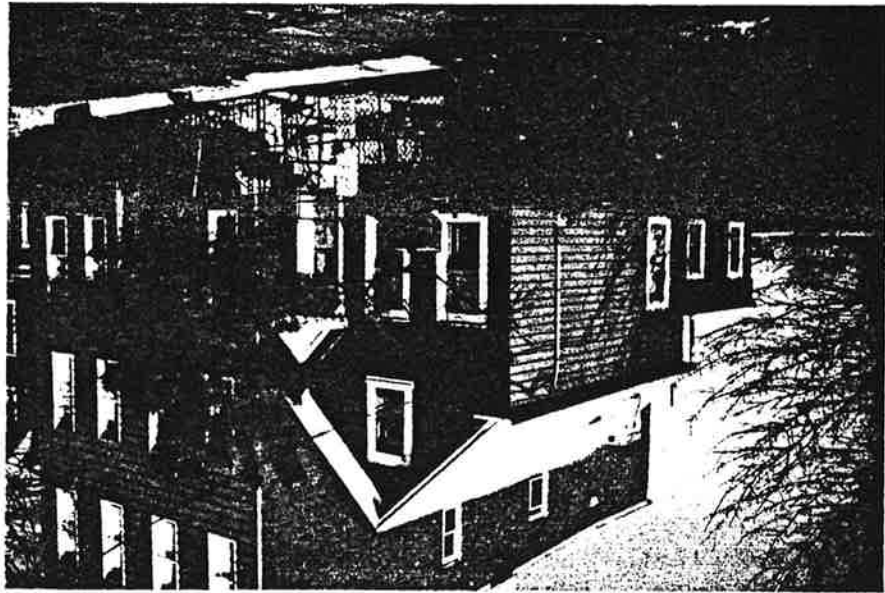
Site No. 0906-B3mel
11 Nelson Avenue
Jersey City, N.J.
Photo Neg. No. 212/23
Map No. 1

1.	11 Nelson Avenue Block: 915	Ante 1873	N	G	R	Folk Victorian ; recessed rectangular plan with side entry; wood framed building with wood board siding; 2 stories, approximately 3 bays; 1/1 wood double hung sash windows gabled roof; rear extension, the equivalent of 2 bays, brick chimney; architaved cornice on roofs; all windows in wood framing; pedimented overdoor; brackets support overdoor; concrete and brick stoop leads up to single wooden entry door with aluminum storm door in front; stoop appears to be a replacement; minor alterations.	Contact: 212/28

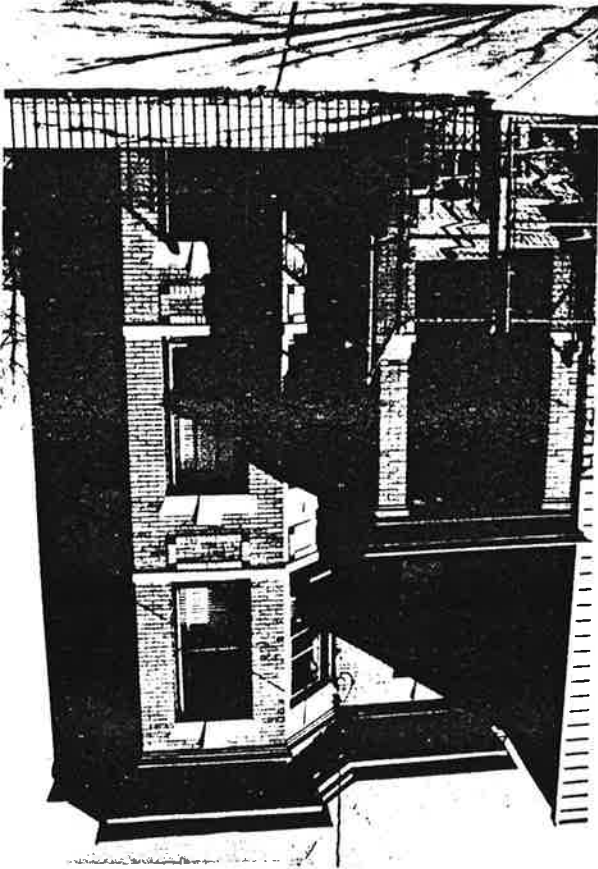
Site No. 0906-B3 mel
84-86 Nelson Avenue
Jersey City, N.J.
Photo Neg. No. 194/21
Map No. 7

MAP #	ADDRESS/LOCATION : PROPERTY NAME	DATE	Signifi- cance to D/S	Condition	USE	DESCRIPTION: Style, Ext. Wall Fabric, Fenestration, Form, Roof, Major Features, Alterations, Stories, etc.	NEGATIVE FILE #
7a.	84-86 Nelson Avenue Block:888 2 individual houses (Contact: 212/35)	Btwn 1896 (G.M. Hopkins Map 1928)				A) #84: Queen Anne; recessed rectangular plan with side entry; 2 story, 2 bay, wood framed building resurfaced with asphalt/fiberglass siding; 1/1 wood double hung sash windows; left side projecting bay window; false mansard roof; architraved wooden cornice with brackets, all windows set in wood framing; architraved wooden cornice atop porch roof supported by 4 wooden posts wood railings and newels; wooden porch and stoop leads up to single wooden entry door; aluminum storm door in front; excepting exterior resurfacing no visible alterations.	Contact: 212/35
7b.						B) #86: Victorian/Queen Anne; recessed rectangular plan with side entry; 2 story, 2 bays; left side bay projects slightly; 1/1 wood double hung sash windows; shed roofs with false shed and triangular pediment; architraved cornice with brackets and modillions; porch roof supported by 4 rounded posts with gingerbread brackets; wooden stoop with like railings and newels; single wooden entry door with aluminum storm door in front; transom window above entry door; excepting exterior resurfacing with asphalt/fiberglass siding, no other major alterations exist.	Contact: 194/21, 212/35

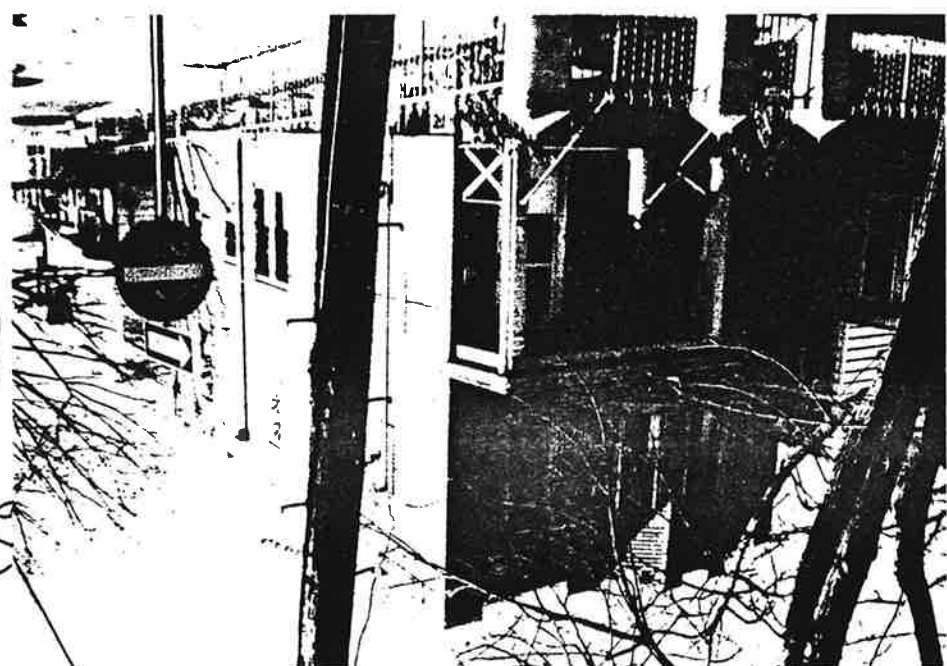
Site No. 0906-B3me
 178 Nelson Ave.
 Sunny City, NY
 Photo No. 213/15
 Map No. 15

15.	178 Nelson Avenue Block: 898 (Contact: 213/7)	Btwn 1896 1928 (G.M. Hopkins Map 1928)	N	G	R	Greek Revival; recessed rectangular plan with rear extension; projecting porch and slightly projecting left side bay; wood framed building resurfaced with asphalt/fiberglass siding; 1/1 wood double hung sash windows of differing sizes; flat roof with crenelles; all windows set in wood framing; architaved cornice atop porch roof; steps and stoop leads up to single wooden entry door with aluminum storm door in front; casement windows set into brick foundation at basement level; exterior resurfacing constitutes a major alteration; iron fencing supported by brick piers surrounds buildings.	Contact: 213/7

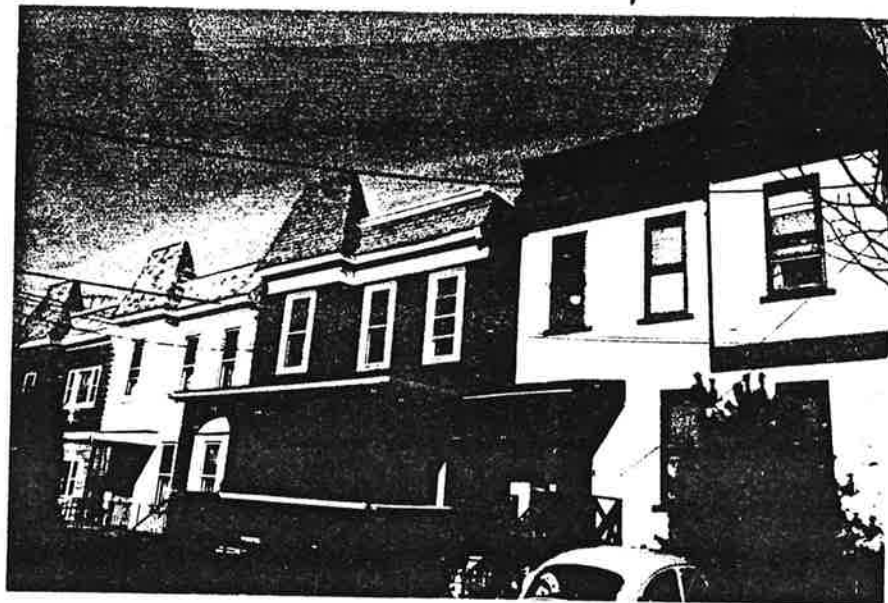
Site No. 0906-D3 nor
 178-184 North
 Street
 Jersey City, N.J.
 Photo Neg. No. 194/19
 Map No. 1

1.	178-184 North Street Block: 888	Btwn 1887- 1896 (San- born 1896)	N	G	R	Victorian Shingle Style; recessed rectangular plans with side entries; 2 stories, 3 bays on each building; 1/1 wood double hung sash windows on wood framed building, some of which have been resurfaced with stucco; others aluminum siding; false mansard type roofs on all 4 buildings; projecting porch roofs on each building, on #'s 178, 180 and 184 this roof consist of an aluminum awning supported by ironposts; a full porch exist on #182; stoops vary, some constructed of wood, others are concrete; iron or wood or a combination of both exist on stoops; single wooden entry doors on all buildings; resurfacing of exteriors constitute a moderate alteration.	Contact: 194/19

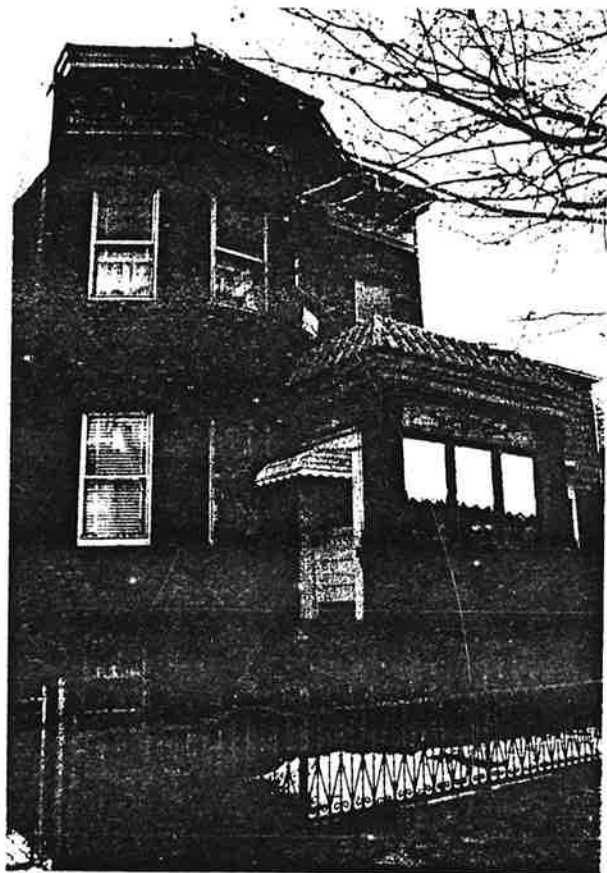
Site No. 0906-23pop
 89 Poplar Street
 Jersey City, N.J.
 Photo Neg. No. 194/36
 Map No. 1

1.	89 Poplar Street Block 890	Btwn 1896- 1928 (G.M. Hopkins 1928)	P Theme	G	R	Greek Revival; recessed rectangular plans with side entry, 2 story, 2 bay, with basement, brick building; 1/1 wood double hung sash windows on 1st and 2nd stories; single paned windows on entryway of building small 1/1 building at basement level; semicircular fanlight type window opening situated below stoop; architraved wooden cornice with modillions dentils and garland relief moldings on frieze; stone lintels; stone sills; dark colored brick at buildings corners accentuate corners of buildings; stone water table; pantiles atop roof of entryway which forms a hip type roof; decorative (fanlight molding above entryway windows; concrete stoop leads up to single wooden entry door; aluminum awning above door; original iron fencing in front; building in excellent condition; no visible alterations.	Contact 194/36
