Bleeker Street in Western Slope Neighborhood of Survey
 Area (ward B) 0906-B3 bl, N.Y. 45 I. 0906 Jersey City,
 Hudson County

NEW JERSEY OFFICE OF CULTURAL AND ENVIRONMENTAL SERVICES
 HISTORIC PRESERVATION SECTION
 DISTRICT/STREETSCAPE CONTINUATION SHEET

N.J. HISTORIC SITES INVENTORY

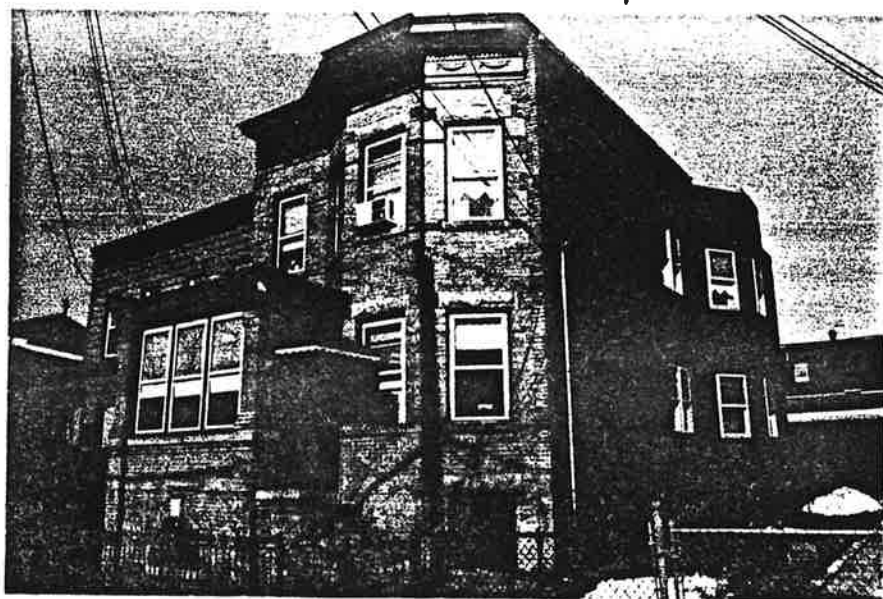
Site No. 0906-23pop
 96 Poplar Street
 Jersey City, N.J.
 Photo Neg. No. 194/35
 Map No. 2

2.	96 Poplar Street Block 194/35	Btwn 1896- 1928 (G.M. Hopkins 1928)	P Theme	G	R	Greek Revival; recessed rectangular plan with side entry; 2 story, 2 bay, brick building with basement; slightly projecting side bay; 1/1 wood double hung sash windows, some replaced by aluminum type windows; shed roofs with architraved wood cornice, stone lintels, stone sills; stone watertable; architraved cornice atop entryway; casement windows at basement level; semicircular arched opening to basement at bottom of stoop; stone keystones atop brick arch; aluminum canopy atop entry door; concrete stoop leads up to single wooden entry door; relief garland moldings on frieze along with dentils; original iron fencing in front of building; vinyl siding on exterior of projecting side bay; minor alterations.	Contact 194/35

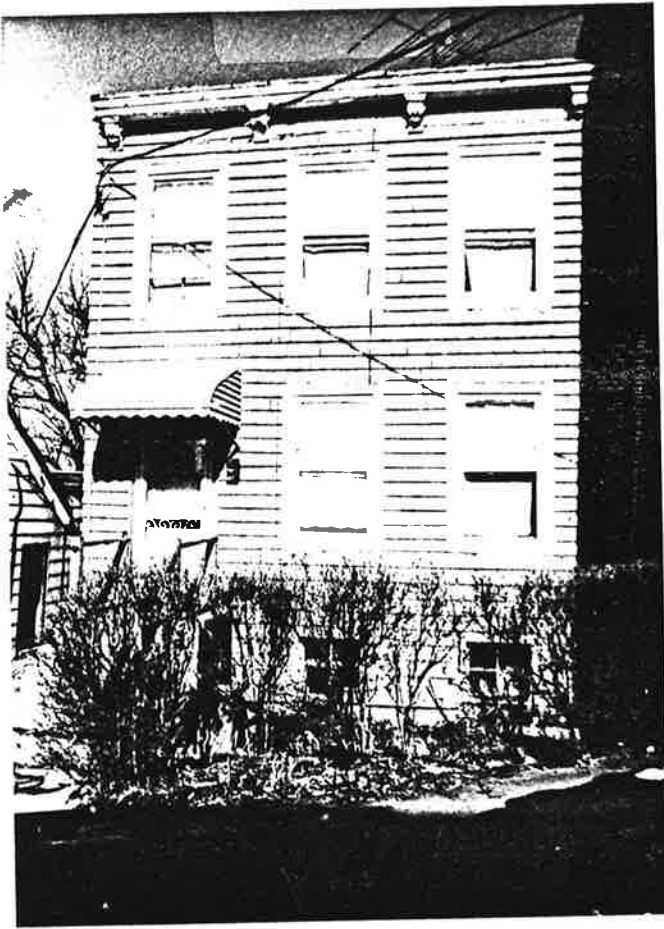
Site No. 0906-D3/res
4 Reserve Avenue
Jersey City, N.J.
Photo Neg. No. 190/6
Map No. 1

1.	4 Reserve Avenue Block/937	Ante 1873 (G.M. Hopkins Map 1873)	P	F	R	Greek Revival; recessed rectangular plan with side entry; 2 story wood framed building with basement; 3 bays; 6/1 wood double hung sash windows on 1st and 2nd stories; 4 lighted casement windows at basement level; shed roof with architaved wooden cornice; 4 ornate corbel brackets on cornice; each window set in wood framing; concrete and wood porch lead up to single wooden entry door; aluminum storm door in front; aluminum awning above entry; just minor alterations to stoop.	Contact 190/6

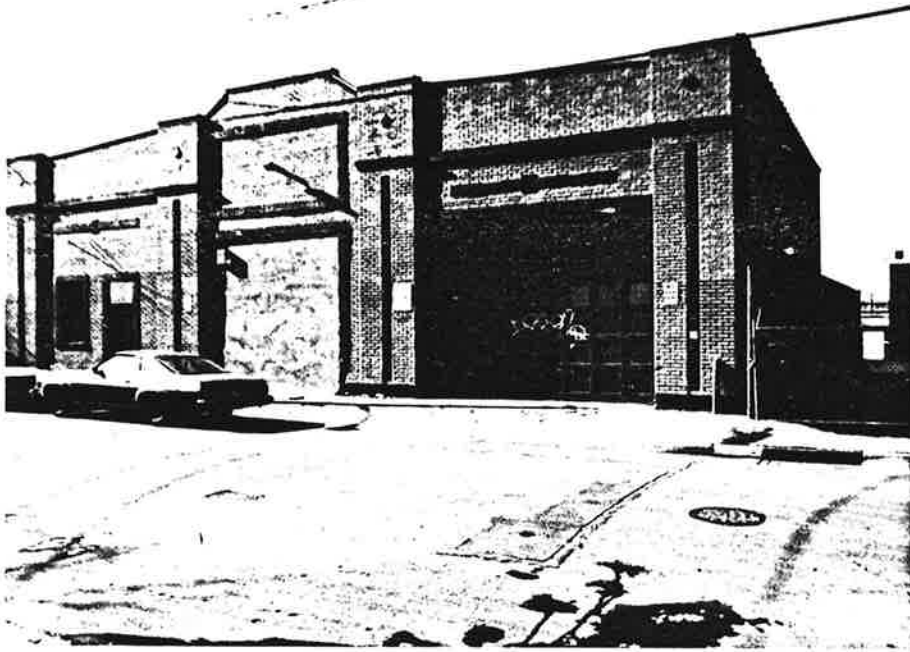
Site No. 0906-D3res
19-33 Reserve Avenue
Jersey City, N.J.
Photo Neg. No. 190/
Map No. 3. 13

AP #	ADDRESS/LOCATION : PROPERTY NAME	DATE	Signifi- cance to D/S	Condition	USE	DESCRIPTION: Style, Ext. Wall Fabric, Fenestration, Form, Roof, Major Features, Alterations, Stories, etc.	NEGATIVE FILE #
3.	19-33 Reserve Avenue Block/940	Btwn 1896- 1928 G.M. Hopkins Map 1928)	N	F	I	Utilitarian recessed rectangular plan with side garage door entry; 1 story; 3 bay brick building; flat roof with brick parapet central bay closed in with cement and cinderblock; brick stiprs adorn exterior.	Contact

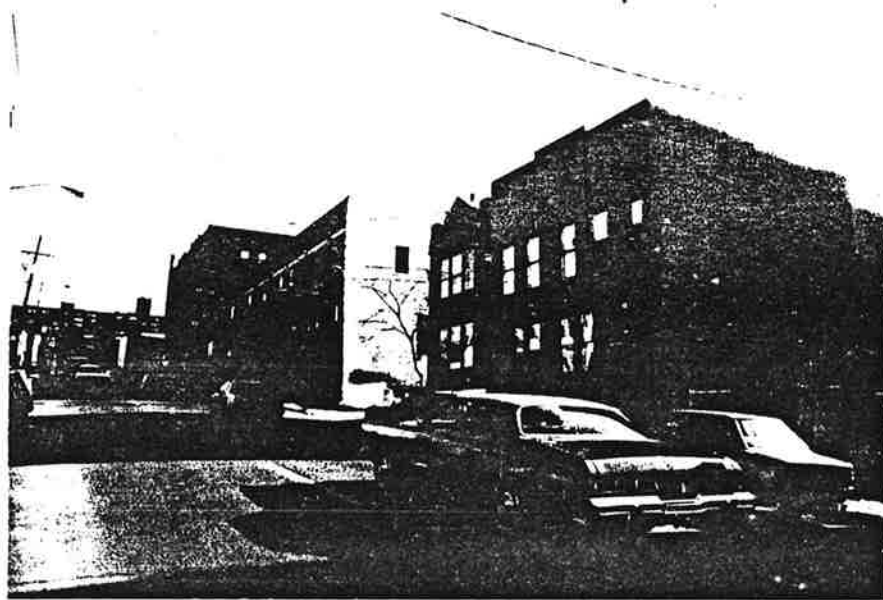
Site No 0906-D3 sec
789-777 Secaucus
Road
Jersey City, N.J.
Photo Neg. No. 191/
3/4
Map No. 1

1.	789-799 Secaucus Road Block 898 Streetscape	Btwn 1896 1928 (G.M. Hopkins 1928)	N	G	R/ I.	<p>A. Vernacular Brick buildings in foreground; recessed rectangular plans with side entries; 2 stories each 2 bay equivalent on #793; 5 bays on #799 1/1 wood double hung sash windows with shed roofs; triangular brick pediment atop #793; single wooden entry door with aluminum canopy atop, entry not visible on #793,</p> <p>B. Utilitarian Brick building Early 20th Century (#789-791) 2 story brick building with 1/1 wood double hung sash windows (1st story); windoes on 2nd story bricked closed shed roof; entry not visible.</p> <p>C. Early 20th Century Art Deco Building; recessed rectangular plans; 4 stories with basement numerous bays on builidngs; 1/1 wood double hung sash windows; iron fire esapce suspended on exterior on Secaucus Road facade; entry set into archway door itself not visible in photo; building houses apartment; no visible alterations.</p>	<p>Contact 191/3</p> <p>Contact 191/3</p>

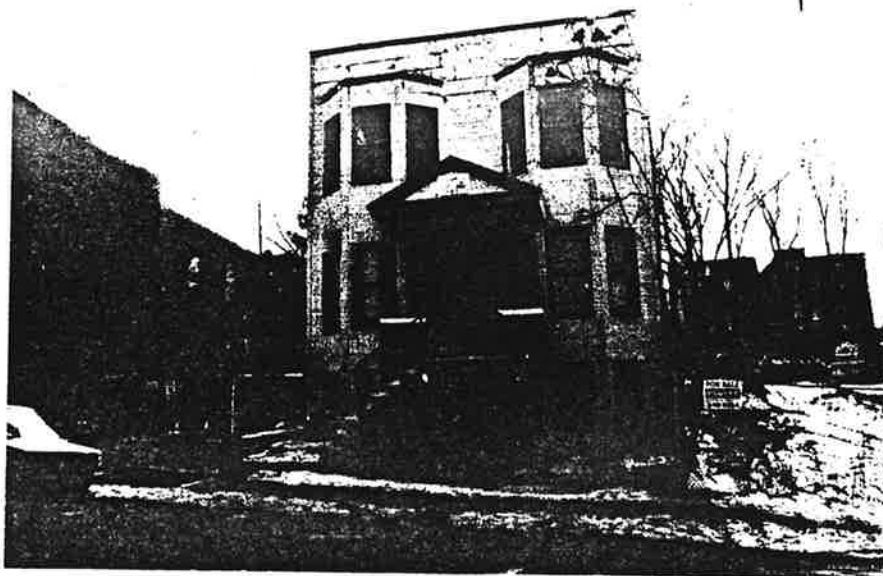
Site No. 0906-D3 sec
803 Secaucus Road
Jersey City, N.J.
Photo Neg. No. 191/
1/2
Map No 2

MAP #	ADDRESS/LOCATION : PROPERTY NAME	DATE	Signifi- cance to D/S	Condition	USE	DESCRIPTION: Style, Ext. Wall Fabric, Fenestration, Form, Roof, Major Features, Alterations, Stories, etc.	NEGATIVE FILE #
2.	803 Secaucus Road Block 898	Btwn. 1896 1928 (G.M. Hopkins 1928)	N	P	V	Greek Revival/Italianate; recessed rectangular plan with central entry; 2 stories; 2 bays; (2 projecting bay windows) basement level; brick exterior; 1/1 wood double hung sash windows set into projecting bays; small 1/1 windows at basement level; most windows are either broken or boarded closed; shed roof; Greek temple-like pedimented porch roof supported by 2 wooden piers; brackets on frieze below pediment; brick and concrete stoop with iron railings lead up to entry; entry boarded closed.	Contact 191/2

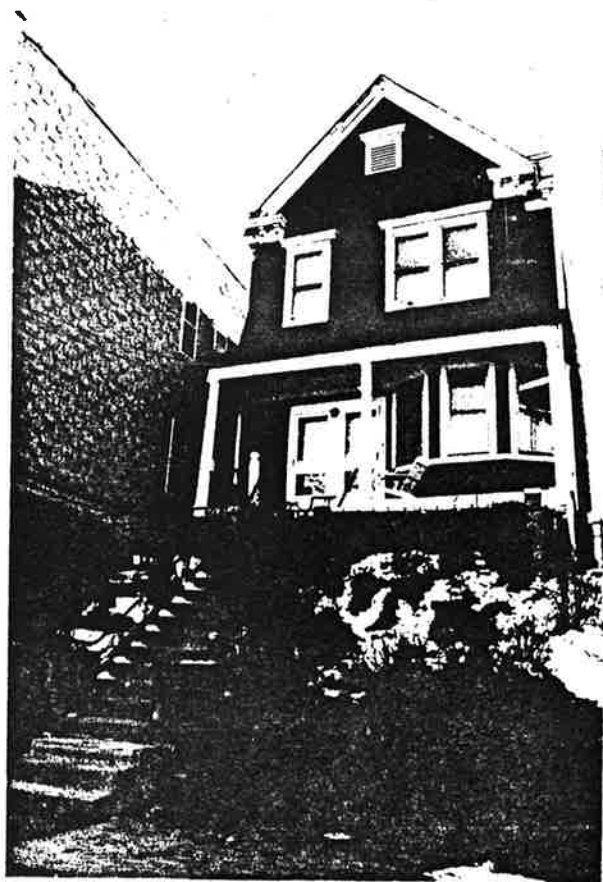
Site No. 0906-D3 zab
 159 Zabriskie Street
 Jersey City, N.J.
 Photo Neg. No. 191/
 Map No. 2

2.	159 Zabriskie Street Block 934	Btwn 1896 1928 (G.M. Hopkins 1928)	N	G	R	Queen Anne recessed rectangular plan with side entries and slightly projecting bay; wood framed buildings 2 1/2 stories, 2 bays, wood framed building with fish scale shingles; 1/1 wood double hung sash windows on building; small louvered window set into gable shed roof with architaved wood cornice; broken cornice atop triangular pediment; wooden window heads with dentiled moldings; thin rounded Doric columns support porch roof, 2 entry doors, each wooden with aluminum storm door in front wooden porch, concrete stoop w-th iron railings lead up to entry, no visible alterations.	Contact 191/20
