(Western Hudson City  
Neighborhood)

NEW JERSEY OFFICE OF CULTURAL AND ENVIRONMENTAL SERVICES  
HISTORIC PRESERVATION SECTION  
DISTRICT/STREETSCAPE CONTINUATION SHEET

N.J. HISTORIC SITES INVENTORY

Bleecker Street in Western Hudson City Neighborhood  
of Survey Area (ward D4) NJHSI # 0906-D4 bfe,  
Jersey City, Hudson Co.  
Page 2 of 4 photo pages.

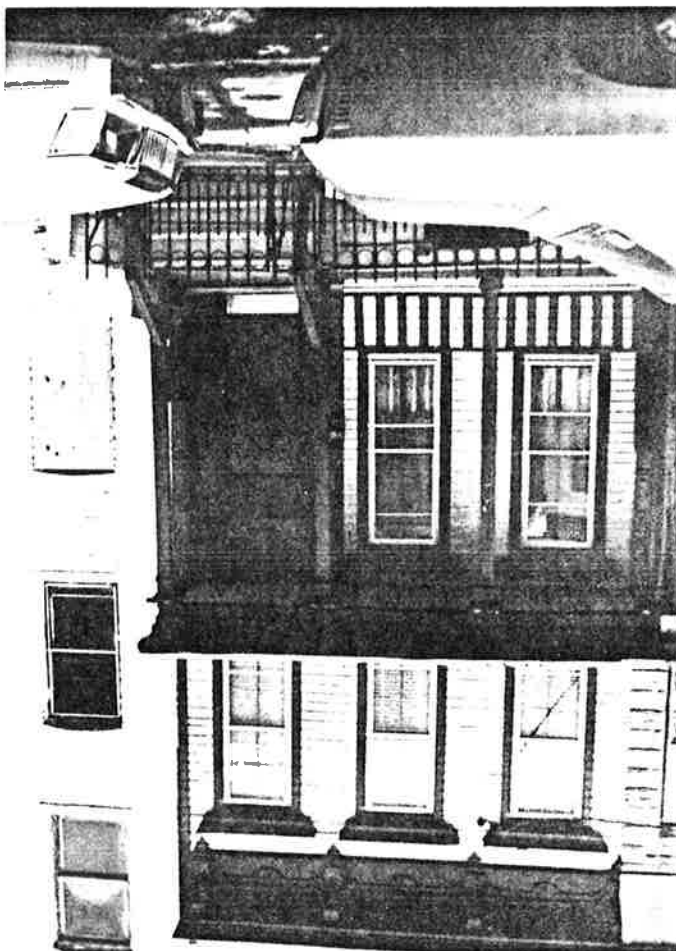
Site No. 0906-D4 bfe  
21 1/2 Bleecker Street  
Jersey City, N.J.  
Photo Neg. No. 245/29  
Map No. 4  
(bet. 1873-1887)

1.	21½ Bleecker Street Block: 819 (Contact: 245/29)	Between 1873- 1887	Y It. Wood Theme	E	R <sup>1</sup>	Italianate, 2 stories, 3 bays, frame, 1 main entry, rectangular plan with rear extension. Wooden porch carried on posts extends across ground story; rectangular windows with cornice heads and wood enframements; bracketed cornice with decorative frieze. Replacement front door. Twin house to #21, which has been altered and inappropriately resurfaced.	Contact: 245/29,28

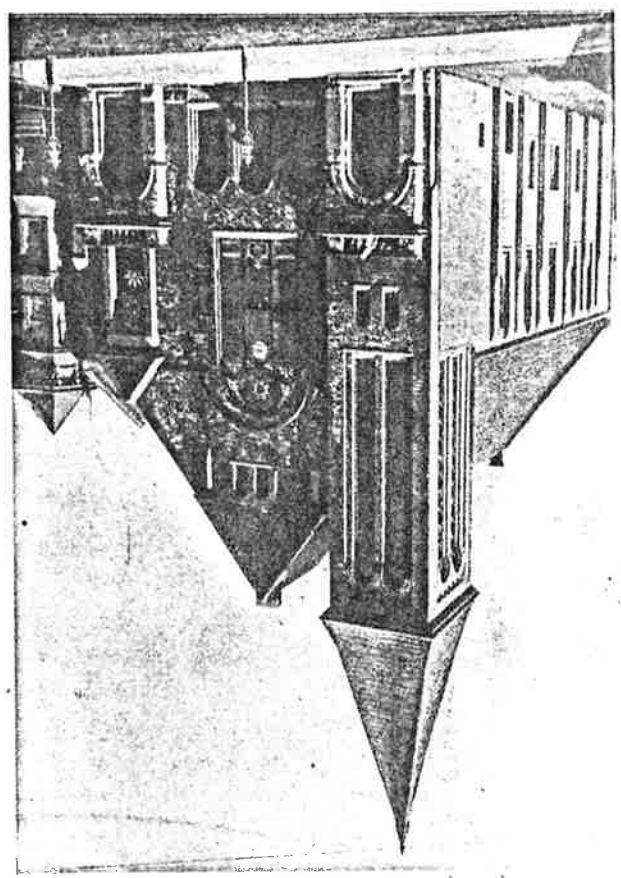
Site No. 0906-D4 bow  
 161 Bowens Street  
 Trinity Baptist Church  
 Jersey City, N.J.  
 Photo Neg. No. 17/28  
 Map No. 3  
 (bat. 1896-1908)

3.	161 Bowers Street Trinity Baptist Church Block 825 (Contact 17/28)	bet. 1896- 1908	P Church theme	E	T	Gothic Revival, 1-2 stories, 1 main entry, frame, T-shaped plan with rear extension. Main entry with triangular head; wood porch with gable roof supported by paired columns is set before main entry; entry set into square tower with pyramidal roof and 4 small corner turrets; in main body of church, large tracery window with pointed arch head and stained glass; gable roof excluding tower section.	Contact 17/28, 219/34

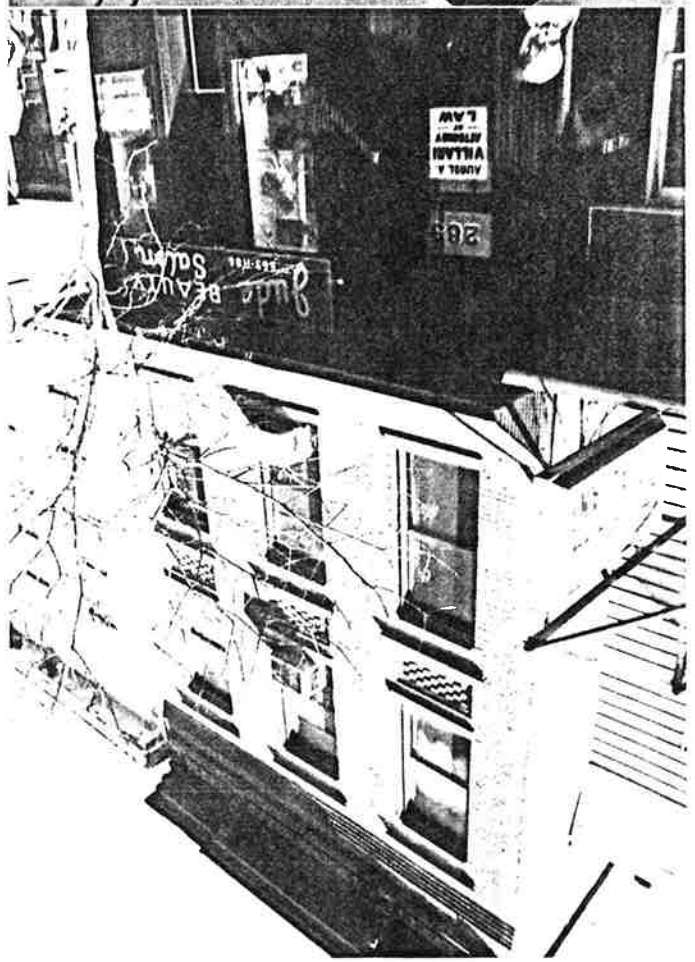
Site No. 0906-D4 cen  
287-289 Central Ave.  
Jersey City, N.J.  
Photo Neg. No. 239/29  
Map No. 4  
(bat. 1873-1887)

4.	287-289 Central Avenue Block 828 (Contact 239/29)	bet 1873- 1887	P Main Street	E	C/ R	<i>Italianate</i> 2 Matching buildings, 3 stories, brick, multiple entries, each with 3 bays and rectangular plan. #287: Commercial ground story. <u>2nd and 3rd stories</u> : windows with 2/2 sash, segmentally arched heads, bracketed stone sills, and cornice lintels; continuous cornice with paired brackets and modillions. #289: Commercial ground story. <u>2nd and 3rd stories</u> : matches #287 except projecting bay has been added to 2nd story and windows have been replaced with rectangular windows with 1/1 sash; cornice continuous with #287. Ground story of both buildings has been altered.	Contact 239/29

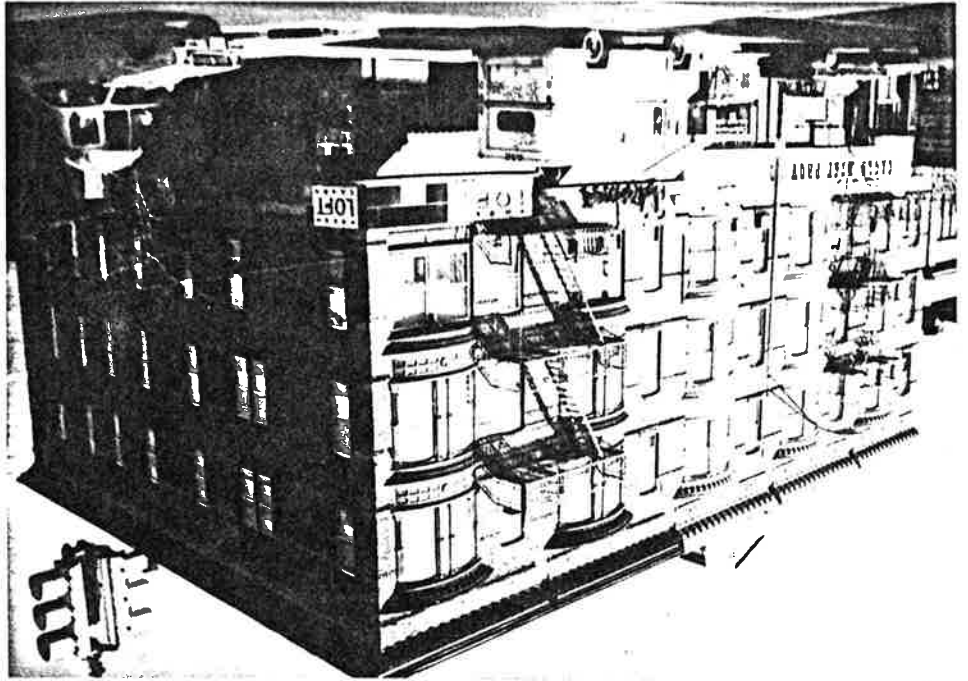
Site No. 0906-D4 cam  
 349-355 Central Ave.  
 Jersey City, N.J.  
 Photo Neg. No. 214/S  
 Map No. 11  
 (1893)

MAP #	ADDRESS/LOCATION : PROPERTY NAME	DATE	Signifi- cance to D/S	Condition	USE	DESCRIPTION: Style, Ext. Wall Fabric, Fenestration, Form, Roof, Major Features, Alterations, Stories, etc.	NEGATIVE FILE #
11,	349-355 Central Avenue Block 825 (Contact 214/5)	1893 (pedi- ment)	P Main St.	G	C / R	5 related Italianate Variant buildings, 4 stories, brick, multiple entries, rectangular plans with rear extensions. Commercial ground stories. <u>2nd - 4th stories</u> : #349-351 each has metal bowed bay reaching to the top of the 4th story; #353-355 have matching bays from the 3rd-4th stories; windows of all bays separated by fluted pilasters; rectangular panels below windows of bays; bays topped by bracketed cornice; double windows replace bays on 2nd story of #353-355; in addition to bay, each building with single window with segmentally arched stone head on each story; all windows rectangular with 1/1 sash; all buildings topped by bracketed cornices with decorated friezes; cornice of #351 surmounted by triangular pediment on a base. All ground stories have been altered.	Contact 214/5

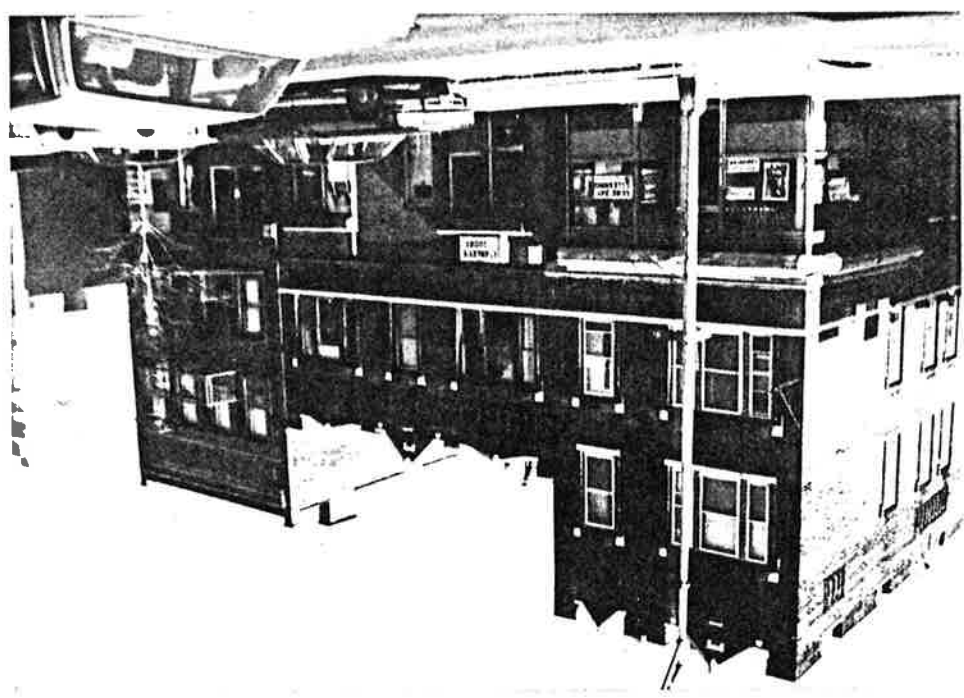
Site No. 0906-D4 can  
499-501 Central Ave.  
Jersey City, N.J.  
Photo Neg. No. 215/3  
Map No. 24  
(bat. 1919-1928)

MAP #	ADDRESS/LOCATION : PROPERTY NAME	DATE	Signifi- cance to D/S	Condition	USE	DESCRIPTION: Style, Ext. Wall Fabric, Fenestration, Form, Roof, Major Features, Alterations, Stories, etc.	NEGATIVE FILE #
24. ont'						belt course forms continuous sill for 2nd story win- dows; building terminates in blind arcade topped by battlemented parapet with stone accents. #501: 2 stories, 3 bays. 2nd story: 2 tripartite windows with central single window; all windows rectangular with 1/1 sash; stone belt course extending from #499 forms continuous sill; blind arcade matching that of #499; battlemented parapet with stone accents similar to that of #499.

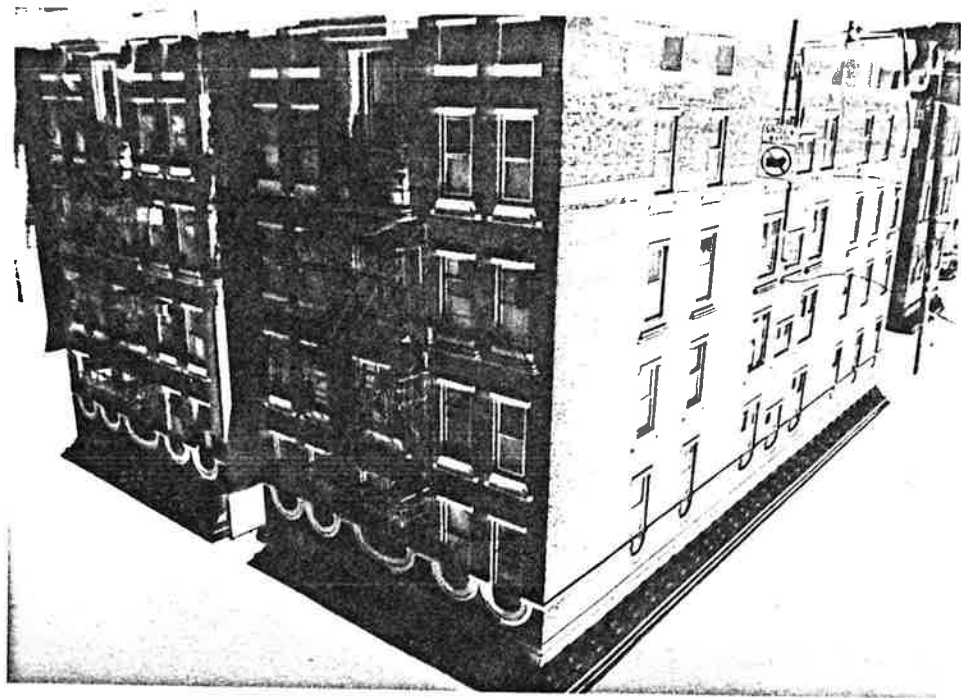
Site No. 0906-D4 cas  
573-577 Cathedral Avenue  
Jersey City, N.J.  
Photo Neg. No. 197/15  
Map No. 29  
(bat. 1908-1919)

IP #	ADDRESS/LOCATION : PROPERTY NAME	DATE	Signifi- cance to D/S	Condition	USE	DESCRIPTION: Style, Ext. Wall Fabric, Fenestration, Form, Roof, Major Features, Alterations, Stories, etc.	NEGATIVE FILE #
29.	573-577 Central Avenue Block 808 (Contact 197/15)	Bet. 1908- 1919	P Main Street	G	R2	2 matching Renaissance Revival apartments, 4 stories; brick; each with 5 bays, 1 main entry, and rectangular plan. Each entry topped by stone pediment; all windows rectangular with 1/1 sash and stone sills; stone cornice window heads on ground - 3rd stories, joined round arched heads on 4th story; double windows on each story above entry; continuous bracketed cornices with plain friezes.	Contact 197/15

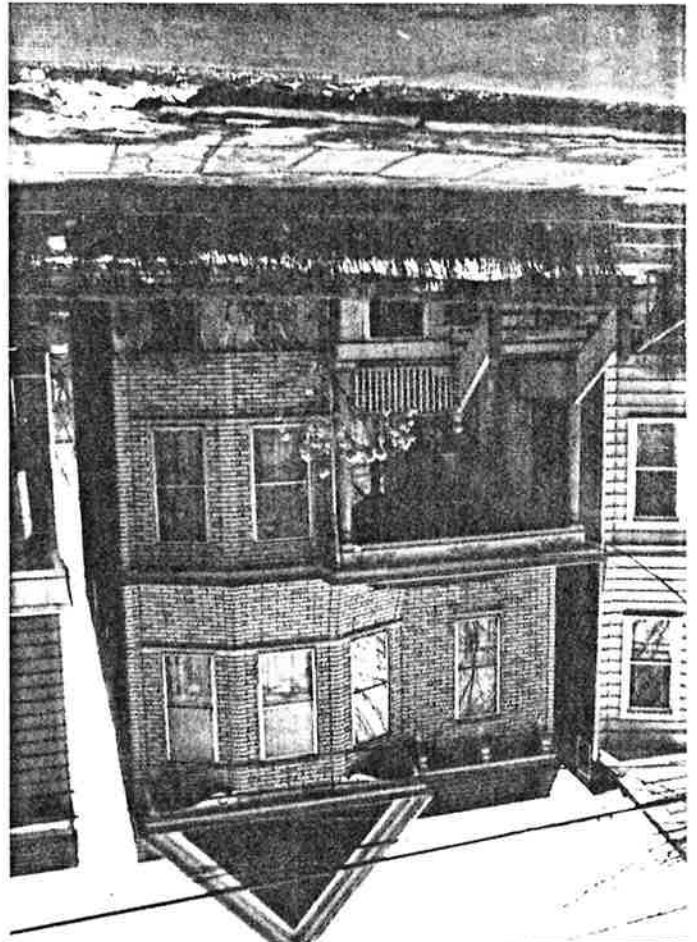
Site No. 0906-D4 cha  
 99 Charles Street  
 Jersey City, N.J.  
 Photo Neg. No. 218/12  
 Map No. 8  
 (bet. 1896-1908)

8.	99 Charles Street Block 868 (Contact 218/12)	bet. 1896- 1908	P Queen Anne Theme	E	R1	Queen Anne vernacular, 2 stories, frame, 1 main entry, rectangular plan with rear extension; Wooden porch with decorated frieze and balusters is set on columns before main entry; wooden railings down steps; main entry with sidelights; tripartite projecting bay rises height of building; all windows rectangular with 1/1 sash; projecting bay topped by gable roof end; bracketed pent roof end forms main roof line. Building has been resurfaced.	Contact 218/12

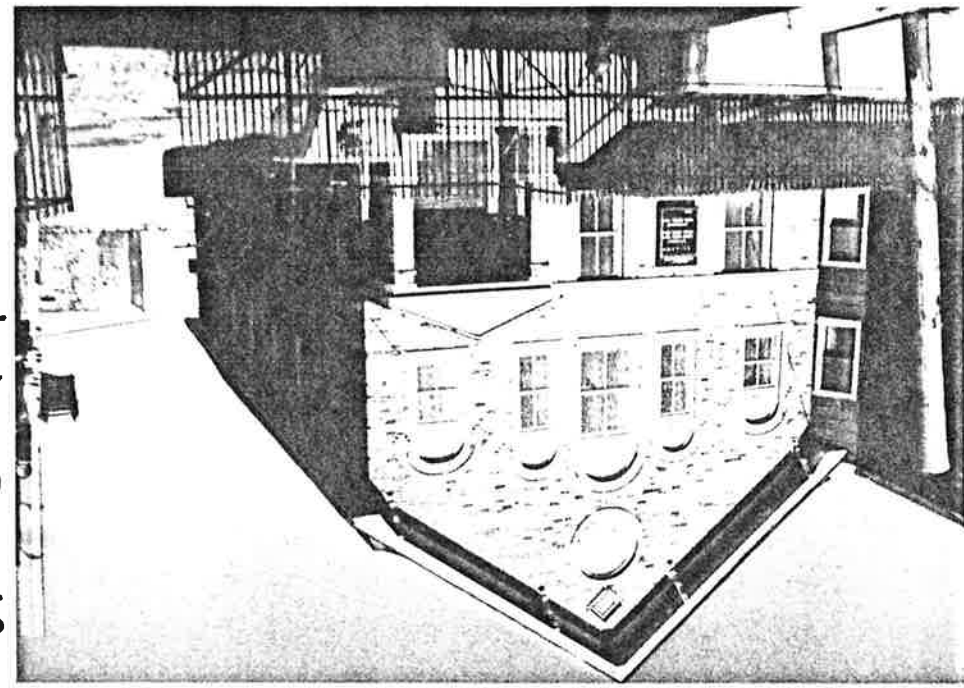
Site No. 0906 - D4 con  
 158 Congress Street  
 German Seventh Day  
 Adventist Church  
 Jersey City, N.J.  
 Photo Neg. No. 215/11  
 Map No. 4  
 (b.t. 1919-1928)

4.	158 Congress Street German Seventh Day Adventist Church Block: 814 (Contact: 215/11)	Between 1919- 1928	P Church theme	E	T	Romanesque Revival church, 2 stories, brick, 1 main entry, rectangular plan. <u>GROUND STORY</u> : Gable roofed porch set on brick piers before main entry; rectangular windows with 2/2 sash; decorative brickwork belt course at top of story. <u>2nd STORY</u> : Rectangular windows with 2/2 sash, stone sills, and round arched heads decoratively outlined in contrasting brick; stained glass in tympanums of arches; central bull's eye window with stained glass above 2nd story windows; gable roof with bracketed cornice and gable facing street.	Contact: 215/11, 17/33

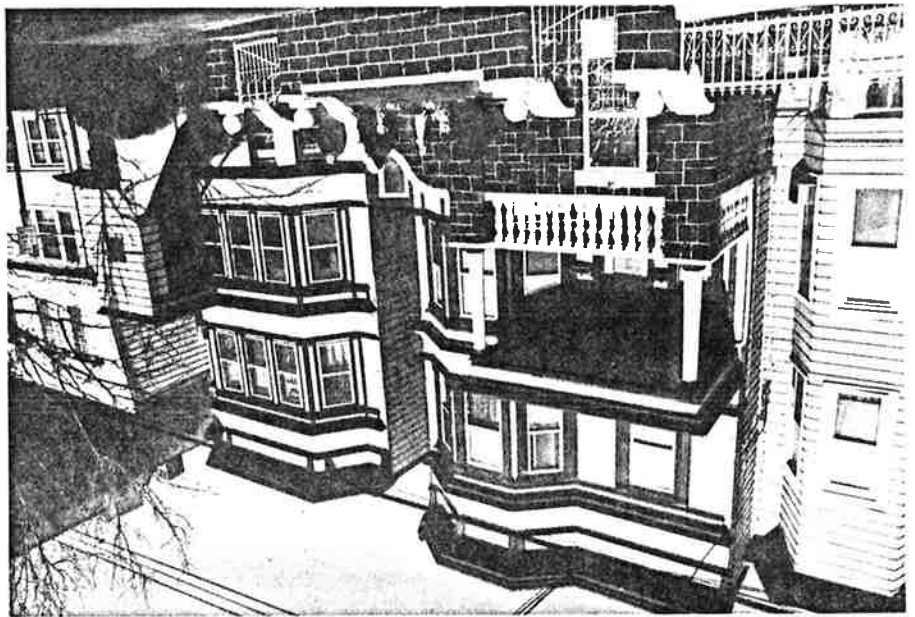
Site No. 0906 - D4 con  
 188 Congress Street  
 Jersey City, N.J.  
 Photo Neg. No. 196/24  
 Map No. 7  
 (bet. 1908 - 1919)

MAP #	ADDRESS/LOCATION : PROPERTY NAME	DATE	Signifi- cance to D/S	Condition	USE	DESCRIPTION: Style, Ext. Wall Fabric, Fenestration, Form, Roof, Major Features, Alterations, Stories, etc.	NEGATIVE FILE #
7.	188 Congress Street Block: 881 (Contact: ;196/27)	Between 1908- 1919	P It. Wood Theme	E	R <sup>2</sup>	Italianate Variant, 2 stories, frame, multiple entries, rectangular plan. Wooden porch with columns, decorated frieze, and balustrade is set before main entries; tripartite projecting bay rises height of building; all windows rectangular with 1/1 sash; each window enframed by fluted pilasters and topped by swag ornamented panel; bracketed cornice with modillions and decorated frieze.	Contact: 196/27

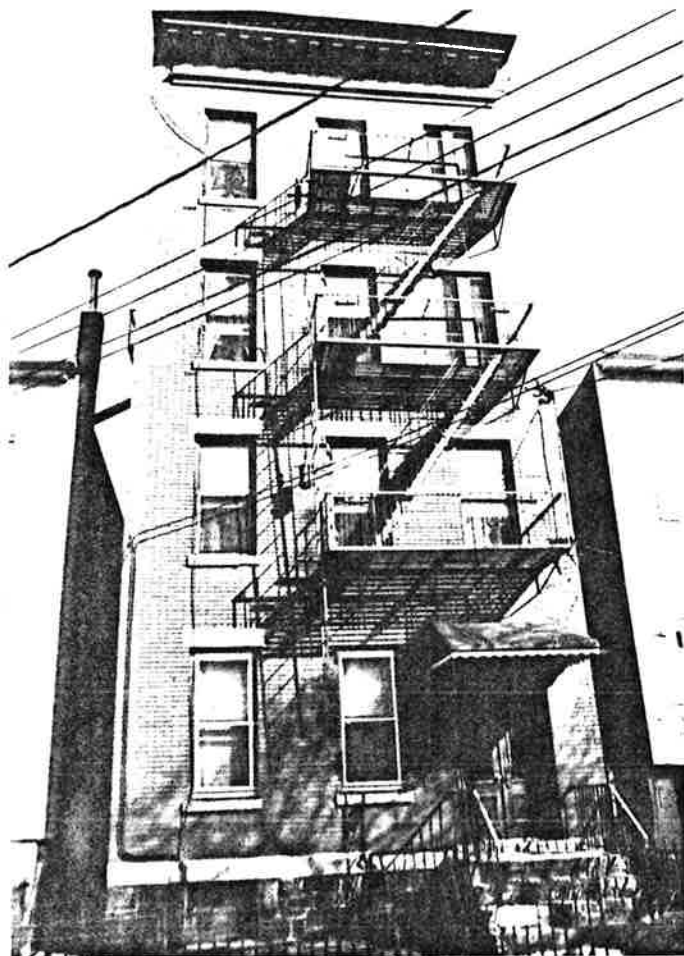
Site No. 0906-D4 gnf  
282 Griffith Street  
Jersey City, N.J.  
Photo Neg. No. 199 / 13  
Map No. 7  
(bet. 1896-1908)

MAP #	ADDRESS/LOCATION : PROPERTY NAME	DATE	Signifi- cance to D/S	Condition	USE	DESCRIPTION: Style, Ext. Wall Fabric, Fenestration, Form, Roof, Major Features, Alterations, Stories, etc.	NEGATIVE FILE #
7.	282 Griffith Street Block: 864 (Contact: 199/13)	Between 1896- 1908	P It. Brick Theme	E	R <sup>2</sup>	Italianate, 4 stories, 3 bays, brick, 1 main entry, rectangular plan. Rectangular windows with 1/1 sash, stone lintels and sills; stone water table; bracketed cornice with dentils and plain frieze.	Contact: 199/13

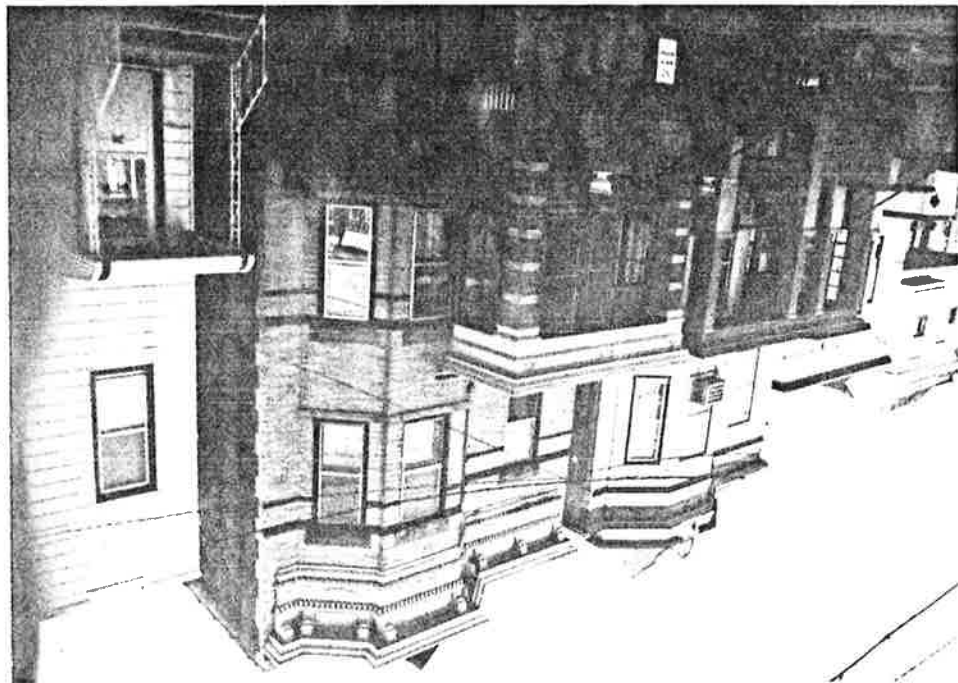
Site No. 0906-D4 in v  
30-32 Inging Street  
Jewey City, N.J.  
Photo Neg. No. 197/29  
Map No. 4  
(bet. 1908-1919)

4.	30-32 Irving Street Block 810 (Contact 197/29)	Bet. 1908- 1919	P It. Brick Theme	G, R1 E		Almost identical mirror image Italianate Variant buildings, 2 stories, brick, each with 1 main entry and rectangular plan. Each building with porch set on brick piers before main entry; tripartite projecting bay rising height of building; rectangular windows with 1/1 sash, stone lintels and sills; and bracketed cornice with dentils and swag and tassel decorated frieze. #30 has brick quoins at corners of building. Stone lintels of #30 are deteriorating.	Contact 197/29, 32

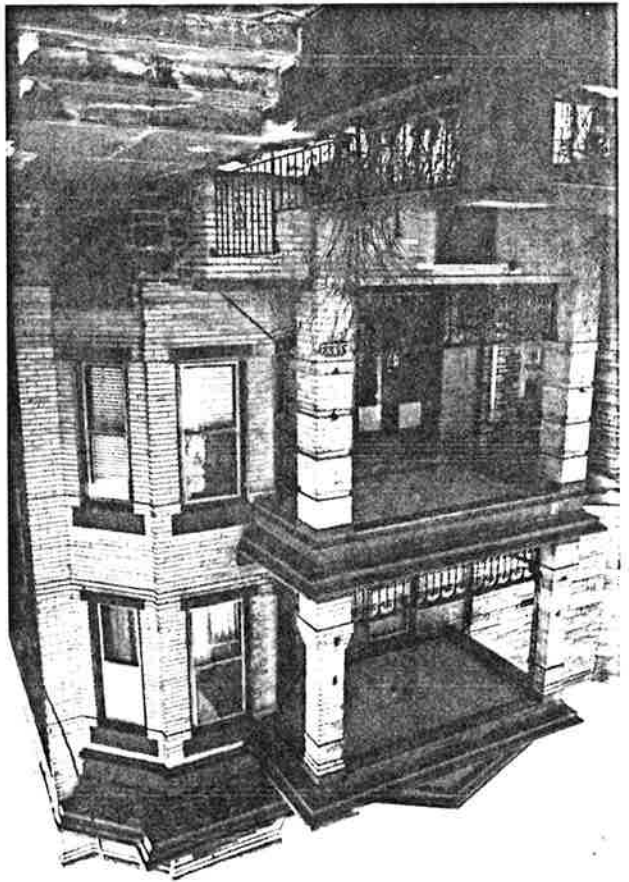
Site No. 0906-D4JFK  
 3332 J.F. Kennedy Blvd.  
 Jersey City, N.J.  
 Photo Neg. No. 193/6  
 Map No. 1  
 (bar, 1908-1919)

1.	3332 J.F. Kennedy Boulevard Block: 857 (Contact: 193/6)	Between 1908- 1919	P It. Brick Theme	G	R <sup>1</sup>	Italianate Variant, 2 stories, brick, 1 main entry, irregular rectangular plan. Two tier porch set on brick piers; porch terminates in central pediment; tripartite projecting bay rises height of building; rectangular windows with 1/1 sash, stone lintels and sills; bracketed cornice; brick parapet.	Contact: 193/6

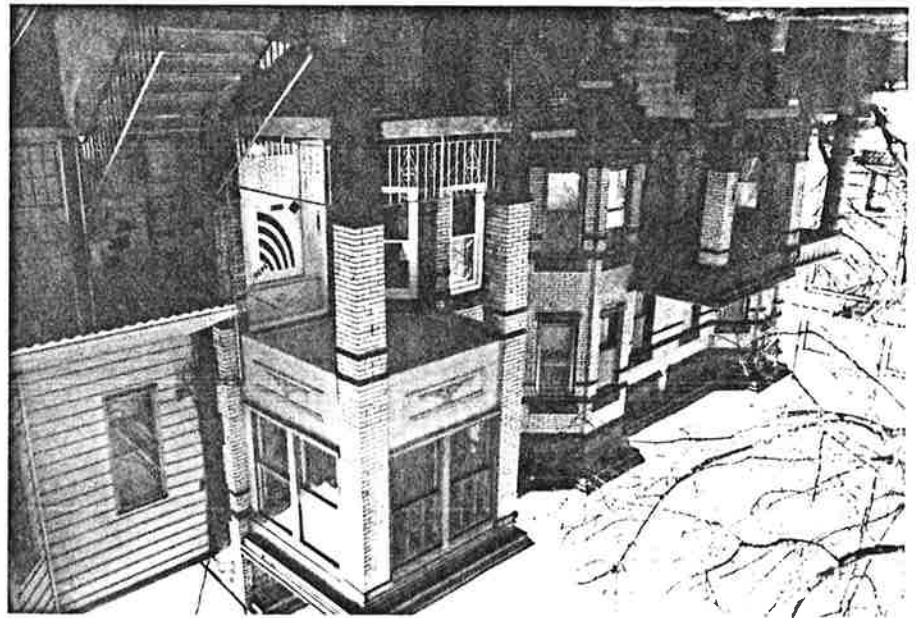
Site No. 0906-D4.jfk  
 3456A-3458 J.F.  
 Kennedy Blvd.  
 Jersey City, N.J.  
 Photo Neg. No. 193/19  
 Map No. 6  
 (bet. 1908-1919)

6.	3456A-3458 J.F. Kennedy Boulevard Block: 868 (Contact: 193/19)	Between 1908- 1919	P It. Brick Theme	G	R <sup>1</sup>	Italianate Variant double house, 2 stories, brick, each section with 1 main entry and rectangular plan. Porch set on brick piers before each entry; each section with tripartite projecting bay rising height of building; all windows rectangular with 1/1 sash, stone lintels and sills; bracketed cornice with plain frieze. Porch entablature of #3458 has been replaced with modern siding.	Contact: 193/19

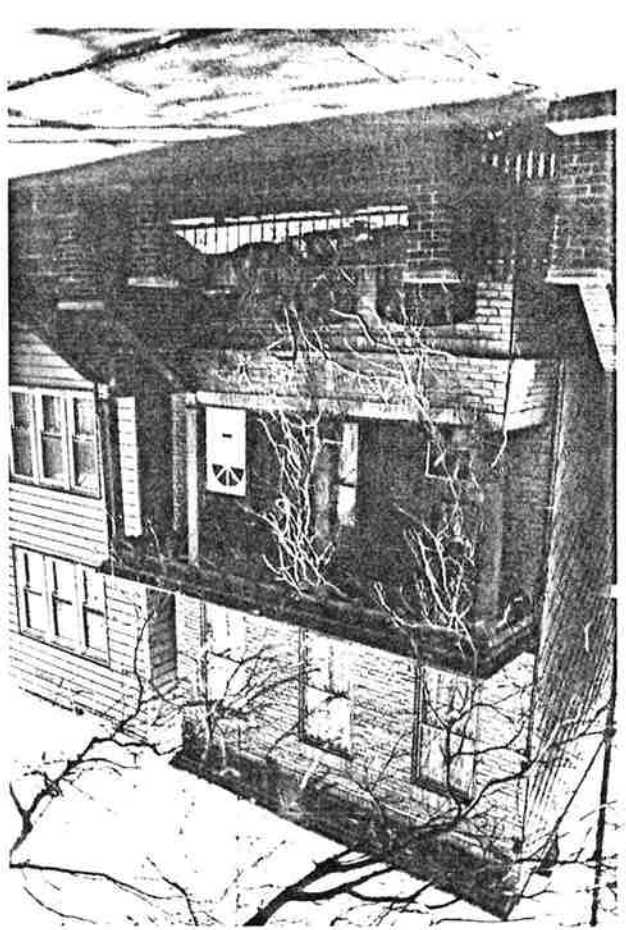
Site No. 0906-D4.jfk  
 3708 J.F. Kennedy Blvd.  
 Jersey City, N.J.  
 Photo Neg. No. 191/5  
 Map No. 14  
 (before 1873)

MAP #	ADDRESS/LOCATION : PROPERTY NAME	DATE	Signifi- cance to D/S	Condition	USE	DESCRIPTION: Style, Ext. Wall Fabric, Fenestration, Form, Roof, Major Features, Alterations, Stories, etc.	NEGATIVE FILE #
14.	3708 J.F. Kennedy Boulevard Block: 897 (Contact: 191/5)	Before 1873	P It. Wood Theme	E	R <sup>1</sup>	Italianate, 2 stories, 3 bays, frame, 1 main entry, rectangular plan with rear extension. Wood porch with bracketed cornice set on posts with cutout brackets extends across ground story; rectangular windows with 1/1 sash; bracketed cornice with modillions. Building has been resurfaced and trim removed. Property listed on the 1873 map as belonging to H. DeMott.	Contact: 191/5

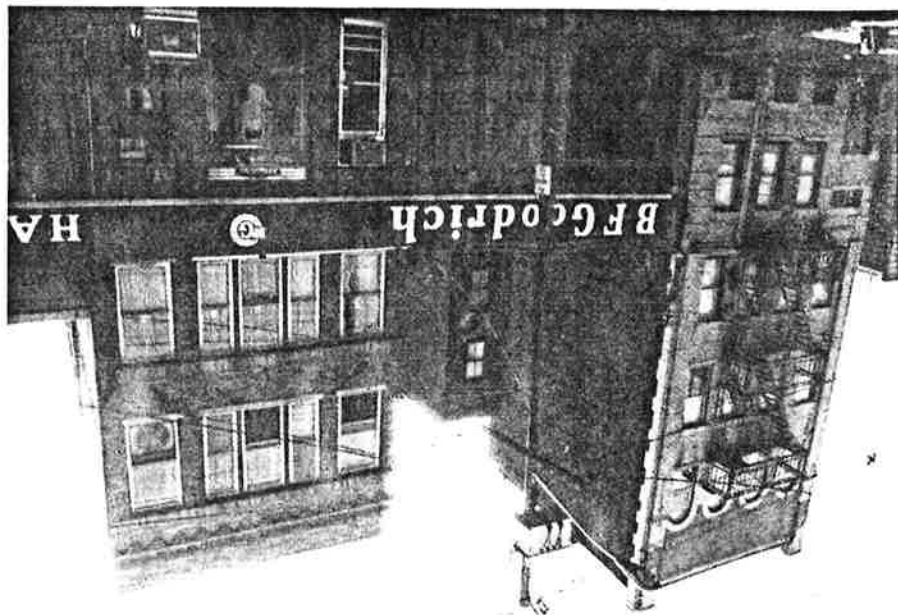
Site No. 0906-D4 Leo  
49 Leonard Street  
Jewey City, N.J.  
Photo Neg. No. 195/22  
Map No. 2  
(bat. 1908-1919)

2.	49 Leonard Street Block 808 (Contact 195/22)	bet. 1908- 1919	P Comm- ercial Style Theme	G	C/ R	Commercial style, 3 stories, 3 bays, 2 main entries, brick, rectangular plan. <u>Ground story</u> : two entries, each with transom and brick lintel, flank large, central plate glass window; modern metal sign across top of story. <u>2nd-3rd stories</u> : tripartite window flanked by single windows; all windows rectangular with 6/1 sash, stone sills, and continuous brick lintel; brick fascia and corbel table topped by stone outlined brick parapet.	Contact 195/22

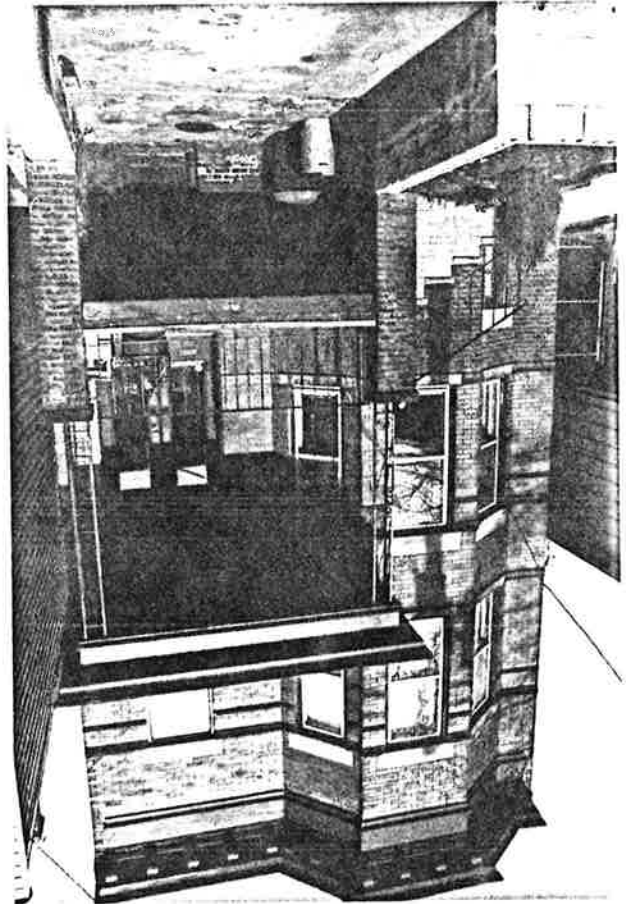
Site No. 0906-D4 not  
 160 North Street  
 Jersey City, N.J.  
 Photo Neg. No. 196/16  
 Map No. 11  
 (bar. 1908-1919)

MAP #	ADDRESS/LOCATION : PROPERTY NAME	DATE	Signifi- cance to D/S	Condition	USE	DESCRIPTION: Style, Ext. Wall Fabric, Fenestration, Form, Roof, Major Features, Alterations, Stories, etc.	NEGATIVE FILE #
11.	160 North Street Block: 887 (Contact: 196/16)	Between 1908- 1919	P It. Brick Theme	E	R <sup>1</sup>	Italianate Variant, 2 stories, brick, 1 main entry, rectangular plan. Porch set on modern metal supports before main entry; tripartite projecting bay extends height of building; rectangular windows with 1/1 sash, stone lintels and sills; bracketed cornice with plain frieze.	Contact: 196/16

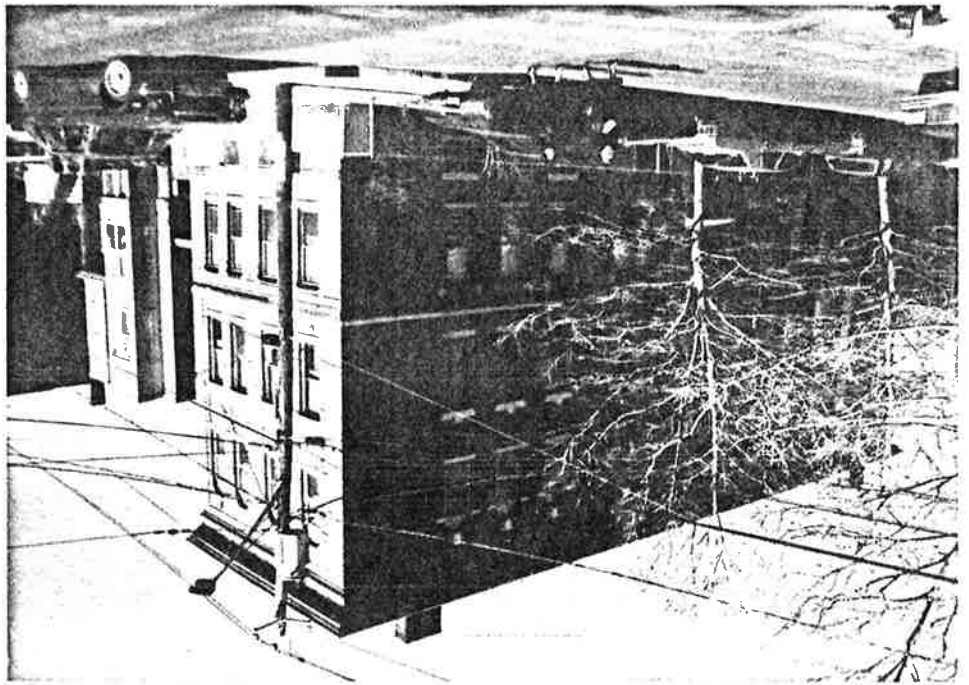
Site No. 0906-D4 pas  
 34-38 Pennac Ave.  
 Jersey City, N.J.  
 Photo Neg. No. 215/15  
 Map No. 4  
 (bet. 1908-1919)

MAP #	ADDRESS/LOCATION : PROPERTY NAME	DATE	Signifi- cance to D/S	Condition	USE	DESCRIPTION: Style, Ext. Wall Fabric, Fenestration, Form, Roof, Major Features, Alterations, Stories, etc.	NEGATIVE FILE #
1.	34-38 Passaic Avenue Block: 815 (Contact: 215/15)	Between 1908- 1919	P Geo. Revival/ Apt. Theme	E	R <sup>2</sup>	Georgian Revival, 3 stories, brick, 1 main entry, rectangular plan with rear light well court. Stone belt course above ground story; rectangular windows with 1/1 sash and stone sills; windows with flat arched stone lintels with keystone on 2nd story; windows with round arched heads with stone keystone on 3rd story; bracketed cornice with plain frieze.	Contact 215/15

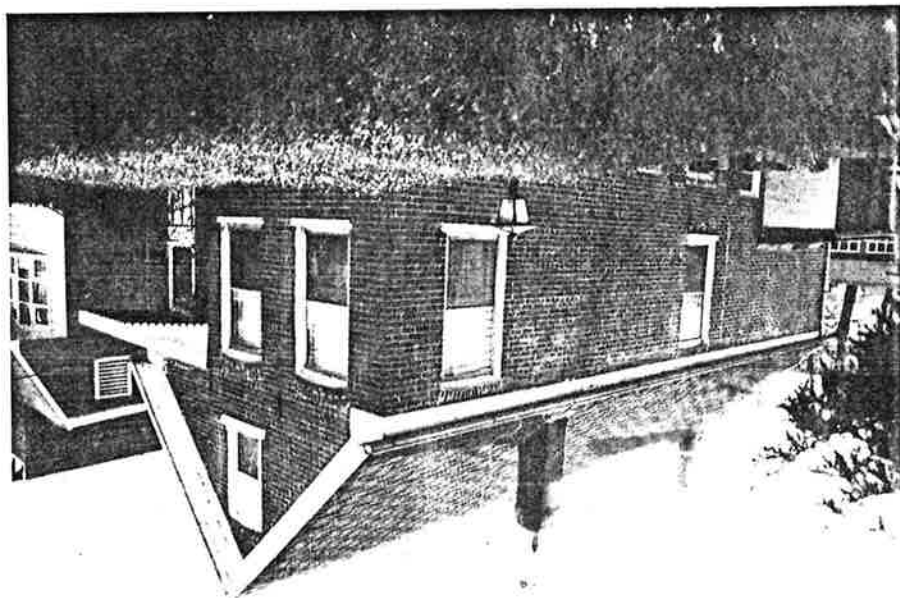
Site No. 0906-D4 part  
 93 Pateron Street  
 Jersey City, N.J.  
 Photo Neg. No. 196/32  
 Map No. 7  
 (ver. 1873-1887)

P #	ADDRESS/LOCATION : PROPERTY NAME	DATE	Significance to D/S	Condition	USE	DESCRIPTION: Style, Ext. Wall Fabric, Fenestration, Form, Roof, Major Features, Alterations, Stories, etc.	NEGATIVE FILE #
7.	93 Paterson Street Block 876 (Contact 196/32)	bet. 1873- 1887	P It. brick theme	G/ E	R1	Italianate vernacular, 1 1/2 stories, 1 main entry, brick, rectangular plan with side extension. Entry with modern metal overdoor; rectangular windows with 1/1 sash, wood sills, and segmentally arched brick heads; gable roof with gable facing street.	Contact 196/32

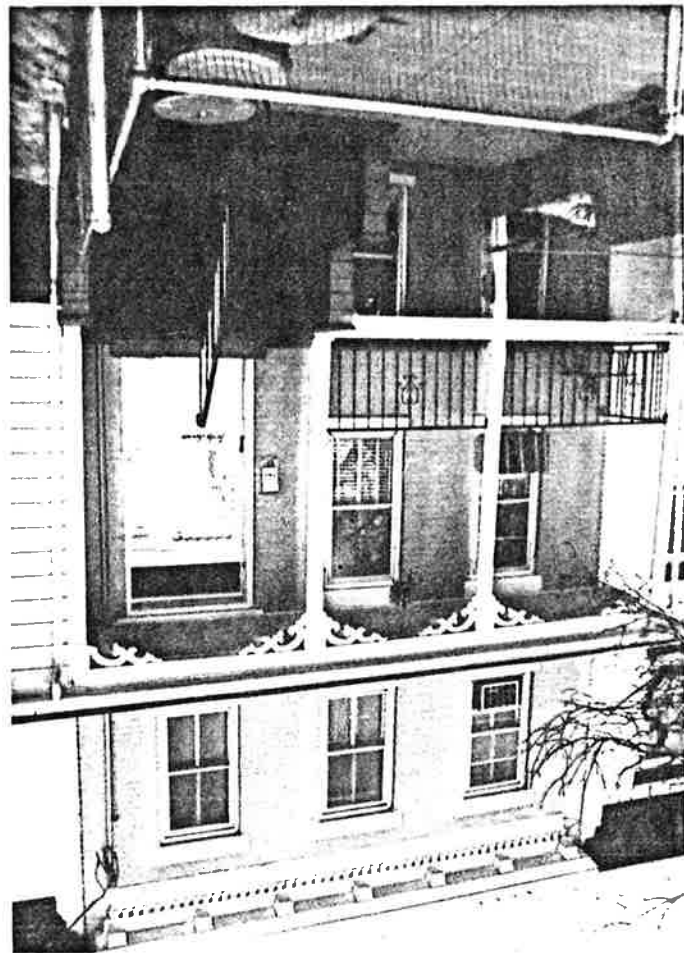
Site No. 0906-D4 pop  
 45-49 Poplar Street  
 Jersey City, N.J.  
 Photo Neg. No. 191/24  
 Map No. 4  
 (before 1873)

MAP #	ADDRESS/LOCATION : PROPERTY NAME	DATE	Signifi- cance to D/S	Condition	USE	DESCRIPTION: Style, Ext. Wall Fabric, Fenestration, Form, Roof, Major Features, Alterations, Stories, etc.	NEGATIVE FILE #
4.	45-49 Poplar Street Block: 810 (Contact: 197/24,25)	Before 1873	#45- 47 Y Gr. Revival Theme; #49 N	E	R <sup>1</sup>	3 matching Greek Revival residences, brick; each with 2 stories with basement, 3 bays, 1 main entry, and rectangular plan. Each building has rectangular windows with stone lintels and sills and a bracketed cornice with dentils and a plain frieze. #45 has a modern overdoor and windows with 1/1 sash. #47 has windows with 2/2 sash and a wooden porch carried by posts with ornate cut out brackets; the ground story of #49 has been completely altered. Property listed on 1873 Map as belonging to the Estate of Wm. Whyard.	Contact: 197/24,25

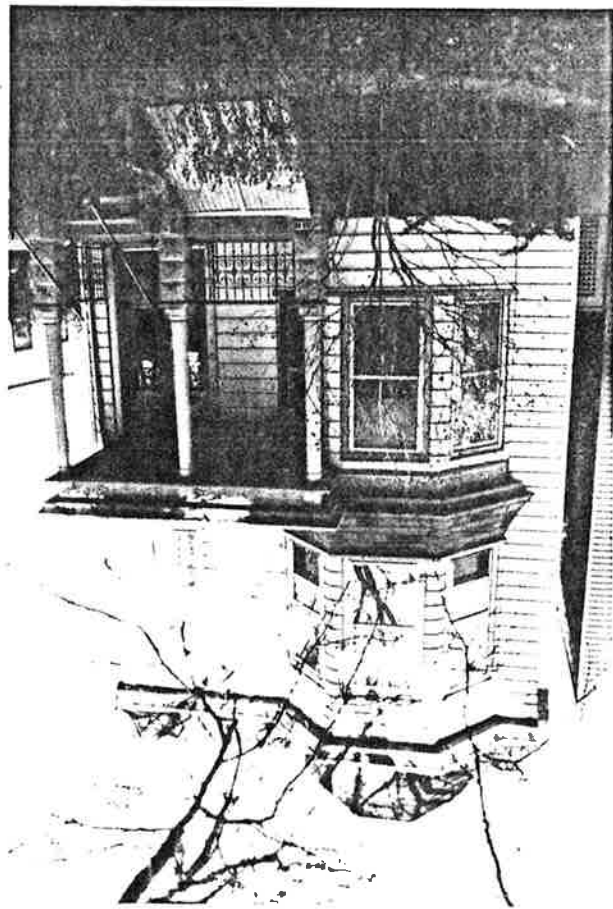
Site No. 0906-D4 Sanf  
93 Sanford Place  
Jersey City, N.J.  
Photo Neg. No. 239/16  
Map No. 2  
(bat. 1896-1908)

2.	93 Sanford Place Block 855 (Contact 239/16)	Bet. 1896- 1908	P Queen Anne Theme	E	R1	Queen Anne, 2 stories, 1 main entry, frame, rectangular plan. Wood porch with cornice, dentils, plain frieze, and pediment with brackets before the main entry extends across the front facade and covers part of the side elevation; main entry with transom and sidelights; tripartite projecting bay rises height of building; rectangular windows with 1/1 sash and wood enframements; projecting bay terminates in projecting cornice with brackets and modillions topped by gable roof end; cornice continuous across facade below roof line; building terminates in small cornice with dentils.	Contact 239/16, 31/25

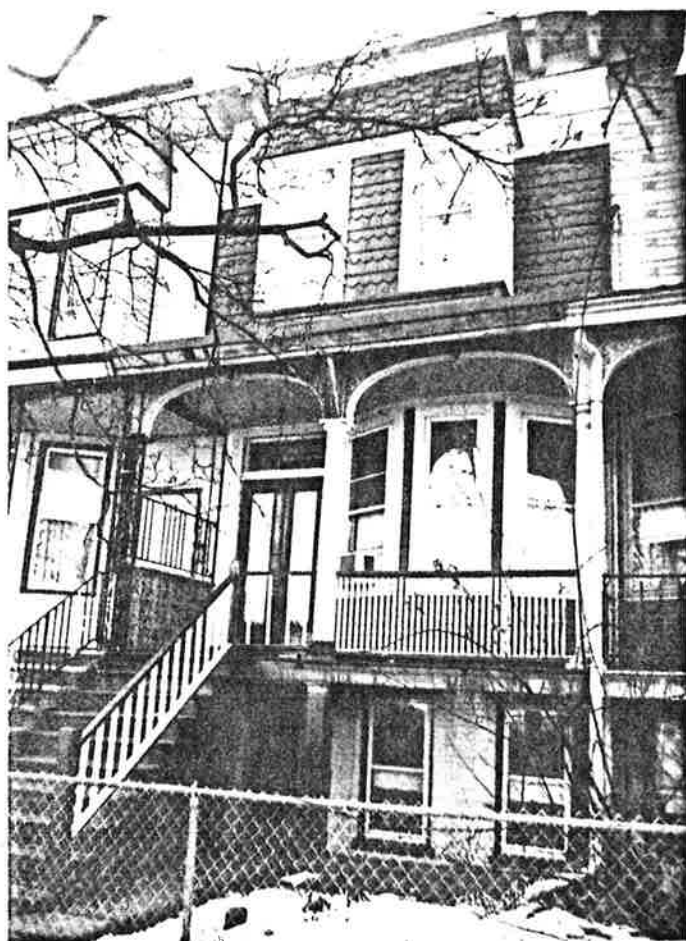
Site No. 0906-D4 Sharp  
25 1/2 Sherman Place  
Jersey City, N.J.  
Photo Neg. No. 240/17A  
Map No. 4  
(bet. 1873-1887)

4.	25 1/2 Sherman Place Block 830 (Contact 240/17A)	bet. 1873- 1887	p Dist.	G	R1	Queen Anne, 2 stories with basement, frame, 1 main entry, rectangular plan. <u>Ground story</u> : wooden porch set on columns with basket handle arches between the columns; main entry with transom; tripartite projecting bay with rectangular windows with 1/1 sash. <u>2nd story</u> : rectangular projecting bay with rectangular windows with 1/1 sash; cornice with brackets on either side of projecting bay. Porch cornice has been covered over with modern siding; left-most porch column has been replaced by modern metal support; building has been resurfaced.	Contact 240/17A

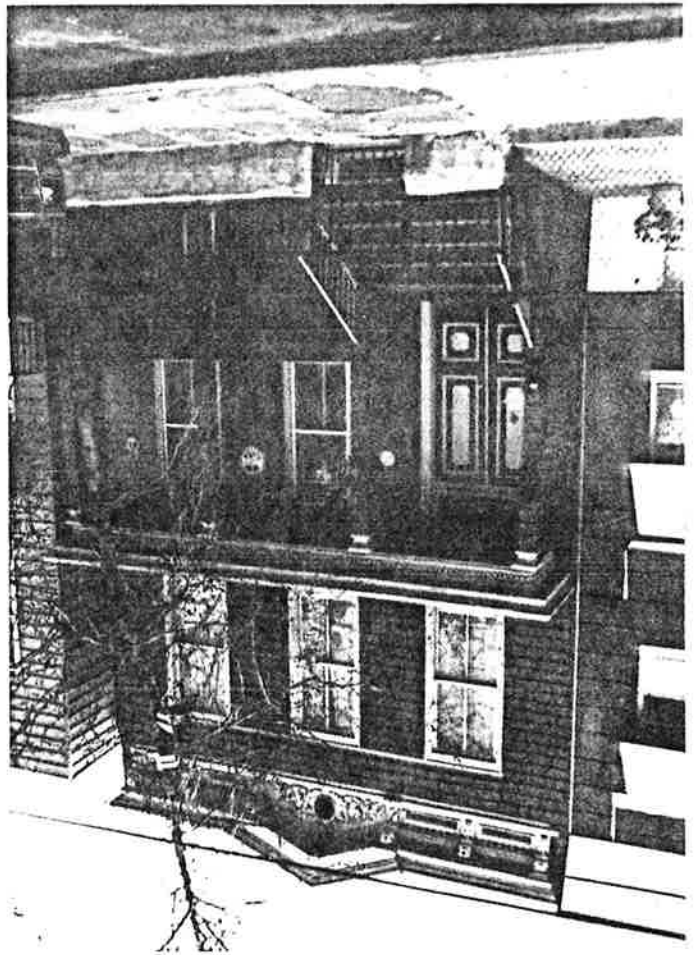
Site No. 0906-D4 sou  
228 South Street  
Jenney City, N.J.  
Photo Neg. No. 245/8  
Map No. 9  
(bar. 1873-1887)

AP #	ADDRESS/LOCATION : PROPERTY NAME	DATE	Signifi- cance to D/S	Condition	USE	DESCRIPTION: Style, Ext. Wall Fabric, Fenestration, Form, Roof, Major Features, Alterations, Stories, etc.	NEGATIVE FILE #
9.	228 South Street Block 874 (Contact 245/8)	bet. 1873- 1887	P It. Wood Theme	E	R1	Italianate, 2 stories, 3 bays, 1 main entry, frame, rectangular plan. Wooden porch with cornice and denticulated frieze set on posts extends across ground story; panelled entry door with transom; rectangular windows with 2/2 sash and wood enframements; highly decorative cornice with ornate brackets, dentils, panelled frieze; and central triangular elevation topping an area with ornate foliate decoration in relief. Facade and porch, excluding porch cornice, have been resurfaced.	Contact 245/8

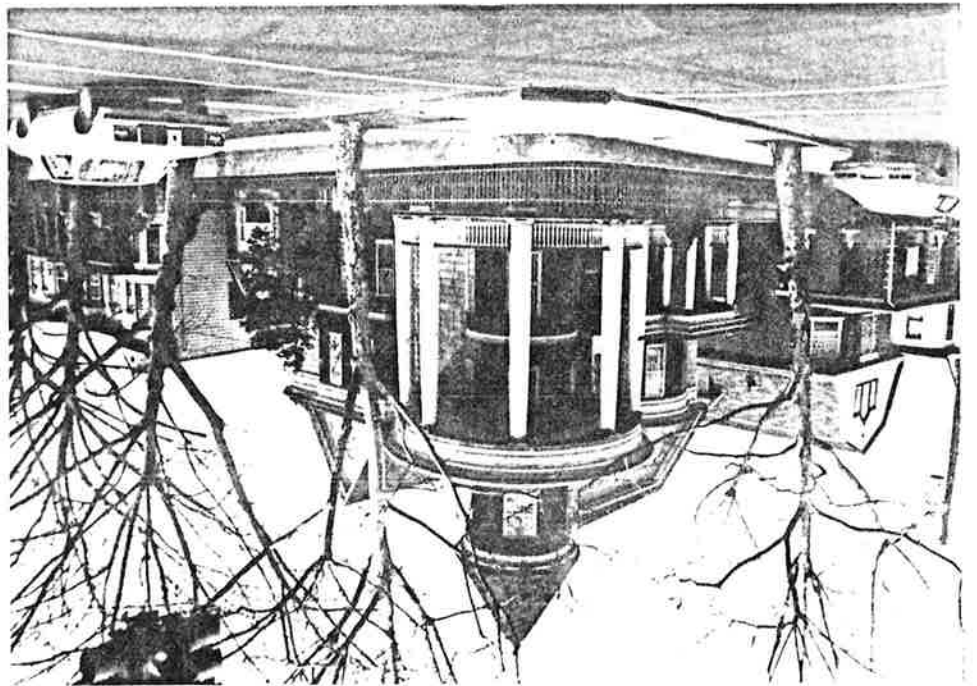
Site No. 0906 - D4 sum  
880 Summit Avenue  
Jersey City, N.J.  
Photo Neg. No. 17/6  
Map No. 1  
(c. 1900)

1.	880 Summit Avenue Block 830 (Contact 17/6)	c. 1900	P Dist.	E	R1	Queen Anne, 2 1/2 story, frame, 1 main entry, irregular rectangular plan. At corner, a 2 story, round, columned portico encloses a 2 1/2 story round tower capped by a conical roof. To left, a 1 story, column supported porch and main entry with transom on ground story; small curvilinear projecting bay on 2nd story; hipped roof with cutaway area leaving space for windows at 2 1/2 story level. To right, 2 story projecting bay, tripartite on ground story, rectangular on 2nd story; cross gable roof with window with round arched head in gable end; remaining windows rectangular with 1/1 sash.	Contact 17/6, 5; 241/26A, 28A

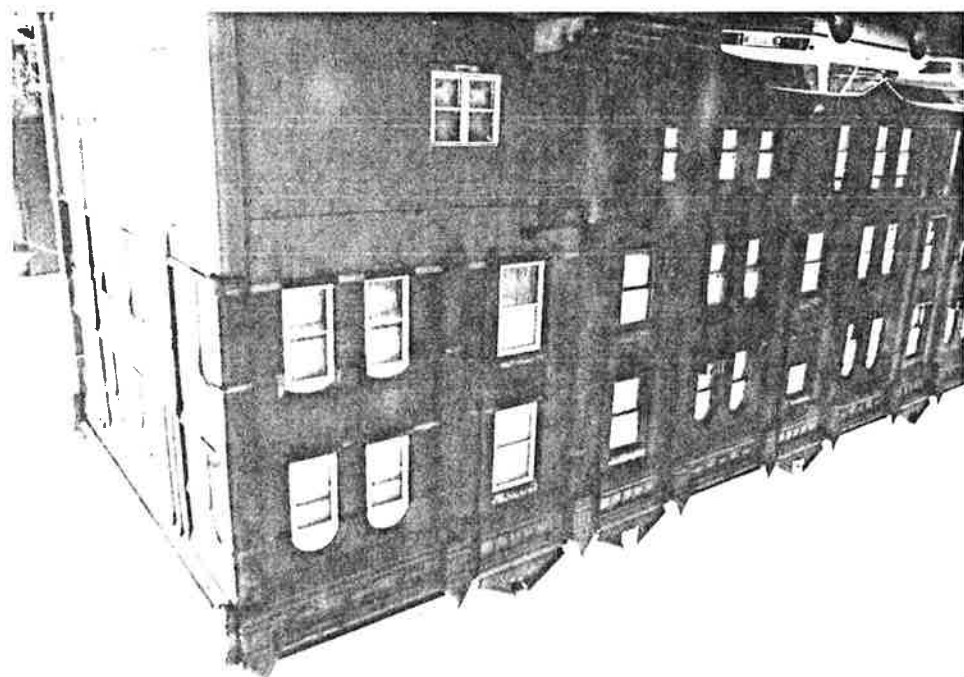
Site No. 0906-D4 sum  
962-968 Summit Ave.  
Jersey City, N.J.  
Photo Neg. No. 199/23  
Map No. 18  
(bat. 1887-1896)

#18 Continued					3rd story: rectangular window with stone lintel and sill and decorative panel beneath it above entry; remaining windows rectangular with round arched heads with decorative brickwork; all windows with 1/1 sash. 3 story pilasters topped by ornamental pediment separate buildings; matching pilaster on 2nd and 3rd stories sets off windows above entry; windows above entry enframed by 2 story pilasters topped by decorative broken pediment; continuous corbel table above 3rd story windows; small cornice with dentils and swag decorated frieze above remaining windows. Stone trim is deteriorating.	
19	965 Summit Avenue Block 863 (Contact 199/25)	bet. 1873- 1887	P Second Empire Theme	E R1		Second Empire, 3 stories with basement, 3 bays, frame, 1 main entry, rectangular plan. Wood porch with bracketed cornice and plain frieze set on posts with brackets extends across ground story; rectangular windows with 1/1 sash; cornice with ornate foliate brackets, modillions, and panelled frieze topped by straight sided mansard roof; dormers with pedimented heads. Building has been resurfaced.	Contact 199/25

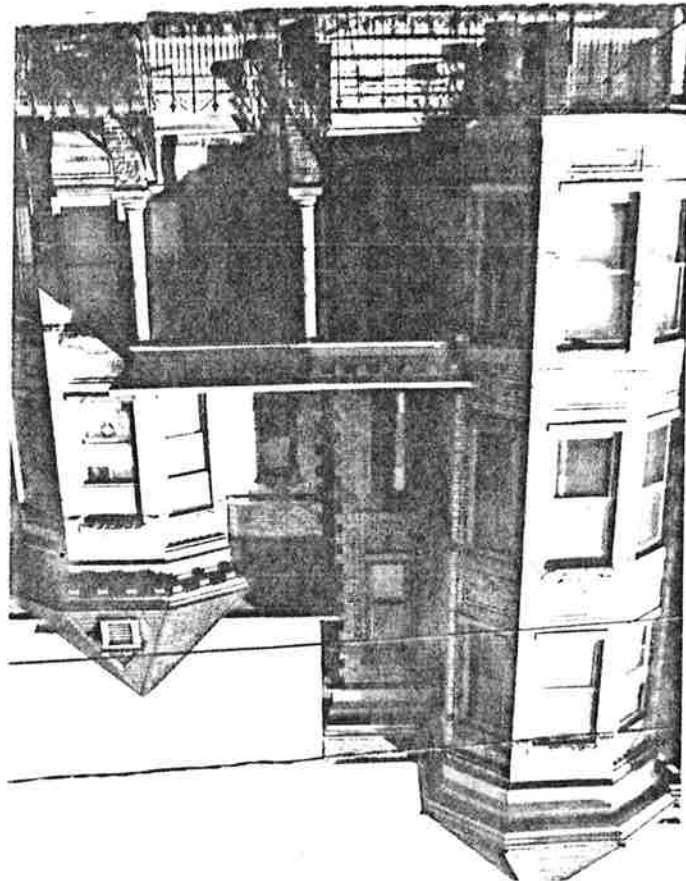
Site No. 0906-D4 sum  
 933A-935 Summit Avenue  
 Jersey City, N.J.  
 Photo Neg. No. 239/21  
 Map No. 13  
 (bat. 1896-1908)

#13 Continued)					stone head with keystone; pedimented ventilator in tent roof of tower; stone bands join lintels. A wood porch with bracketed cornice set on columns extends across both entries. Some of the stone lintels of both buildings are deteriorating.

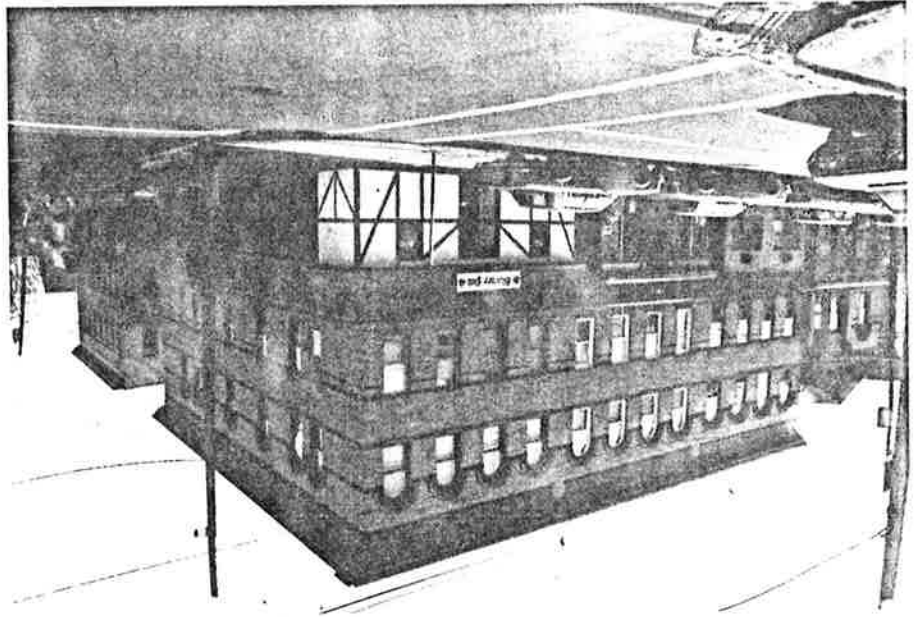
Site No. 0906-D4 sum  
1131-1135 Summit Ave.  
Jersey City, N.J.  
Photo Neg. No. 196/7  
Map No. 28  
(bat. 1896-1908)

MAP #	ADDRESS/LOCATION : PROPERTY NAME	DATE	Signifi- cance to D/S	Condition	USE	DESCRIPTION: Style, Ext. Wall Fabric, Fenestration, Form, Roof, Major Features, Alterations, Stories, etc.	NEGATIVE FILE #
28	1131-1135 Summit Ave. Block 887 (Contact 196/7)	bet. 1896- 1908	P It. Brick Theme	E	C/ R	3 Italianate buildings with continuous facade, 3 stories, 12 bays, multiple entries, brick, rectangular plans. <u>Ground story</u> : commercial area with various architectural motifs; bracketed cornice with panelled frieze at top of story. <u>2nd story</u> : rectangular windows with 1/1 sash, stone lintels and sills; continuous dark brick band immediately below lintels. <u>3rd story</u> : windows with 1/1 sash, stone sills, and round arched brick heads; dark brick bands run between window heads and between sills; bracketed cornices with dentils and swag and tassel decorated friezes. Top cornice and frieze and ground story cornice and frieze match those of #1129 next door. (See Map No. 26).	Contact 196/7

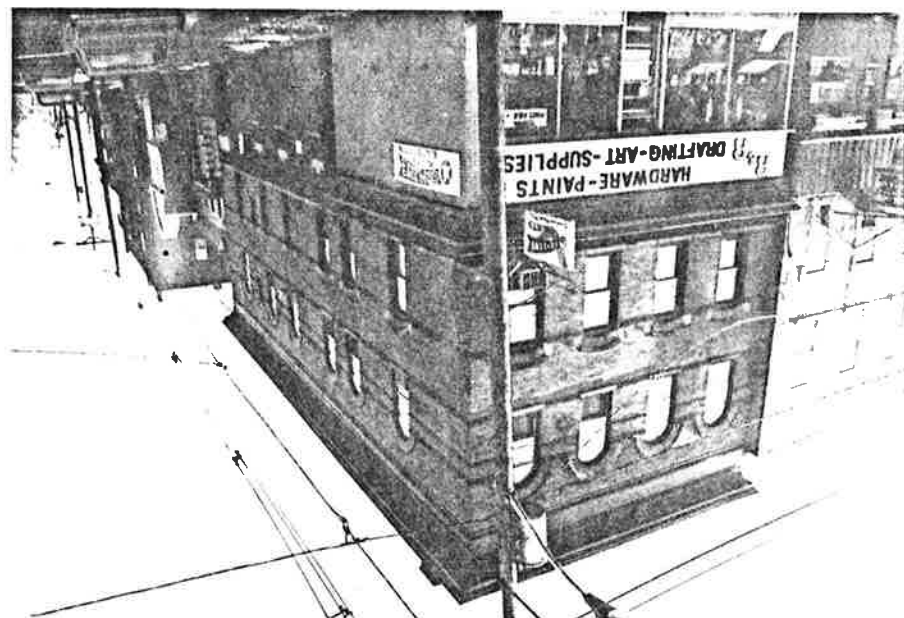
Site No. 0906-D4 sum  
1169-1171 Summit Ave.  
Jersey City, N.J.  
Photo Neg. No. 195/35  
Map No. 35  
(bet. 1896-1908)

MAP #	ADDRESS/LOCATION : PROPERTY NAME	DATE	Signifi- cance to D/S	Condition	USE	DESCRIPTION: Style, Ext. Wall Fabric, Fenestration, Form, Roof, Major Features, Alterations, Stories, etc.	NEGATIVE FILE #
	1169-1171 Summit Avenue Block 893 (Contact 195/35)	bet. 1896- 1908	P It. wood Theme	E	C / R	Italianate, 3 stories, 7 bays, 2 main entries, frame, rectangular plan. <u>Ground story</u> : commercial area with plate glass windows; <u>residential area with entry</u> flanked by paired windows; bracketed cornice with panelled frieze runs across top of story. <u>2nd-3rd stories</u> : rectangular windows with 1/1 sash; ornate bracketed cornice with panelled frieze. Ground story has been altered; remainder of building has been resurfaced and trim removed.	Contact 195/35
