(Western Hudson City  
Neighborhood)

NEW JERSEY OFFICE OF CULTURAL AND ENVIRONMENTAL SERVICES  
HISTORIC PRESERVATION SECTION  
DISTRICT/STREETSCAPE CONTINUATION SHEET

N.J. HISTORIC SITES INVENTORY

Bleecker Street in Western Hudson City Neighborhood  
of Survey Area (ward D4) NJHSI # 0906-D4 bfe,  
Jersey City, Hudson Co.  
Page 2 of 4 photo pages.

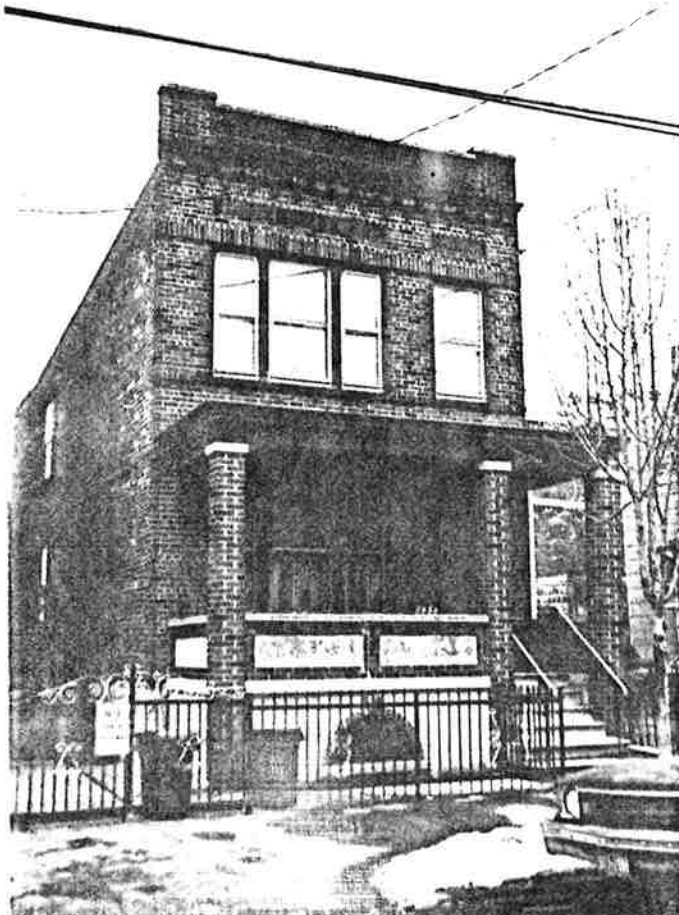
Site No. 0906-D4 thor  
135 Thorne Street  
Jersey City, N.J.  
Photo Neg. No. 245/5  
Map No. 6  
(bet. 1919-1928)

6.	135 Thorne Street Block 869 (Contact 245/5)	bet. 1919- 1928	P Dec. Brick Theme	G	R1	Decorated brick, 2 stories, 2 bays, brick, 1 main entry, rectangular plan. Porch with cornice and plain frieze set on brick piers extends across ground story; triple window on each story; single window over entry; all windows rectangular with 1/1 sash; fluted brick bands above 2nd story windows; building terminates in corbel table topped by small denticulated cornice surmounted by stone capped brick parapet.	Contact 245/5
