Bowers Street in East Hudson City Neighborhood of  
 Survey Area (Ward 8) 0906-05 bars, NY H.S.I. 0906  
 Jersey City, Hudson County

NEW JERSEY OFFICE OF CULTURAL AND ENVIRONMENTAL SERVICES  
HISTORIC PRESERVATION SECTION  
DISTRICT/STREETSCAPE CONTINUATION SHEET

N.J. HISTORIC SITES INVENTORY

District/Streetscape Continuation Page # 1 Inventory # 0906-D5-bow

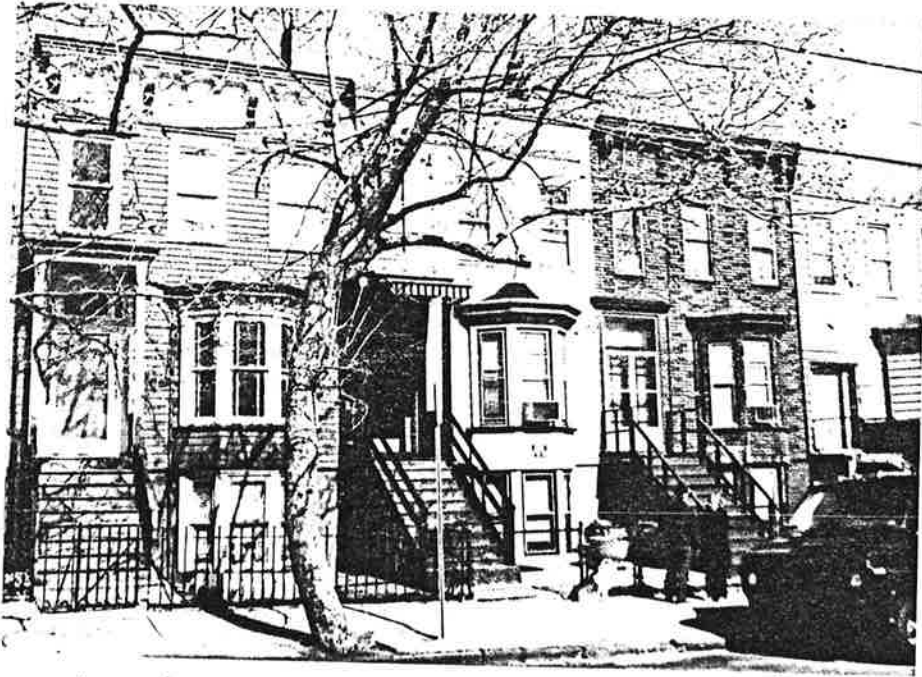
Site No. 0906-D5 bow  
58-64 Bowers Street  
Jersey City, N. J.  
Photo Neg. No. 219/16  
Map No. 1

1.	58-64 Bowers Street Block/774 4 Wood framed rowhouses	Bet. 1873- 1887 (L.D. Fowler Map 1887)	P Theme	G/ F	R	Italianate; recessed rectangular plan with side entry each building 2 stories, 3 bays, wood framed buildings each with basement levels; 1/1 wood double hung sash window treatment on all buildings; but #62 also has 2/2 wood double hung sash windows on 3rd story' shed roofs with architaved wooden cornices adorned with brackets and modillions; cornices atop Nos. 60 and 64 concealed by aluminum siding; architaved wood window heads atop 2nd story windows of #58, such window heads appear to have been removed from Nos. 60 and 64; small modillioned cornices atop projecting 1st story bay; slightly projecting porch roofs supported by wooden posts on #58 and #60, wooden stoop and railings lead up to single wooden entry doors with transom light above on #58 and #60; a similar stoop leads up to double wooden entry doors fronted by double aluminum storm doors on #58, #60, #62; #64 too has a single wooden entry door however a replacement concrete stoop exist in front; excepting #58; all other buildings are severely altered; aluminum siding on #60 and #64; asphalt/fiberglass siding on #62.	Contact 219/16

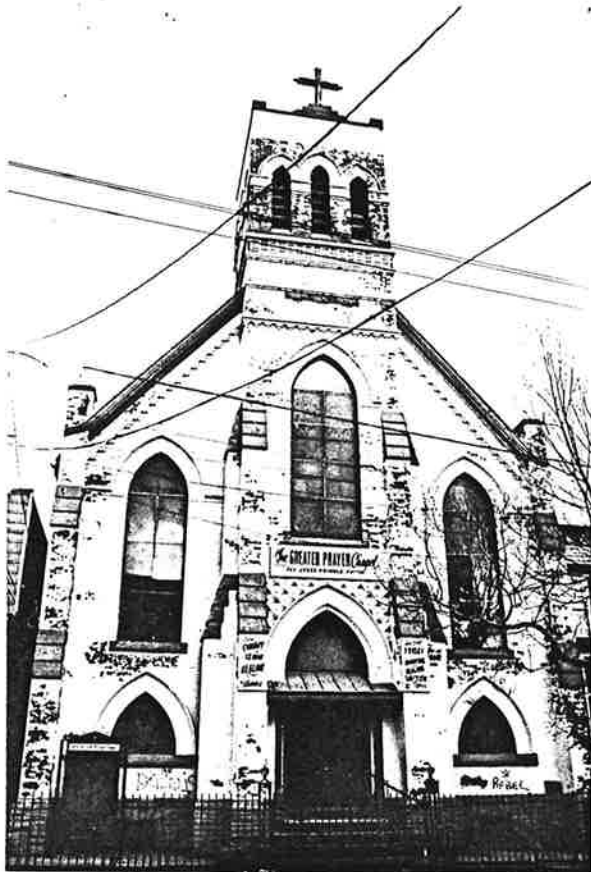
Site No. 0906-D5 bow  
66-68 Bowers Street  
Jersey City, N. J.  
Photo Neg. No. 17/17  
Map No. 2

2.	66-68 Bowers Street Block/774	1892 McLean	Y	G	T	Gothic Revival; recessed rectangular plan with central entry; 2 stories with basement, bell tower atop in center of building; brick exterior, central pavillion or bell tower projects outward; multi-lighted Gothic windows on building; brick Gothic arches above each window; stone cross finial atop bell tower; stone trim on roof; brick buttresses with stone trim at corner of building and surrounding entry; decorative brick moldings adorn building's exterior; stone sills below windows; concrete stoop leads up to double wooden entry doors, wooden over door exist above entry case-ment windows at basement level; wrought iron railings on stoop; iron fencing fronts lot; no visible alterations.	Contact 17/17

The Greater Prayer Chapel  
Historic Name: St. Trinitatis  
Evangelical Lutheran Church  
Built 1892

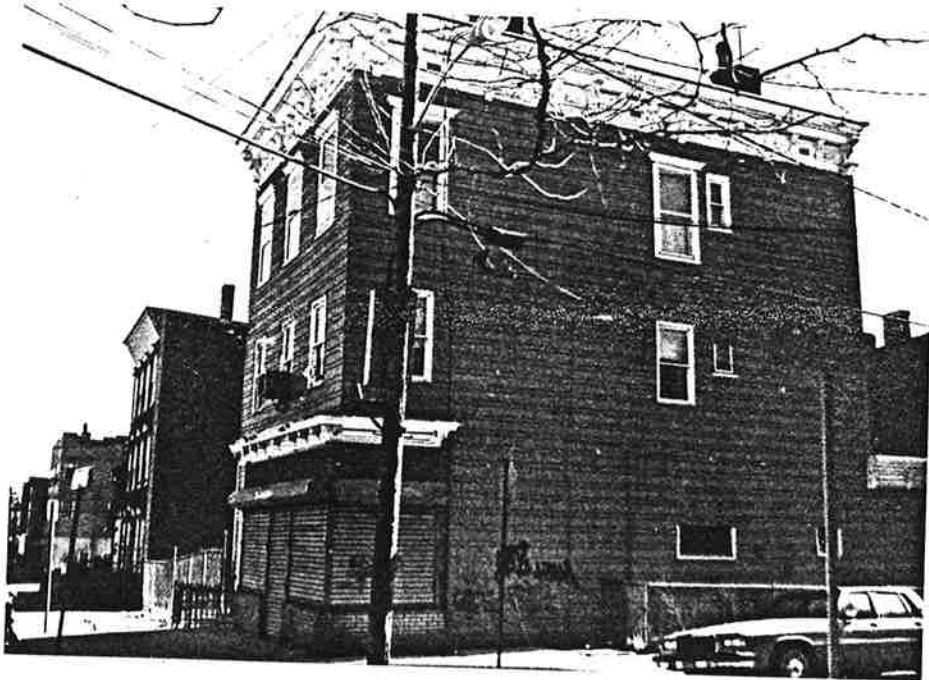
Site No. 0906-D5 bow  
 13 Bowers Street  
 Jersey City, N.J.  
 Photo Neg. No. 219/10  
 Map No. 3

3.	73 Bowers Street Block/765	Btwn. 1873 1887 (L.D. Fowler Map ±887)	N	G	R2	Italianate; recessed rectangular plan with central entry; 3 stories, 3 bays, wood framed building with wood shingle siding; 1/1 wood double hung sash windows; small casement window types on first story level; shed roof with brick chimneys; architraved wooden cornice adorned with console wooden brackets; architraved wooden window heads atop 3rd story windows; a second architraved and modillioned wooden cornice exist just above 1st story level of ground floor shop; corrugated metal grates conceal display shop windows; wood shingle siding on buildings exterior; moderate alterations.	Contact 219/10

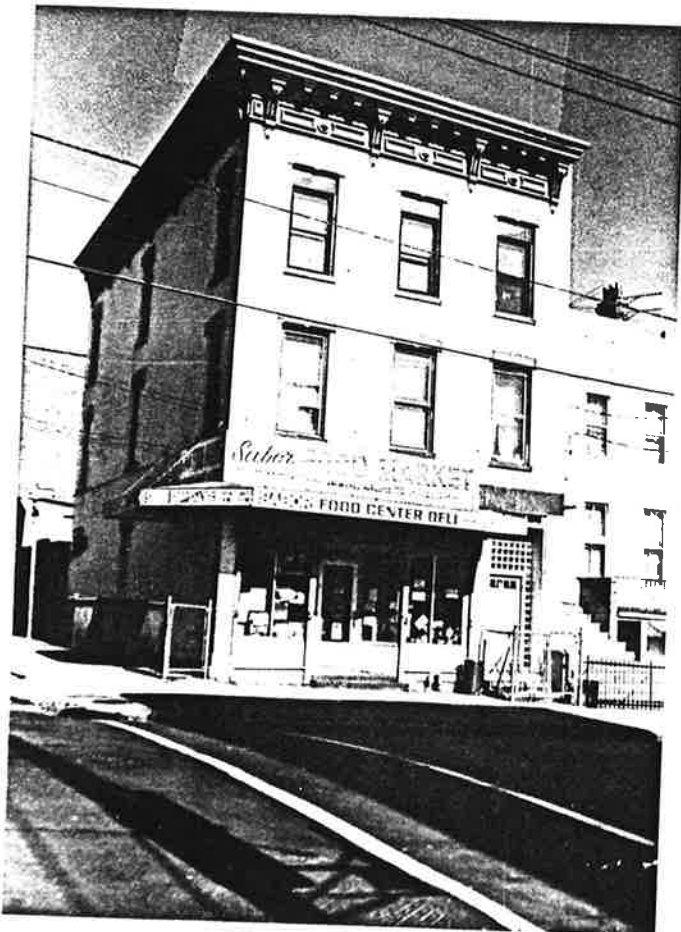
Site No. 0906-D5 bow  
 14 Bowers Street  
 Jersey City, N.J.  
 Photo Neg. No. 219/9  
 Map No. 4

4.	74 Bowers Street Block/774	Btwn. 1873- 1887 (L.D. Fowler Map 1887)	P Theme	G	C/ R	Italianate; recessed rectangular plan with central and side entry; 3 story; 3 bay; brick building; 1/1 wood double hung sash window treatment, large store-front display windows on 1st story level; shed roof with architraved cornice adorned with brackets and modillions; rectangular relief panels and rosette moldings on frieze; stone lintels and sills; store entry consist of a single wooden entry door with a large glass panel imbedded; a single wooden entry door exist to the right providing access to 2nd and 3rd story apartments; transom light exist above this right side entry; large sign suspended from building's facade just above 1st story level; moderate alterations.	Contact

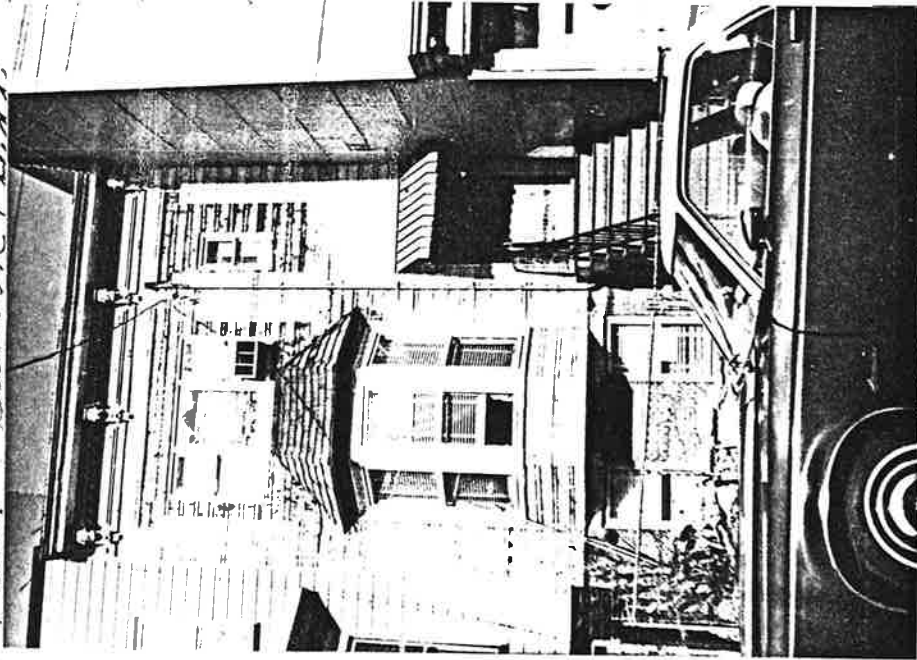
Site No. 0906-D5 low  
78 Bowers Street  
Jersey City, N.J.  
Photo Neg. No. 219/11  
Map No. 7

7.	78 Bowers Street Block/773	Ante 1873	N	p	R	Italianate; recessed rectangular plan with side entry 2 story with basement wood framed building with wood shingle siding; 1/1 wood double hung sash window treatment; projecting 1st story bay window; shed roof with architraved wooden cornice adorned with corbel brackets; stone lintels and sills at basement level; brick foundation; wooden stoop leads up to single wooden awning situated just above entry door; minor alterations.	Contact 219/11

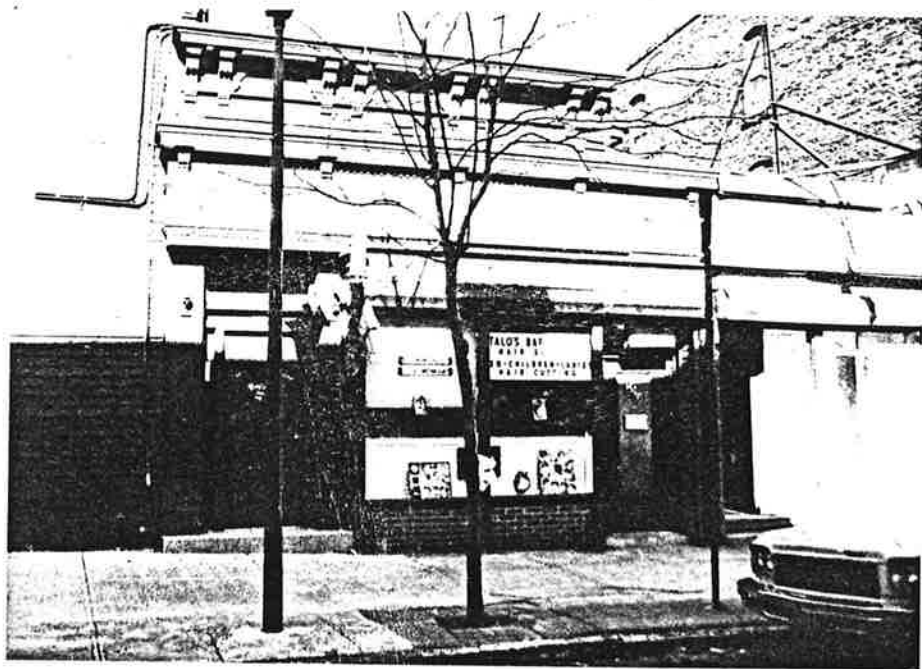
Site No. 0906-D5 bow  
120 - 122 Bowers  
Street  
Jersey City, N.J.  
Photo Neg. No.  $\frac{215}{33}$   
Map No. 15

MAP #	ADDRESS/LOCATION : PROPERTY NAME	DATE	Signifi- cance to D/S	Condition	USE	DESCRIPTION: Style, Ext. Wall Fabric, Fenestration, Form, Roof, Major Features, Alterations, Stories, etc.	NEGATIVE FILE #
15.	120-122 Bowers Street Block/	Btwn. 1887- 1896 (San- born 1896)	P Theme	G	C	Italianate; recessed rectangular plan with 2 side entries; a single story shop; a double architaved wooden cornice with brackets atop roof; large shop display windows; each entries consist of a single wooden entry door with transom lights above; no visible alterations.	Contact 215/33

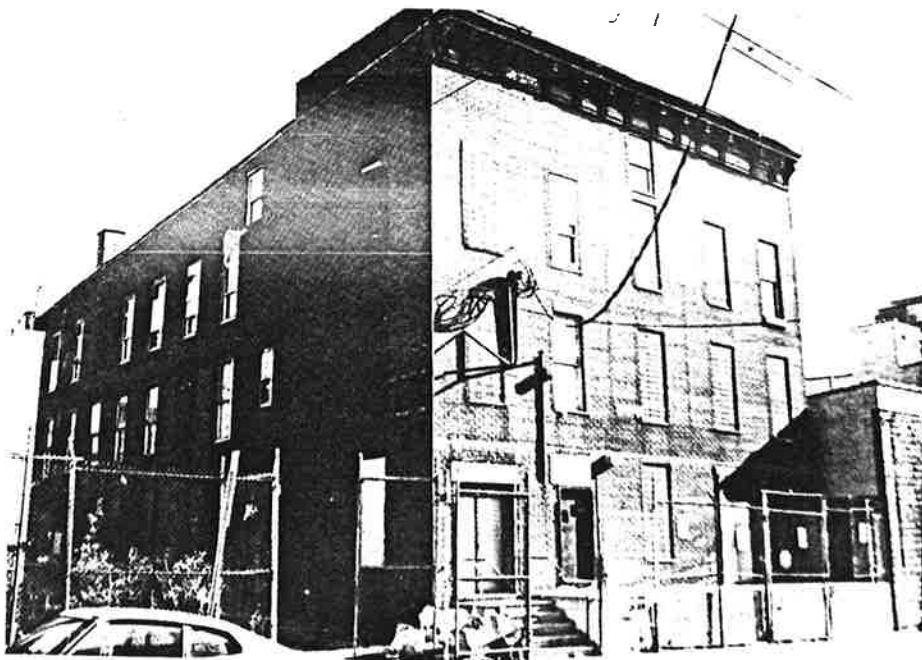
Site No. 0906-D5 cam  
102 Cambridge  
Avenue  
Jersey City, N.J.  
Photo Neg. No. 215/36  
Map No. 5

5.	102 Cambridge Avenue  Block/763	Btwn 1887- 1896 (San- born 1896)	N	P	R2	Italianate; recessed rectangular plan with side entries; 3 story wood framed building with basement level; 5 bays on facade; 7 bays on side of building; entire exterior is resurfaced with asphalt/fiber-glass siding; 1/1 wood double hung sash windows; many of which are filled in; shed roof with brick chimney; architraved and bracketed wooden cornice; rectangular panels on frieze; concrete stoop panels on frieze; concrete stoop ( a replacement) fronts a recessed single wooden entry door; building is severely altered.	Contact 215/36

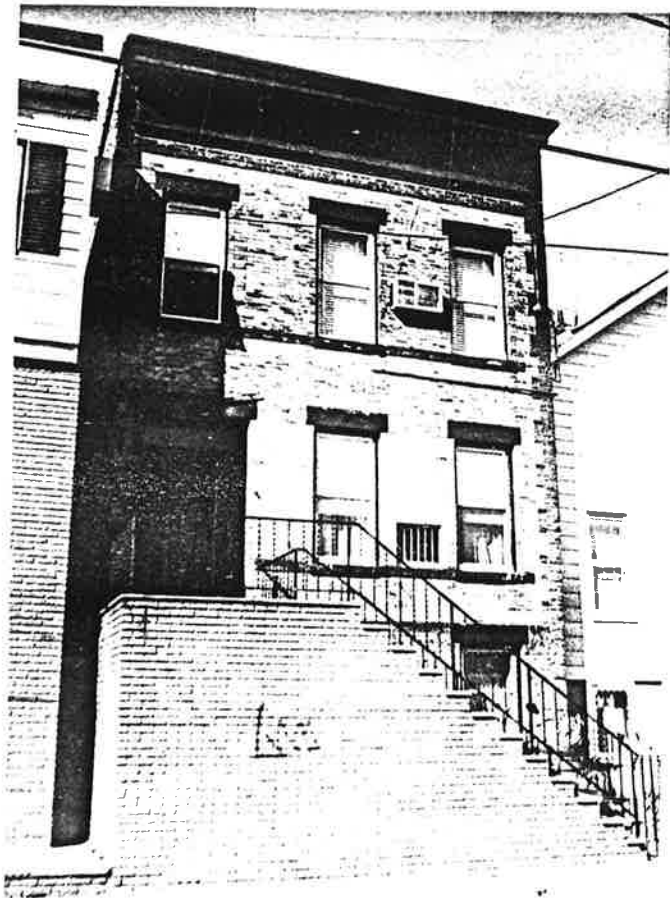
Site No. 0906-D5cam  
197 Cambridge Avenue  
Jersey City, N.J.  
Photo Neg. No. 214/35  
Map No. 12

12.	197 Cambridge Avenue Block 781 (Contact 214/35)	bet. 1908- 1919	P Theme	G	R1	Italianate, 2 stories with basement, 3 bays, brick 1 main entry; rectangular plan with rear extension Main entry with stone lintel; rectangular windows with 1/1 sash, storm sills and lintels; bracketed cornice with plain frieze; quoin effect in contrasting brick at corners of building. Replacement brick stoop and railings.	Contact 214/35

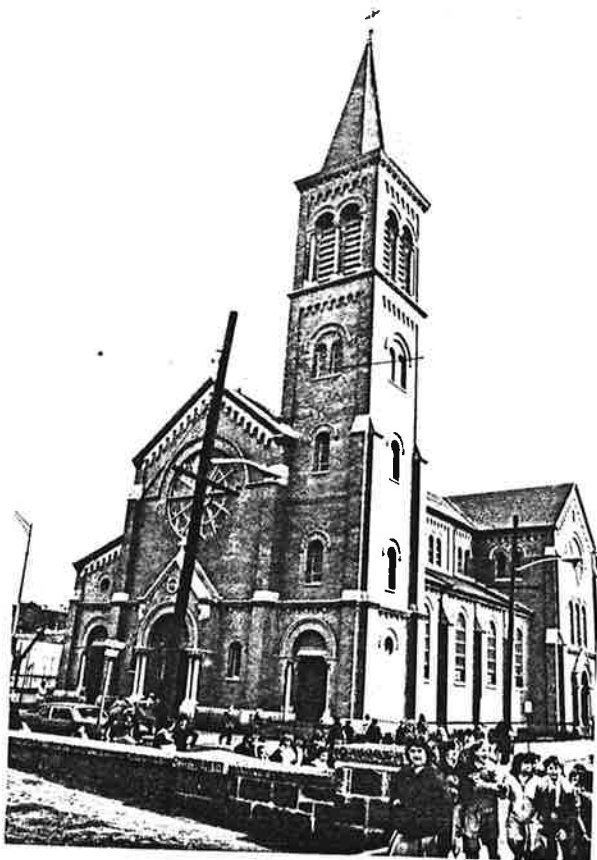
Site No. 0906-D5cen  
220-224 Central Avenue  
Jersey City, N.J.  
Photo Neg. No. 17/9  
Map No. 1.

1.	220-224 Central Avenue Block/734  St. Nicholas R.C. Church Architect, William Schickel (N.Y.C.)  (R.E.R. 1904)	1905 Corner stone	Y	E	T	Romanesque, recessed irregular rectangular plan with central and side entries; main portion of church is approximately 3 stories in height; church tower or campanile is 5 stories; brick exterior; cross-gabled roof atop nave of church tent roof atop bell tower; 1/1,2/2 oculus stained glass windows set into nave portion of building; stone cross finials atop tent roof and gabled roofs of church; brick buttresses with stone tops surround exterior of church building; brick corbel stop along gabled roofs of church; segmental stone arches exist above windows of building; stone sills below each window; all major windows have a semicircular head; louvered panels in window opening at top of bell tower; stone water table; main entryway of church consist of a rounded arch supported by Corinthian stone columns; a side entry flanks main central entry; stone overdoors exist above each flanking entry of main entry; concrete stoop leading up to entry doors; iron fencing surrounding building; no visible alterations; building exists as a fine example and interpretation of this particular style.	Contact 17/9

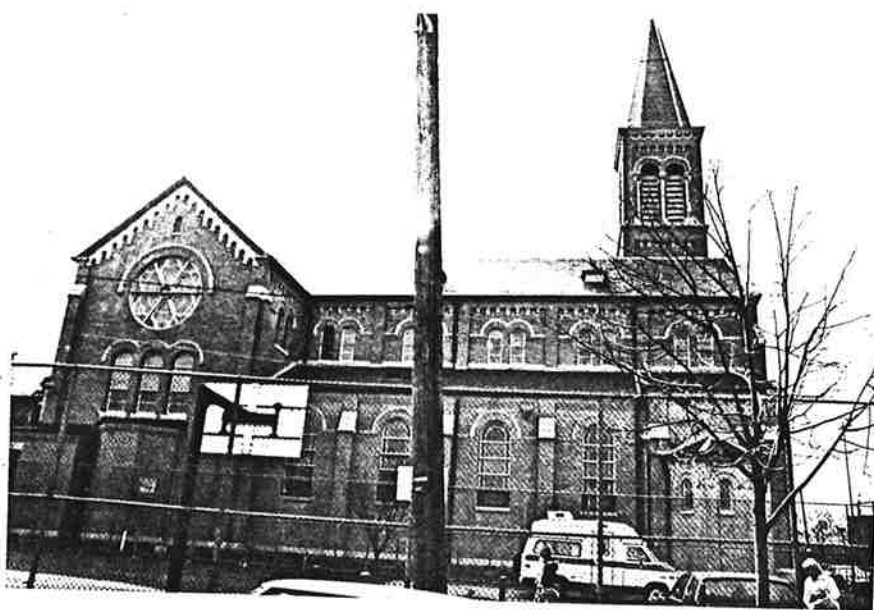
Site No. 0906-D5cen  
220-224 Central  
Avenue  
Jersey City, N.J.  
Photo Neg. No. 17/8  
Map No. 1

St. Nicholas R.C. Church  
Architect, William Schibel  
(N.Y.C.) built 1905.  
Cornerstone, (R.E.R.-1904)

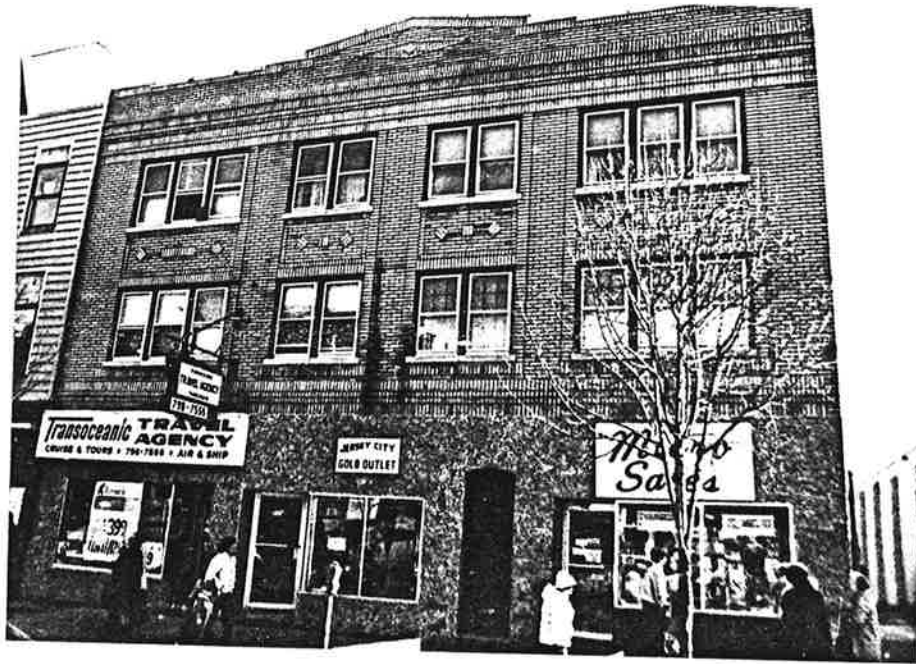
Site No. 0906-D5cen  
 274-276 Central  
 Avenue  
 Jersey City, N.J.  
 Photo Neg. No. 240/  
 Map No. 4 /24A

4.	274-276 Central Avenue Block/743	Ante 1873 (G.M. Hopkins 1873)	N	F	C/ R	Early 20th Century Vernacular; recessed rectangular plan with numerous entries on facade; brick exterior; 3 stories, 4 bays; flat floor with brick parapet; 1/1 and 6/1 wood double hung sash window treatment; some replacement aluminum types; display windows at basement level; steel and glass entry doors serve as access to 1st story shops; single wooden entry door serves as access to 2nd and 3rd story apartments; resurfacing of 1st story exterior and addition of inappropriate windows constitute a major alteration.	Contact 240/24A

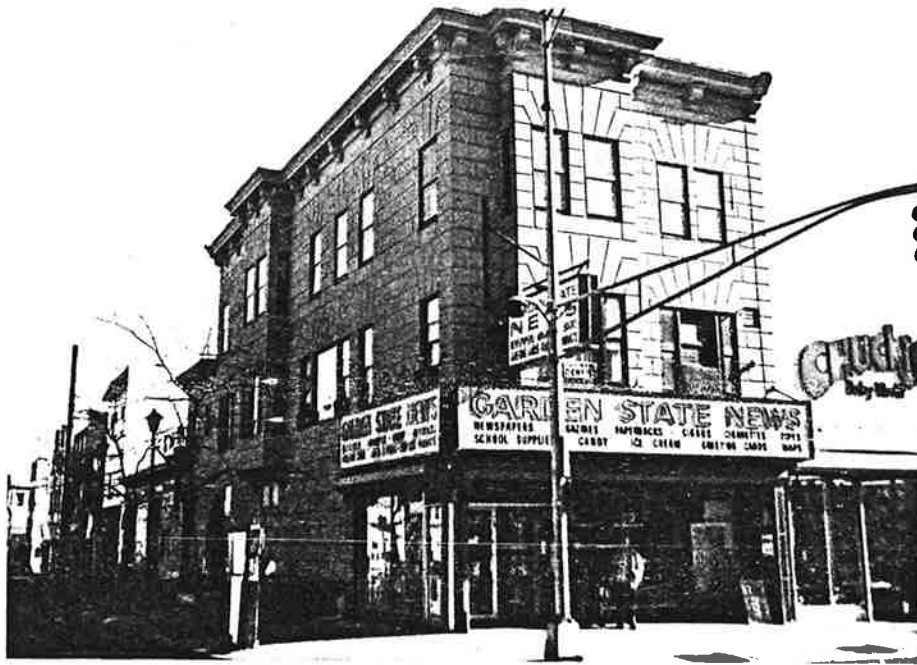
Site No. 0906-D5cen  
 366 Central Avenue  
 Jersey City, N.J.  
 Photo Neg. No. 215/  
 Map No. 14

14.	366 Central Avenue Block/762	Btwn. 1887- 1896 (San- born 1896)	N	F	C/ R	Italianate; recessed irregular rectangular plan with 2 entries (facade) and 2 entries on side; slightly projecting bay on facade; originally a brick building now resurfaced with rusticated stucco; 1/1 wood double hung sash window treatment; storefront display windows at 1st story level; flat roof with architraved wooden cornice adorned with console wooden brackets projecting bay on side of building extending from 2nd to 3rd stories and situated in center of buildings side; sign hung from buildings facade and a wraparound type sign exist just above 1st story level; single wooden entry door serves as entry to 2nd and 3rd story apartments at side of building; steel and glass entry door serving 1st story shop; severe alterations.	Contact 215/32

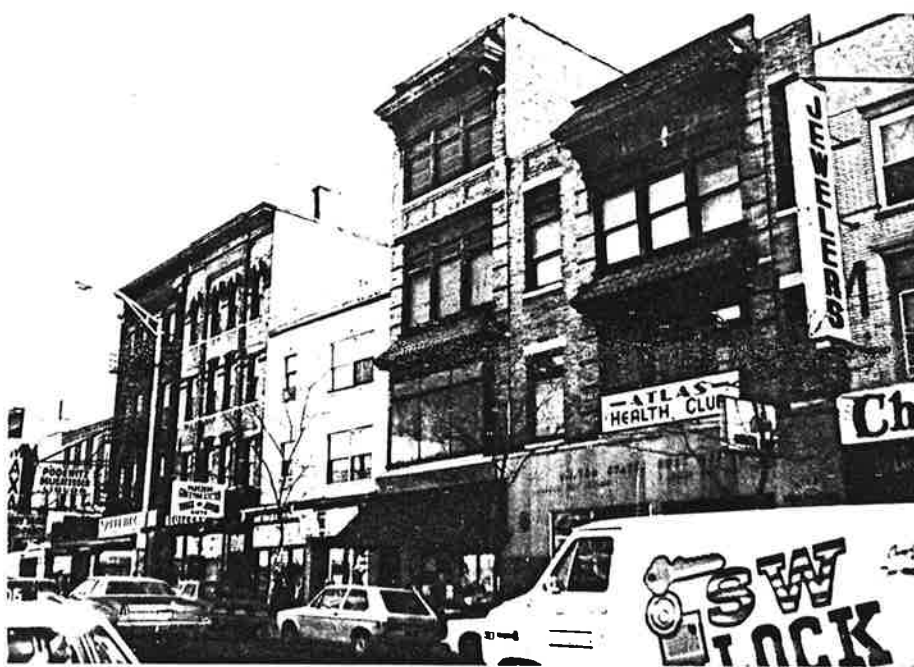
Site No. 0906-D5cen  
404-392 Central Avenue  
Jersey City, N.J.  
Photo Neg. No. 214/13  
Map No. 16

16.	CONTINUED					<p>canvas canopy just above 1st story; a single wooden entry door exist to left of 1st sotry display windows, no visible alterations.</p> <p>c) Classical Revival; recessed rectangular plan with central entries; 2 story; 2 bays brick building now resurfaced with rusticated stucco; flat roof with slight parapet; 1/1 wood double hung sash windows; large storefront display windows; one entry to store located on left consist of a single steel and glass entry door; other entry consists of a recessed single wooden entry door; not visible in photo; major alterations.</p> <p>SEE #17 FOR DESCRIPTION OF #440-#398</p>	Contact 214/13

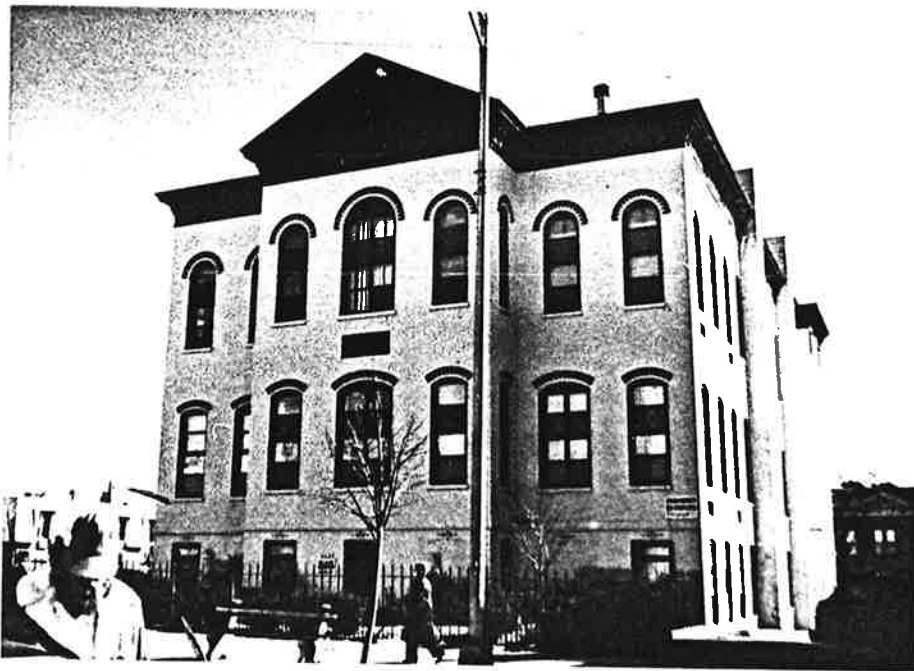
Site No. 0906-D5cen  
 464-470 Central  
 Avenue  
 Jersey City, N.J.  
 Photo Neg. No. 214/25  
 Map No. 20

MAP #	ADDRESS/LOCATION : PROPERTY NAME	DATE	Signifi- cance to D/S	Condition	USE	DESCRIPTION: Style, Ext. Wall Fabric, Fenestration, Form, Roof, Major Features, Alterations, Stories, etc.	NEGATIVE FILE #
20	464-470 Central Avenue Block/781 Historic Name: Public School #7 building converted to condominiums units	1876	Y	E	R2	Italianate; recessed rectangular plan with central projecting pavillion; 3 stories; 8 bays; brick exterior; 2/2, 4/4 and 1/1 wood double hung sash; windows on building; brick exteriors; flat roof with triangular pediment atop; architaved bracketed wood cornice; segmental brick lintels, stone sills; stone water table just above basement or 1st story level; both stoops (See May No. 20) have been removed and replaced by windows; brick chimney shafts run up along building's right side, minor alterations.	Contact 18/7
21	476-472 Central Avenue Block/791 3 Individual Buildings	#476 Btwn 1896- 1928 (G.M. Hopkins Map 1928) #474 Btwn 1887- 1896 (San- born 1896) #472 Btwn. 1873- 1887 (L.D. Fowler Map 1887	P Theme	G	C/ R	Italianate; (#472-#474); recessed rectangular plans with side entries; each building 3 stories; 3 bays; wood framed; #474 has exterior resurfacing with asphalt/fiberglass siding; 1/1 wood double hung sash windows on both buildings; large storefront display windows at 1st story level; shed roofs with brick chimneys; architaved wooden cornices with brackets and modillions; clapboard siding on #472; a second architaved wooden cornice exist just above 1st stories of #474 and #472; single wooden entry door; #472 as well as a steel and glass door providing access to store; a similar entry treatment on #474.  b) Italianate Variant (#476); recessed rectangular plan with central entry; 3 stories, 4 bays; brick building flat roof with brick parapet; cornice appears to have been shaved; stone pediments and trim above 3rd story windows; crown like stone lintels above 2nd story windows; windows on 3rd story have rounded window heads with brackets above; iron fire escape suspended from building's facade; large storefront display windows on 1st stories; entry not visible; moderate alterations.	Contact 214/26

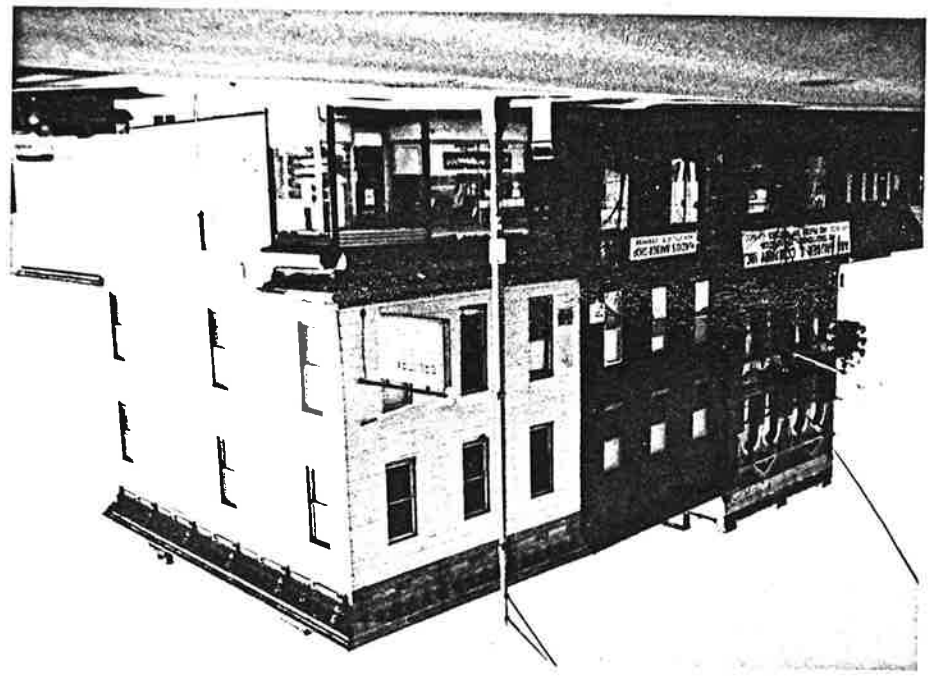
Site No. 8906-85 cen  
 485 Central Avenue  
 Jersey City, N.Y.  
 Photo Neg. No. 215  
 Map No. 22

22.	485 Central Avenue Block/814	Btwn. 1896 1928 (G.M. Hopkins Map 1928)				Italianate; recessed rectangular plan with central and side entry; 3 stories, 4 bays; wood framed building now resurfaced with rusticated stucco 8 1/1 wood double hung sash windows; shed roof with architraved wooden cornice adorned with brackets and modillions; a second cornice similar to the one at top exist just above 1st story; large display windows on 1st story; left side entry consist of a single wooden entry door with wooden canopy above; extensive alterations.	Contact 215/4

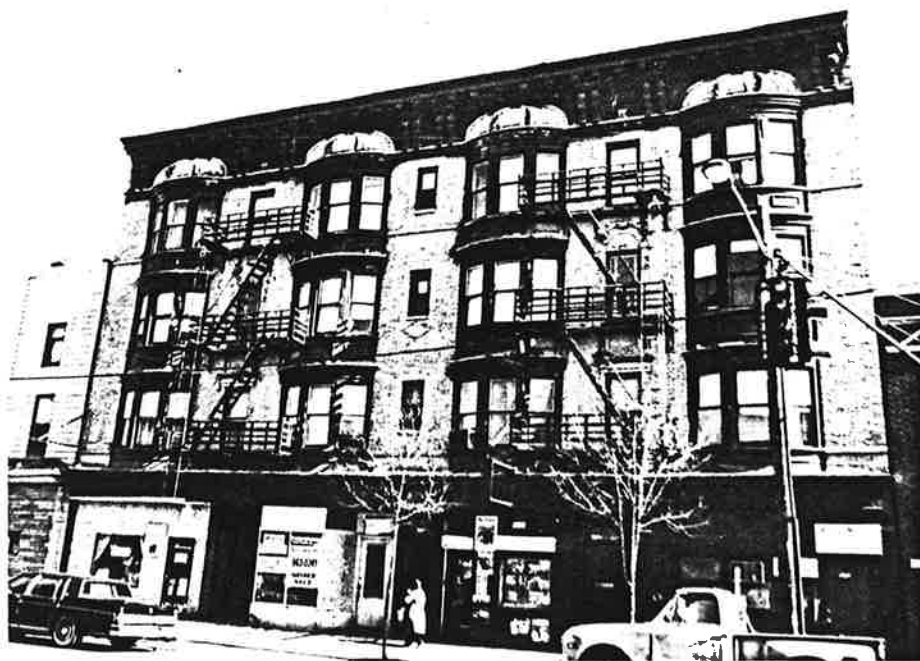
Site No. 0906-D5 cen  
516-520 Central  
Avenue  
Jersey City, N.J.  
Photo Neg. No. 198/9  
Map No. 24

MAP #	ADDRESS/LOCATION : PROPERTY NAME	DATE	Signifi- cance to D/S	Condition	USE	DESCRIPTION: Style, Ext. Wall Fabric, Fenestration, Form, Roof, Major Features, Alterations, Stories, etc.	NEGATIVE FILE #
24.	516-520 Central Avenue Block/791 4 attached brick buildings	Btwn. 1896- 1928 (G.M. Hopkins Map 1928)	P. Theme	G	C/ R	Italianate; recessed rectangular plans with side entries; projecting bowed bays on each building; 4 stories; each approximately 2 bays; brick exteriors; shed roof with large wooden cornice adorned with brackets and modillions; a second architraved and modillioned wooden cornice exist just above 1st story level; display windows at 1st story shops; iron fire escapes suspended from facades of buildings; single wooden entry doors with transom lights above; minor alterations.	Contact 198/9

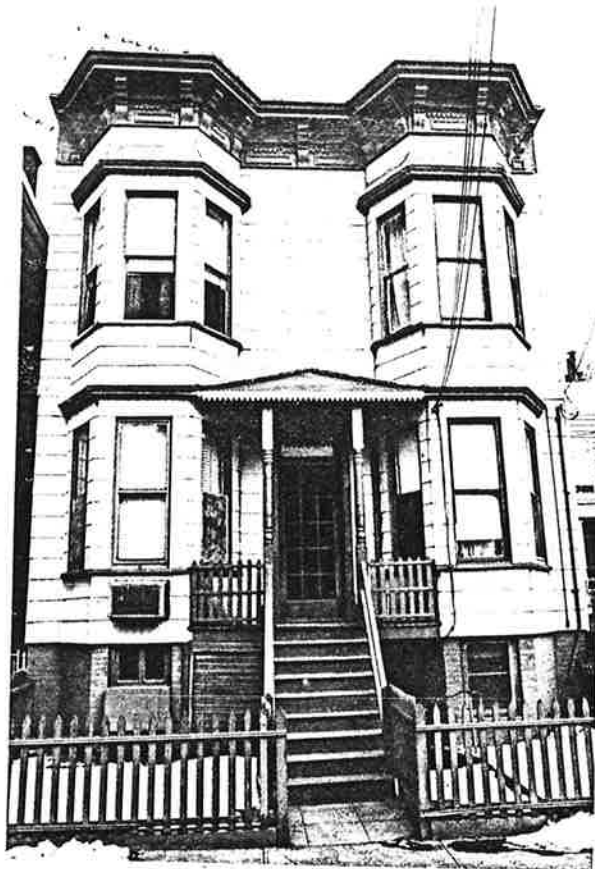
Site No. 0906-D5 fer  
100 Perry Street  
Jersey City, N.J.  
Photo Neg. No. 183/1.7  
Map No. 1

1.	100 Ferry Street Block/734		N	F	R2	Italianate; recessed rectangular plan with central entry; 2 stories, 2 bays; each projecting; wood framed building with vinyl siding; 9 1/1 wood double hung sash windows on 1st and 2nd stories, casement windows at basement level; shed roof with architraved wooden cornice adorned with console wooden brackets; wood trim above windows on 1st and 2nd stories, pedimented roof supported by rounded wooden posts, wooden stoop with wood railings lead up to single wooden entry door; transom light situated above entry; sunken concrete stoop on right side of stoop leads to basement entry, exterior resurfacing constitutes a moderate removable alteration.	Contact 183/17

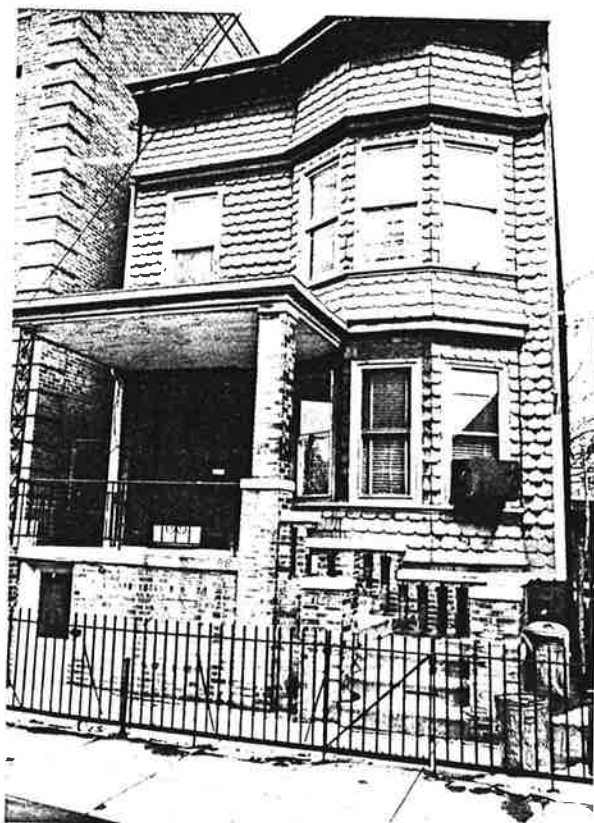
Site No. 0906-D5 fer  
104 Perry Street  
Jersey City, N.J.  
Photo Neg. No. 183/1.6  
Map No. 2

2.	104 Ferry Street Block/734		P Theme	E	R	Italianate; recessed rectangular plan with side entry 2 story, 2 bays, wood framed building with wood shingle fish scale siding; 1/1 wood double hung sash windows; casement windows at basement shed roof with architraved cornice adorned with modillions; L-shaped brick and concrete stoop leads up to single wooden entry doors; side lights flank door; basement entry situated at boom of porch; sunken concrete stoop in front basement entry; basement entry consists of a single wooden entry door; iron fencing (not original in front lot); replacement iron support posts - a minor alteration.	Contact 183/16

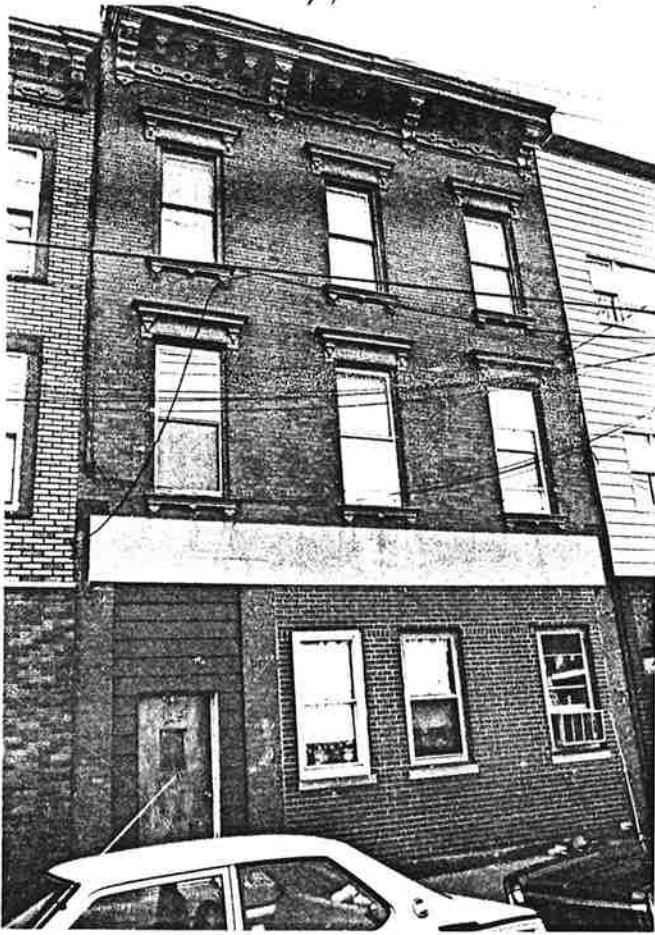
Site No. 0906-D5 fra  
125 Franklin Street  
Jersey City, N.J.  
Photo Neg. No. <sup>241</sup>/<sub>3A</sub>  
Map No. 4

4.	125 Franklin Street Block/735  *P.S. #8	Ante 1873 (G.M.. Hopkins Map 1873	P Theme	F	R	Italianate; recessed rectangular plan with side entry; 3 stories, 3 bays; brick exterior; 1/1 wood double hung sash windows; some windows are replaced by 1/1 aluminum types; shed roof with architraved, bracketed and modillioned wooden cornice; round moldings on frieze of cornice; stone window heads and sills, new brick facing and partial aluminum siding surrounding entry on 1st story; entry consist of a single wooden entry door; moderate alterations.	Contact 241/3A

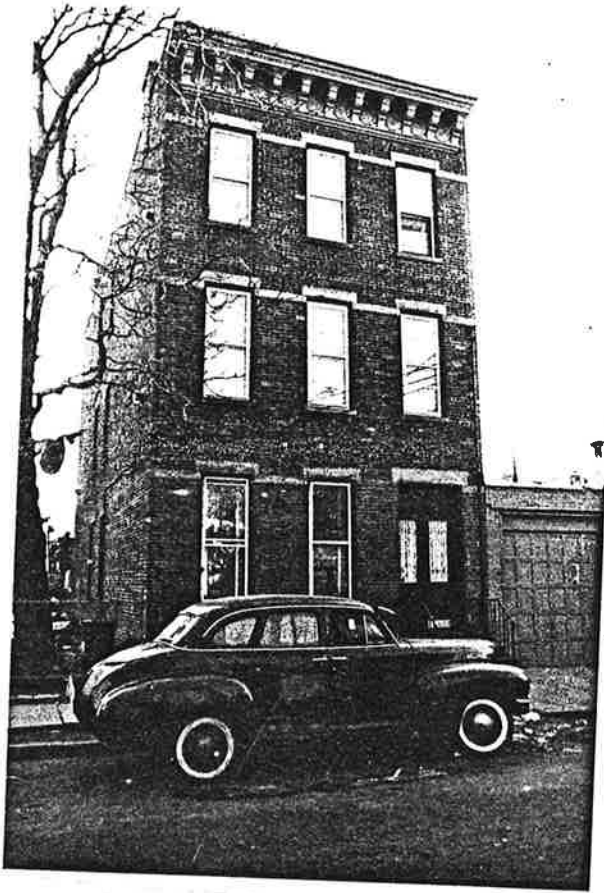
Site No. 0906-D6g  
31 Griffith Street  
Jersey City, N.J.  
Photo Neg. No. 10/24  
Map No. 1

MAP #	ADDRESS/LOCATION : PROPERTY NAME	DATE	Signifi- cance to D/S	Condition	USE	DESCRIPTION: Style, Ext. Wall Fabric, Fenestration, Form, Roof, Major Features, Alterations, Stories, etc.	NEGATIVE FILE #
1	31 Griffith Street	Btwn. 1887- 1896 (San- born 1896)		G	R	Italianate, recessed rectangular plan with side entry; 3 story, 3 bays, brick exterior; 7 1/1 wood double hung sash windows low sloping shed, roof with bracketed wood cornice (architraved); octagonal wood moldings on frieze of cornice, stone lintels, stone sills; stone strips set in between bays; 6 1/1 wood double hung sash windows on side of building; large stone lintel-like over door; entry consist of concrete stoop with iron railings, entry consist of double wood doors with large glass panels set in transom window above doors decorative panels on each individual door.	10/24
2	33-39 Griffith Street Block 749  C & D Auto Body Shop 33 Griffith Street	#33 Btwn 1887 1896 (San born 1896) #35- #39 Ante 1873 (G.M. Hopkins 1873)		G	C/ R	Utilitarian Garage; recessed rectangular plans with large central entries; 1 story, 3 bays; brick exterior; 1 1/1 wood double hung sash window on extreme right side of buildng, low closing flat roof with small center parapet, small architreved wood overdoor above center garage door, center garage opening has smaller singular door built into large door; each door has many panels on its exterior, iron bars in front window, two large business signs hang from buildings exterior.	10/25

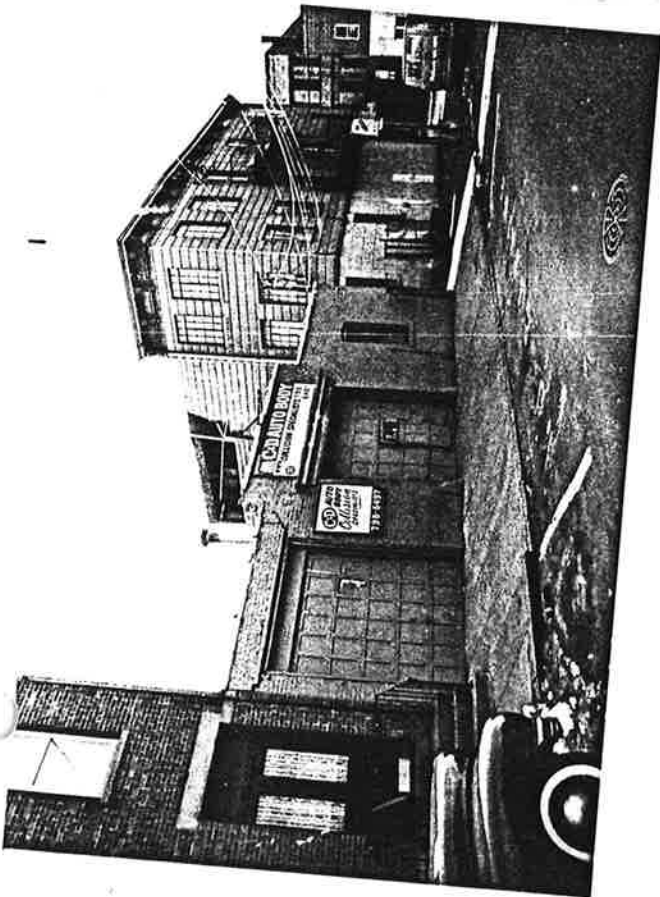
Site No. 0906-D6g  
33-39 Griffith Street  
Jersey City, N.J.  
Photo Neg. No. 10/25, 26  
Map No. 2

MAP #	ADDRESS/LOCATION : PROPERTY NAME	DATE	Signifi- cance to D/S	Condition	USE	DESCRIPTION: Style, Ext. Wall Fabric, Fenestration, Form, Roof, Major Features, Alterations, Stories, etc.	NEGATIVE FILE #
	33-39 Griffith Street Block 749			G	C/ R	wood cornice, iron fire escape spans 2nd and 3rd stories on Griffith Street side, 2nd and 3rd stories covered with clapboard wood siding, entry consist of 1st story serves as a small store display window on side of building; small grocery store on 1st story of building, entry on Palisade Ave. (not visible); small sign above side window moderate alterations on building.	Contact 10/25

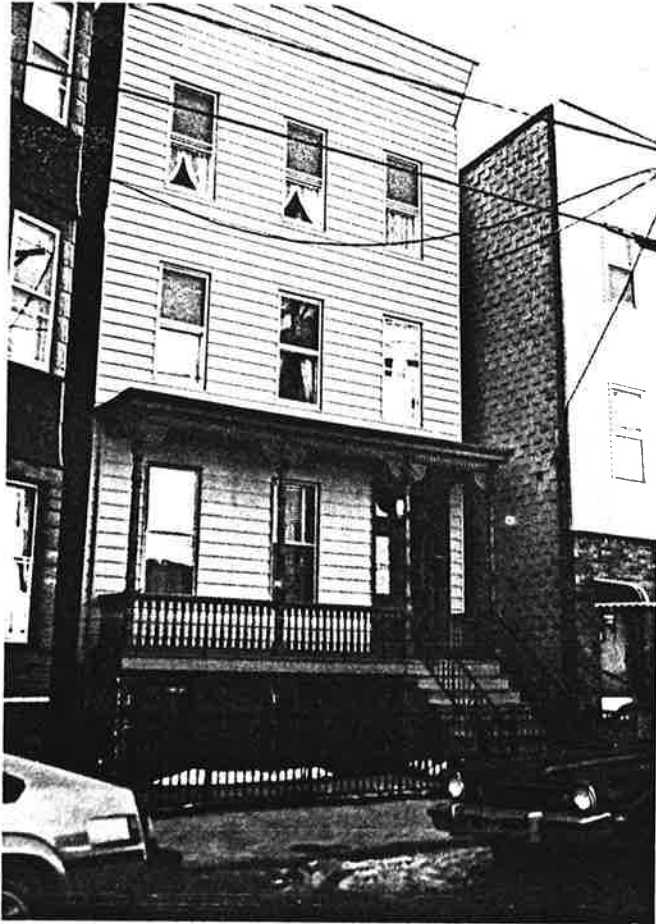
Site No. 0906-D5 gri  
139 Griffith Street  
Jersey City, N.J.  
Photo Neg. No. 215/27  
Map No. 7

7.	139 Griffith Street Block/753	Btwn 1873 1887 (L.D. Fowler Map 1887)	P Theme	G	R	Italianate; recessed rectangular plan with side entry; 3 stories, 3 bays wood framed building with basement level exterior resurfaced with aluminum siding; 1/1 wood and aluminum double hung sash window treatment; 2/2 windows of same type at basement level; shed roof cornice concealed by aluminum siding; architraved wooden cornice with moldings on trim; curved Victorian brackets on rounded wooden posses; wooden stoop with wood railings and rounded newels; double wooden entry doors with transom light above, basement entry exist behind wooden stoop; iron fencing in front; extensive but reversible alterations.	Contact 215/27

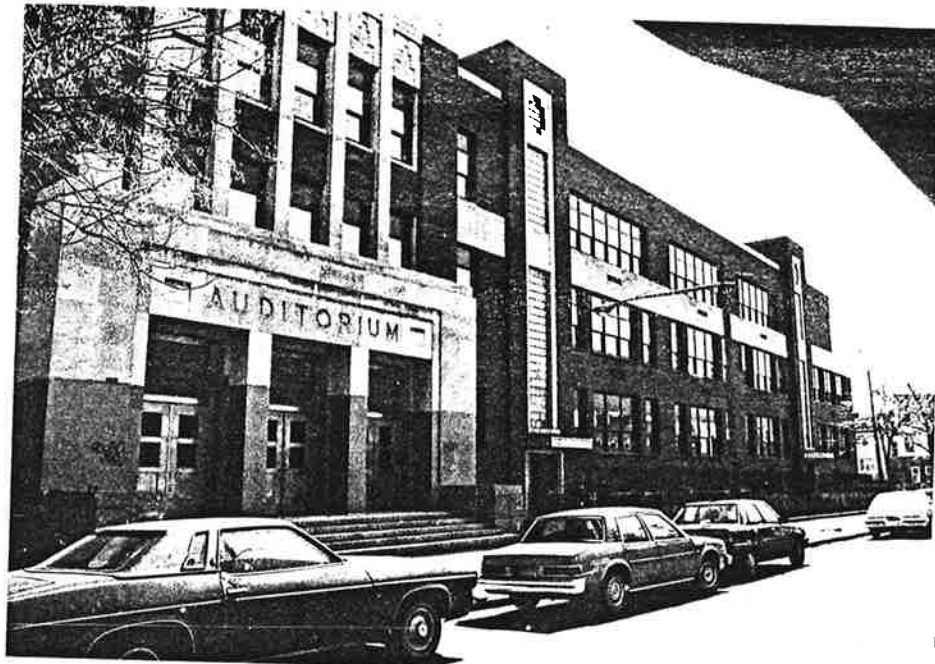
Site No. 0906-D5han  
2-30 Hancock  
Avenue  
Jersey City, N.J.  
Photo Neg. No. 241/  
Map No. 1 2A  
P.S. #8  
(Built 1949, Sanborn)

1.	2-30 Hancock Avenue Block 745 Public School #8	Built 1949 (Sanborn Map)	P	E	E	Art Deco; recessed irregular rectangular building with a central rectangular open space; 3 story with basement brick and stone building; numerous bays in which number of windows vary; 1/1 aluminum type windows; small multiple; lights on a vertical strip situated on bay that encloses stairway; flat roof with brick parapet; stone trim atop parapet; carved Art Deco stone panels above 3rd Story of projecting pavillion; entries exist on this projecting pavillion(left side in photo); stone facing around entries appear to be granite; 3 double steel doors with multi-lighted transom windows above; two secondary entries exist along Hancock Ave. side each situated on bays housing stairways; rectangular overdoors above secondary entries; stone stairs leading up to entries; building in fine condition; no visible alterations.	Contact 241/2A

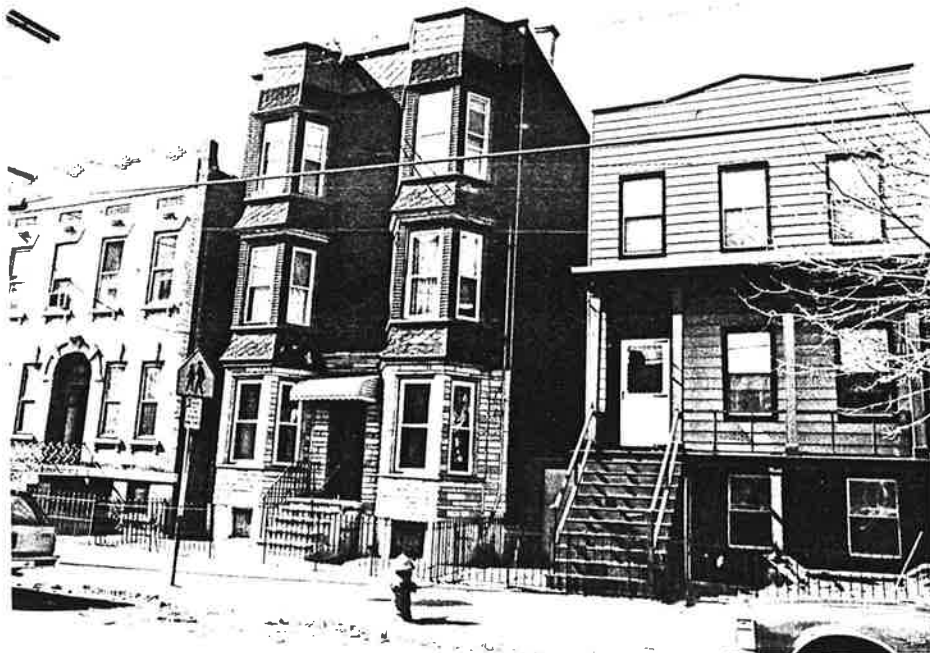
Site No. 0906-D5han  
25-21 Hancock  
Avenue  
Jersey City, N.J.  
Photo Neg. No. 241/  
Map No. 2 1A

2.	Continued					<p>b) Italianate (#23); recessed rectangular plan with central entry; 3 stories; 3 bay; wood framed building with 2 projecting bays; shed roof with brick chimney; 1/1 wood double hung sash windows; some 1/1 windows are replacements of aluminum; building's exterior resurfaced with asphalt/fiberglass siding; casement windows at basement level; concrete and brick stoop with iron railings lead up to single wooden entry door; severely altered.</p> <p>c) Vernacular/Italianate; recessed rectangular plans with side entry;; 2 stories; 3 bays with basement wood framed building; shed roof with slight parapet with very slight pediment; exterior resurfaced with aluminum siding; fluted wooden posts support porch roof; wooden stoop with railings lead up to single wooden entry door fronted by aluminum storm door; transom window above entry; basement entry; situated under wooden stoop; wooden posts support porch and visible at basement level; iron fencing not original; severely altered.</p>	<p>Contact 241/1A</p> <p>Contact 241/1A</p>

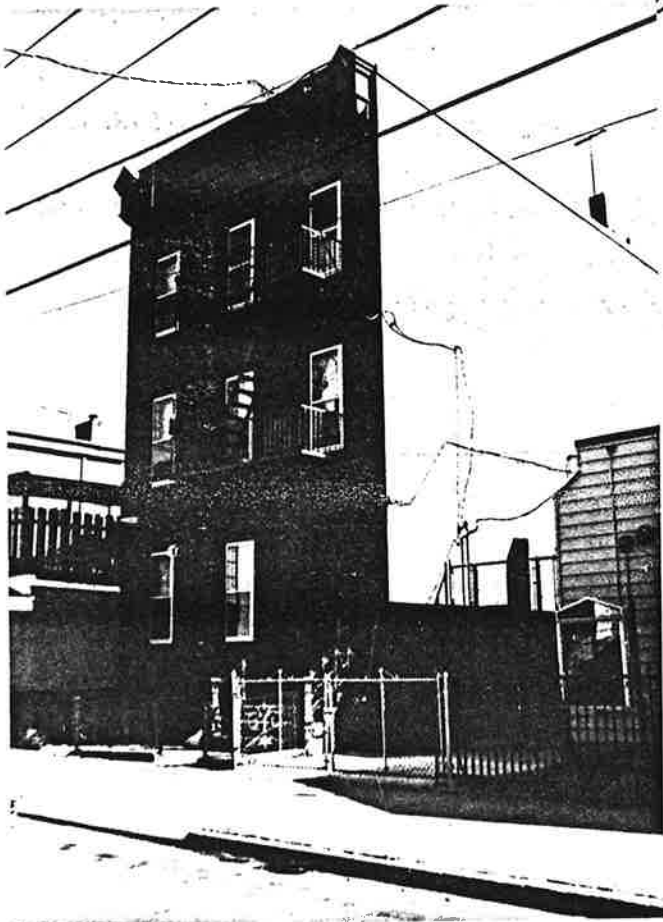
Site No. 0906-D5han  
114 Hancock Avenue  
Jersey City, N.J.  
Photo Neg. No. 216/20  
Map No. 7

7.	114 Hancock Avenue Block/764	Btwn 1887- 1896 (San- born 1896)	P	G	R2	Italianate; recessed rectangular plan with side entry 3 story; 3 bay; brick building; 1/1 aluminum double hung sash windows (replacements); shed roofs with brick chimney; architraved wooden cornice with dentiled moldings; rosette moldings on frieze, stone lintels and sills; iron fire escape suspended from 3rd and 2nd stories; casement windows at basement level; concrete stoop with iron railings lead up to single wooden entry door with fan-light transom above; original wrought iron fencing in front building; replacement windows only major alterations.	Contact 216/20

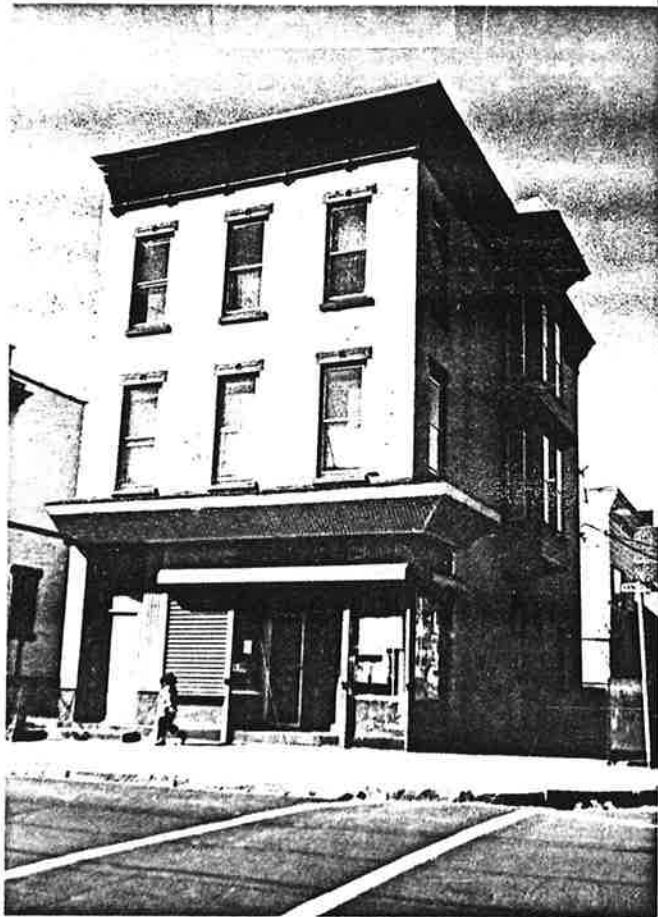
Site No. 0906-D5han  
119 Hancock Avenue  
Jersey City, N.J.  
Photo Neg. No. 216/16  
Map No. 9

9.	119 Hancock Avenue Block/763	Btwn 1873 1887 (L.D. Fowler Map 1887)	P	G	C/ R2	Italianate; recessed rectangular plan with a project- ing bay (2nd and 3rd stories) on buildngs side; 3 stories; 3 bays; brick buildng; 1/1 wood double hung sash windows; some aluminum replacement windows on building; windows on projecting bay are very thin; stone lintels and sills on each window except those on projecting bay; incised carvings on lintels; shed roof with small pyramidal roof above projecting bay; large decoratively carved wooden brackets on cornice; cornice just above 1st story is concealed by aluminum siding; display windows exist on stories exterior on 1st story; retracable corrugated metal security covering exist above 1st story store; fluted aluminum siding covers exterior of 1st story; steel and glass doors with transom light above; left side entry to apartments consist of a single wooden entry door with transom window above; minor alterations.	Contact 216/16
