Bowers Street in East Hudson City Neighborhood of  
 Survey Area (Ward 8) 0906-05 bars, NY H.S.I. 0906  
 Jersey City, Hudson County

NEW JERSEY OFFICE OF CULTURAL AND ENVIRONMENTAL SERVICES  
HISTORIC PRESERVATION SECTION  
DISTRICT/STREETSCAPE CONTINUATION SHEET

N.J. HISTORIC SITES INVENTORY

District/Streetscape Continuation Page # 1 Inventory # 0906-D5-bow

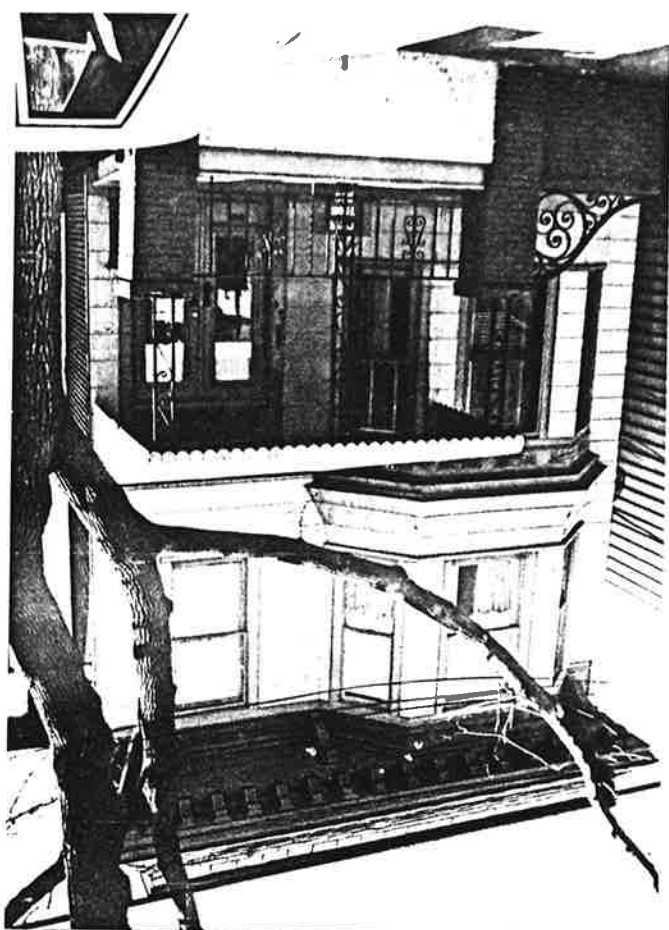
Site No. 0906-85 km  
 144 Hancock Avenue  
 Jersey City, N.J.  
 Photo Neg. No. 216/25  
 Map No. 12

12.	144 Hancock Avenue Block/773	Btwn 1896- 1928 (G.M. Hopkins 1928)	P	G	R	Italianate; recessed rectangular plan with side entry 2 stories; 2 bay; 1 left side projecting bay window wood framed building; with aluminum siding on exterior. 1/1 wood double hung sash windows; shed roofs with architaved wood cornice with wooden modillions and dentils; large wooden brackets on frieze; aluminum canopy porch roof supported by iron posts; concrete porch brick stoop with wrought iron railings; iron railings (replacements on porch; entry consists of double wooden entry doors each with a glass light; transom light above entry doors; exterior resurfacing a moderate alteration.	Contact 216/25

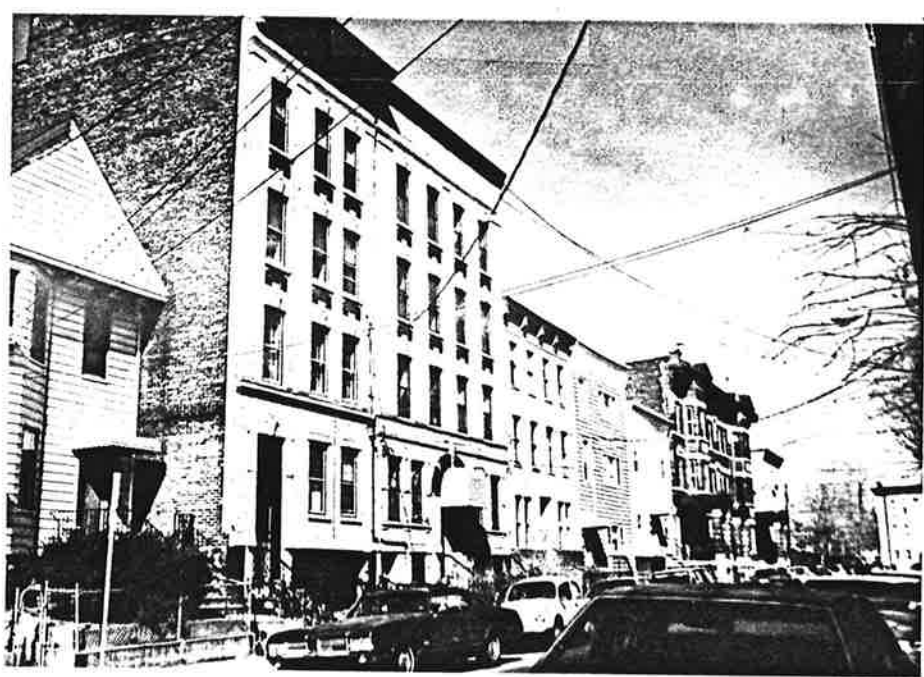
Site No. 0906-D5han  
155-177 Hancock Ave.  
Jersey City, N.J.  
Photo Neg. No. 216/27  
Map No. 14

14.	155-177 Hancock Avenue Block/772 Streetscape See Map No. 17 for 165-169	#159- #163 & #171 Ante 1873 #167 Btwn 1887- 1896 (San- born 1896) #155- #157 #165- #169 Btwn 1896- 1928 (G.M. Hopkins 1928)	N	F	R2	Italianate/Tuscan (#165-169) recessed rectangular plans with side and central entries; #155 and #157 are 5 stories tall 3 and 4 bays respectively brick Italianate style buildings; Nos. 159-161 are 3 story wood framed buildings with 4, 2 and 2 bays respectively; 1/1 wood double hung sash windows on all buildings; some replacement aluminum types on #155 and #157; Nos. 155 and #157 were built as a pair it seems; architraved wood cornices top flat roof with slight brick parapets at side of each building; stone keystones above each of windows on both buildings; the remaining buildings are wood framed much of which is now resurfaced with aluminum siding which has significantly altered the appearance of streetscape; pedimented roofs with small coned roofs adorn #155, #169; single wooden door entries on most building; iron and glass entry doors on Nos. 155 and 157; streetscape altered.	Contact 216/27

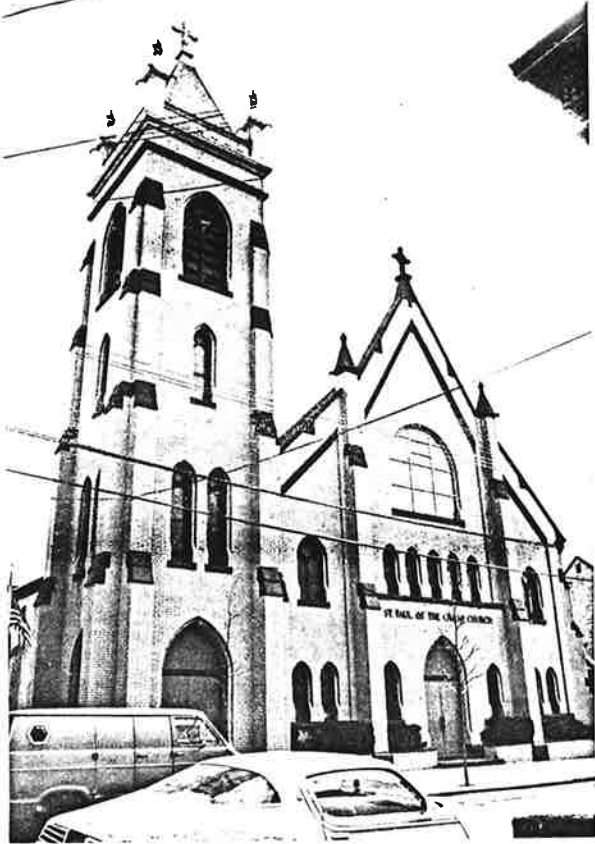
Site No. 0906-D5han  
160 Hancock Avenue  
Jersey City, N.J.  
Photo Neg. No. 17/15  
Map No. 15

15.	160 Hancock Avenue Block/773 St. Paul of the Cross Church	Ante 1873	Y	E	T	Gothic Revival; recessed irregular rectangular plan with main central entry set into nave; secondary entry set into bell tower; bell tower situated at left side of church in photo; numerous lancet windows on bell tower and main body of church itself; brick exterior with stone trim; brick buttresses support building; large stained glass arched window set into nave of building; single and paired stained glass Gothic windows; pointed Gothic arched entries each with double wooden entry doors; gabled roof atop nave with brick parapet with stone trim; stone finial knobs and a cross atop parapet; crocket finial tops atop bell tower which has a pyramidal roof topped by a stone cross at pinnacle; louvred window at 4th story of tower; stone panels accentuates brick buttresses; no visible alterations; church is in excellent condition.	Contact 17/15

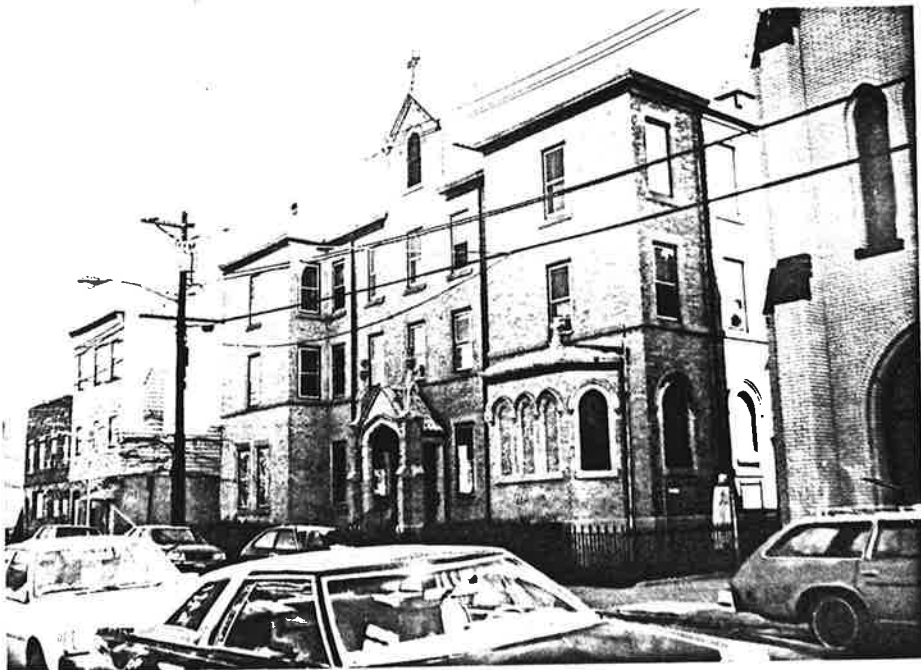
Site No. 0906-D5han  
166 Hancock Avenue  
Jersey City, N.J.  
Photo Neg. No. 216/29  
Map No. 16

16.	166 Hancock Avenue Block/773 St. Paul of the Cross R.C. Church Rectory	Btwn 1896- 1928 (G.M. Hopkins 1928)	Y	E	T	Italian Renaissance; recessed rectangular plan with slightly projecting side bays, central entry; 3 story 6 bay brick building; 1/1 wood and aluminum double hung sash type windows; a projecting 1st story bay (right side of facade) has arched stained glass windows with segmental arched stone window heads stone sills; squared lintels atop rectangular window openings; set back hippped roof; small gabled dormer window above central bay with stone cross finial; brick chimney atop left side of building; architaved stone cornice; another stone cross atop projecting 1st story bay; gabled porch roof supported by brick buttresses forms a Gothic stone arch; iron railings on a concrete stoop leading up to a single wooden entry door; a stone belt course runs around building between 1st and 2nd stories; no alterations.	Contact 216/29

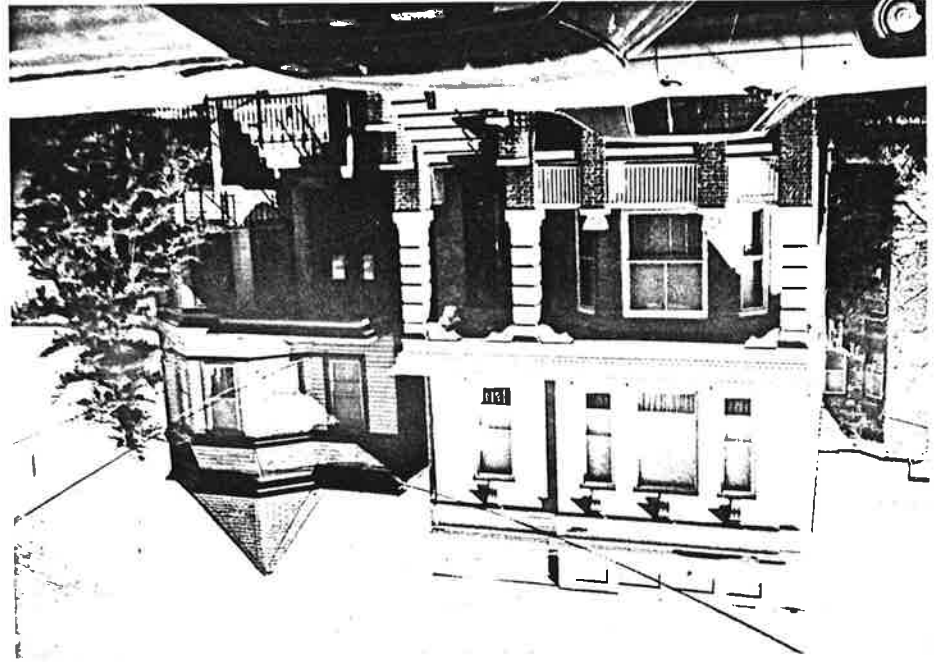
Site No. 0906-85 Man  
 189-191 Hancock Avenue  
 Jersey City, N.Y.  
 Photo Neg. No. 216/32  
 Map No. 18

18.	<u>Continued</u>					b) Queen Anne Variant (#191 recessed rectangular plan with side entry; 2 stories; 2 bays; (1 projecting with basement level; 1/1 wood double hung sash windows; shed roof with a right side corner; tent roof above projecting bay; plain architaved wooden cornice replacement concrete stoop with iron railings lead up to double wooden entry door; each with a large glass light; wood framed building with shingle siding, minor alterations.	Contact 216/32

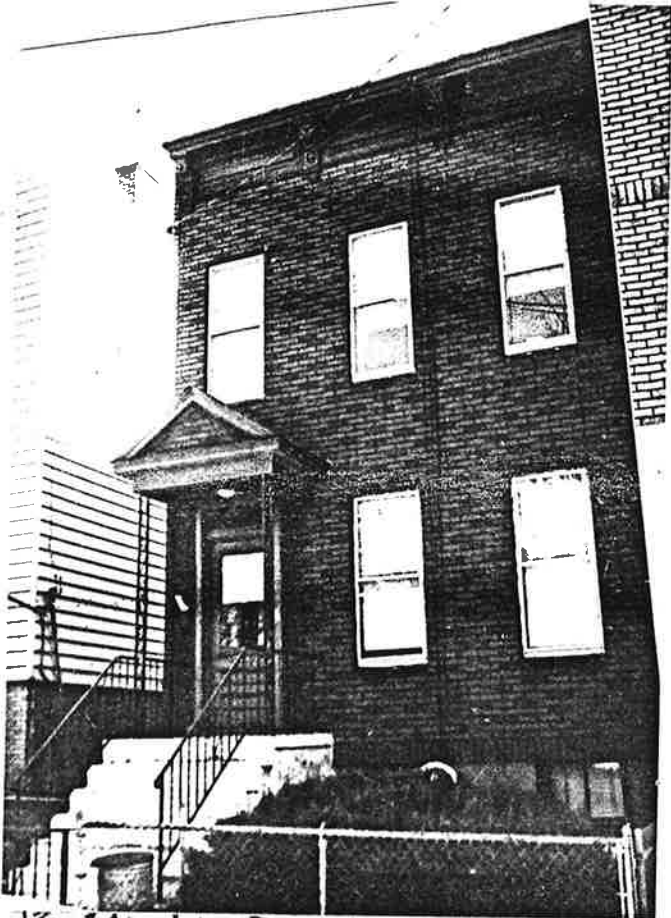
Site No. 0906-D5 han  
210 Hancock Avenue  
Jersey City, N.J.  
Photo Neg. No. 217/1  
Map No. 23

23.	210 Hancock Avenue Block/783	Btwn. 1873 1887 (L.D. Fowler Map 1887)	N	F	R	Italianate; recessed rectangular plan with side entry 2 story; 3 bay wood framed building with basement level; 1/1 wood double hung sash windows; casement windows at basement level; shed roof with architaved and bracketed wooden cornice, small gabled porch roof with architraves; iron posts support roof; replacement concrete stoop with iron railings; aluminum fencing in front; entry consists of a paneled single wooden entry door with transom window above exterior resurfacing constitutes a major alteration.	Contact 217/1

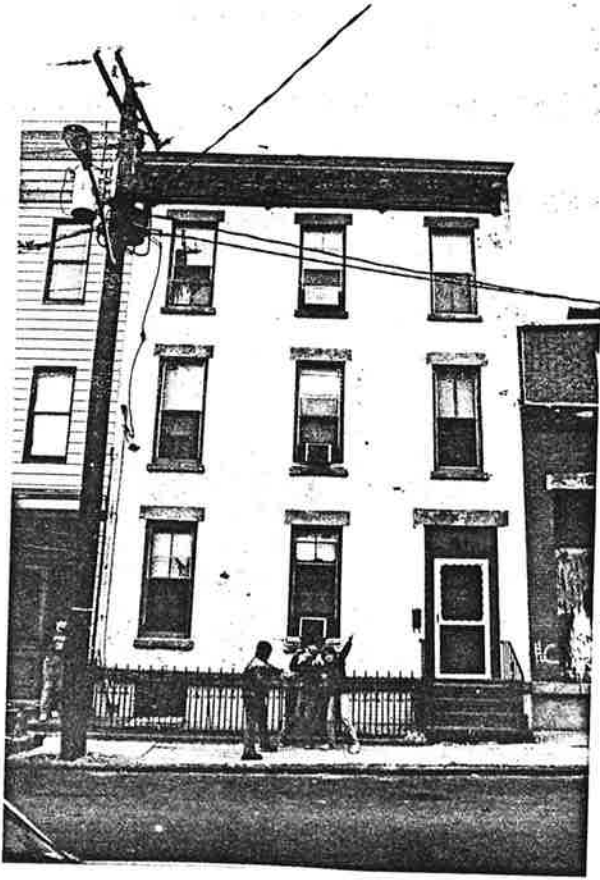
Site No. 0906-D5hut  
8 Hutton Street  
Jersey City, N.J.  
Photo Neg. No. 13/24  
Map No. 1

1.	8 Hutton Street Block/758	Btwn 1887- 1896 (San- born 1896)	P Theme	G	R	Italianate/Greek revival; recessed rectangular plan with side entry; 3 story; 3 bays; brick exterior; 2/2 and 1/1 wood double hung sash windows; casement windows at basement level shed roof with arcgutraved wooden cornice adorned with brackets and modillions; stone lintels and sills; stone lintel-like overdoor; stone water table; brick stoop with iron railings (replacement) leads up to single wooden entry door with aluminum storm door in front; iron fencing fronts building; minor alterations.	Contact 13/24

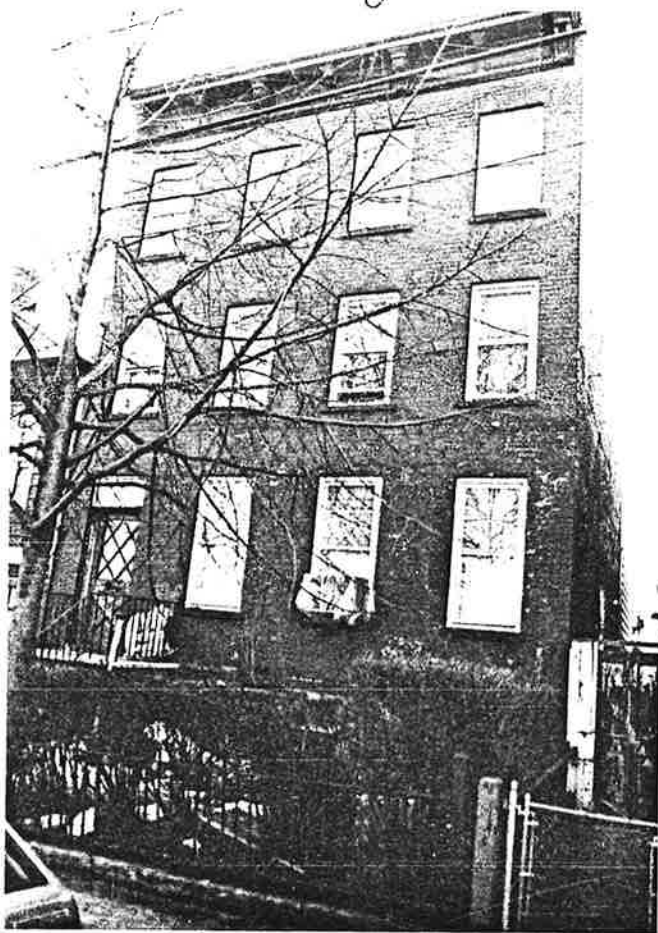
Site No. 0906-D5 man  
 9 Manhattan Avenue  
 Jersey City, NJ  
 Photo Neg. No. 241/17A  
 Map No. 1

1.	9 Manhattan Avenue Block/734	Ante 1873 (G.M. Hopkins Map 1873)	P Theme	G	R2	Italianate; recessed rectangular plan with side entry; 3 story with basement; 4 bays; exterior; 1/1 wood wood double hung sash window treatment, casement windows at base-ment level; shed roof with architraved wooden cornice adorned with brackets and modillions stone lintels and sills; stone water table; concrete and brick stoop with iron railings lead up to single wooden entry door; transom light above entry; no visible alterations.	Contact 241/17A

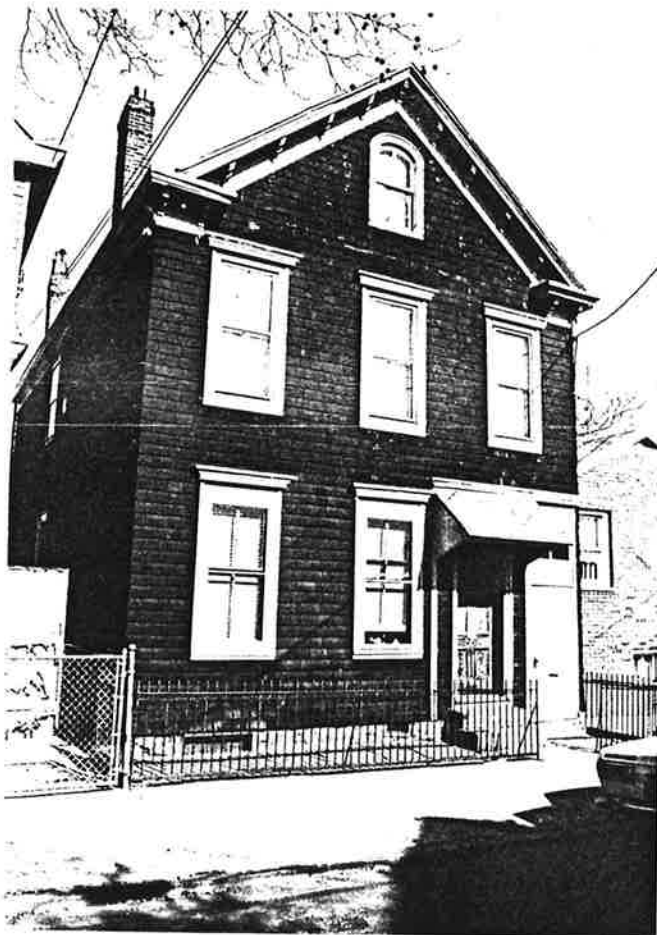
Site No. 0906 - D5 man  
 24 Manhattan Avenue  
 Jersey City, NJ  
 Photo Neg. No. 241/  
 15A  
 Map No. 4

4.	24 Manhattan Avenue Block/735	Ante 1873 (G.M. Hopkins 1873)	P Theme	G	R	Italianate; recessed rectangular plan with side entry; 2 1/2 stories with basement; 3 bay; wood framed building surfaced with wooden shingles; 2/2 wood double hung sash window treatment; each window set in wood framing; gabled roof with extended eaves modillions adorn cornice; brick chimneys atop roof; architaved wood window heads atop windows; attic window has a rounded top sash stone and concrete foundation; small casement window at basement level; 2 entries exist on right side; each a single wooden door; transom window exist above entry to	Contact

MAP #	ADDRESS/LOCATION : PROPERTY NAME	DATE	Signifi- cance to D/S	Condition	USE	DESCRIPTION: Style, Ext. Wall Fabric, Fenestration, Form, Roof, Major Features, Alterations, Stories, etc.	NEGATIVE FILE #
	4 Continued					extreme right and a wooden awning exist above other entry; small 2 step concrete stoop in front; minor alterations.

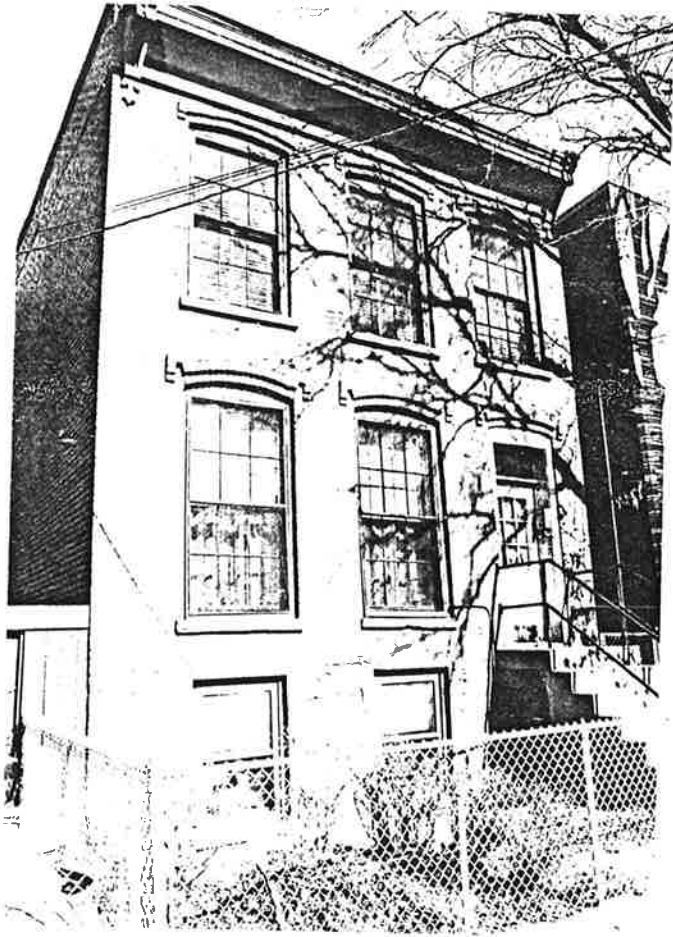
Site No. 0906-D5man  
 34 Manhattan Avenue  
 Jersey City, NJ  
 Photo Neg. No. 241/14A  
 Map No. 5

5.	34 Manhattan Avenue Block/735	Ante 1873  (G.M. Hopkins Map 1873)	P Theme	G	R	Italianate; recessed rectangular plan with side entry; 2 stories with basement; 3 bays; brick exterior; 6/6 and 1/1 wood double hung sash window treatment; shed roof with architaved wooden cornice; large wooden console brackets adorn cornice; segmental brick lintels above windows; stone sills; replacement concrete stoop leads up to single wooden entry door; transom light exist above entry door basement access situated in back of concrete stoop; minor alterations.	Contact 241/19A

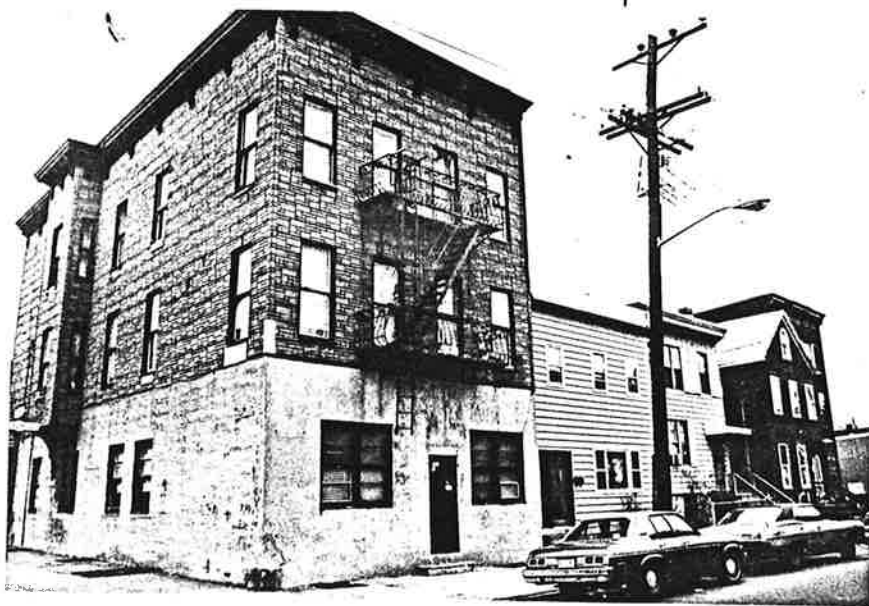
Site No. 0906-05 nyc  
 236-228 New  
 York Avenue  
 Jersey City, N.J.  
 Photo Neg. No. 13/20  
 Map No. 12

12.	236-228 New York Avenue  Block/758  5 Individual buildings	#228- 232 Ante 1873 234 Btwn. 1873- 1887 (L.D. Fowler Map 1887) #231 Btwn. 1887 1896- San- born 1896	N	F/ G	R2 R	Italianate; recessed rectangular plans; some set back further than others; #236 is a 3 story 4 bay wood framed building with asphalt/fiberglass and stucco exterior; 1/1 wood double hung sash windows on most of building; some aluminum replacements used; #234 and #232 are similar in style; both are wood framed 2 stories; 3 bays (#234) and 2 bays (#232) respectively, with basements, the exterior of both are resurfaced with aluminum siding; shed roofs on both 1/1 wood and aluminum type windows; casement windows at basement levels; #230 is a 2 1/2 story wood framed building; 3 bays with gabled roof and brick chimney; 1/1 wood double hung sash windows; arched topped 1/1 wood double hung sash window set into attic story; exterior appears resurfaced with asphalt/fiberglass siding; #228 is a 3 story; 3 bay wood framed building with a shed roof; architraved wooden cornice with brackets; 1/1 wood double hung sash windows on buildings facade; single wooden entry doors exist on all buildings; alterations range from moderate to major.	Contact 13/20

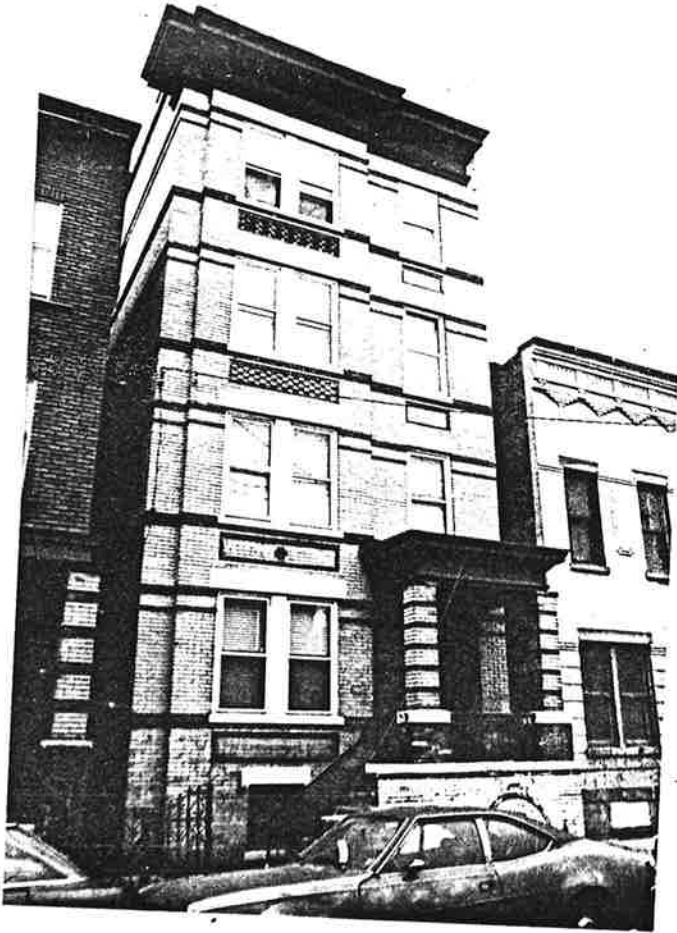
Site No. 0906-D5nya  
 261 New York Avenue  
 Jersey City, N.J.  
 Photo Neg. No. 242/A  
 Map No. 15

15.	261 New York Avenue Block/766	Btwn. 1896- 1928 (G.M. Hopkins Map 1928)	N	G	R2	Neo Grec; recessed rectangular plan with side entry; 4 stories; 2 bays (left side bay projects outward slightly); brick exterior; 1/1 wood with some aluminum replacements double hung sash windows; flat roof with architraved wooden cornice adorned with modillions; decorative brick panels exist below 4th and 3rd story windows on left side casement windows at basement level; stone lintels and sills on all window openings brick belt courses wraparound building at each story; a wooden cornice atop porch roof; 2 brick columns support porch roof; brick and concrete stoop with iron railings lead up to slightly recessed single wooden entry door, no visible alterations.	Contact 242/4

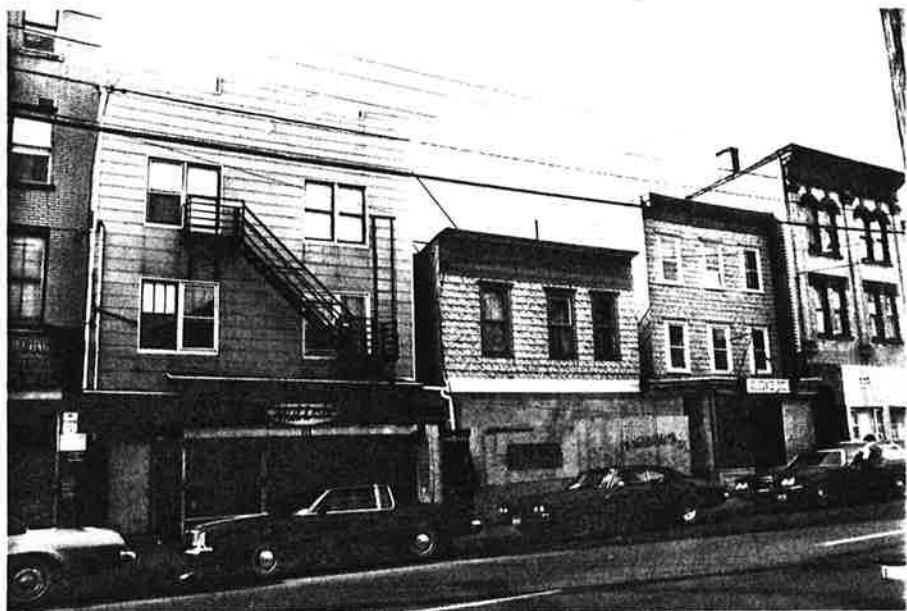
Site No. 0906-D5pal  
379, 381, 383, 385  
Palisade Avenue  
Jersey City, N.J.  
Photo Neg. No. 11/8  
Map No. 4

4.	379, 381, 383, 385 Palisade Ave.	Ante 1873 (G.M. Hopkins Map 1873)	N	F/G	C/ R	Greek Revival (#381, #383) recessed rectangular plans Classical Revival (#385) with side entries 2 stories' 3 bays (#381); 3 stories 3 bays (#383); 3 stories; 2 bays (#385); shed roofs with architraved wooden cornices on all three buildings; 1/1 wood double hung sash windows, some replacement aluminum types on #385; wood framing with fish scale shingles on #381, 383, brick exterior on #351 wooden cornices with modillions and brackets, windows of #381 and #383 set in wood framing; segmental stone lintels with keystones set on 3rd story of #385; stone lintels (plain) on 2nd story of same building; brick chimney atop #385; altered storefronts on Nos. 381 and 383; single wooden entry doors, rounded entry way on #385, 3 brick pilasters with decorative stone capitals on #385, moderate alterations.	Contact 11/10

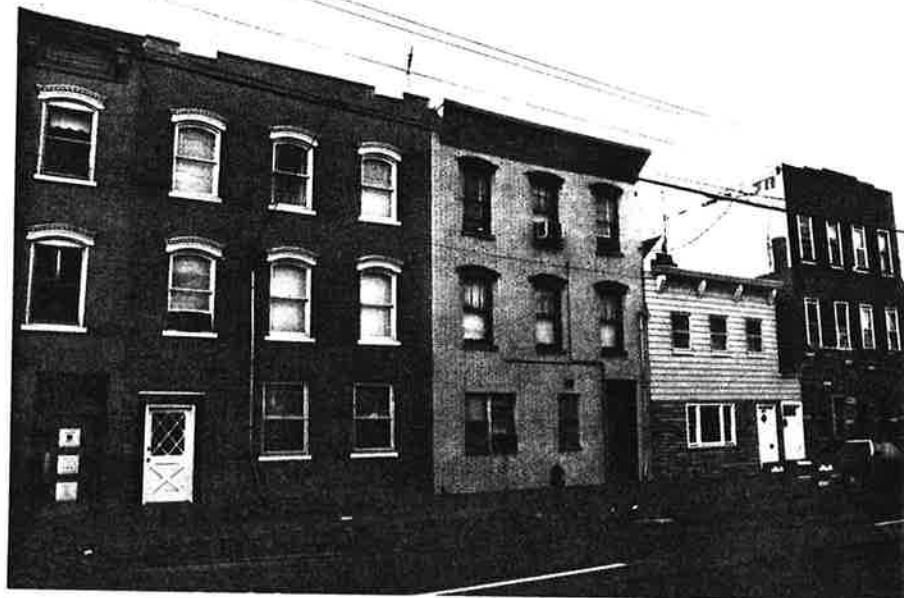
Site No. 0906-D5pal  
389-395 Palisade  
Avenue  
Jersey City, N.J.  
Photo Neg. No. 11/12  
Map No. 6

6.	389-395 Palisade Ave. Block 748	Ante 1873 (G.M. Hopkins Map 1873)	N	G	R	Italianate/Gothic Revival (#393) recessed rectangular plans with side entries; 3 story, 3 bay brick building (#389); 2 story; 3 bays wood framed building (#391), 3 story; 4 bays brick building (#393); facades of #393 and #395 have been resurfaced with aluminum asphalt fiberglass siding and asphalt siding respectively 1/1, 3/1 on 6/1 wood double hung sash windows; aluminum replacement windows on #393 and #395; cornice concealed on #391 by aluminum siding; segmental stone window heads; stone sills on #391; wooden sills on Nos. 393 and 395; shed roof on all except #393 which has a set back gable with decorated vergeboards, single wooden entry doors; transom above entry of #391; minor to moderate alterations.	Contact 11/12

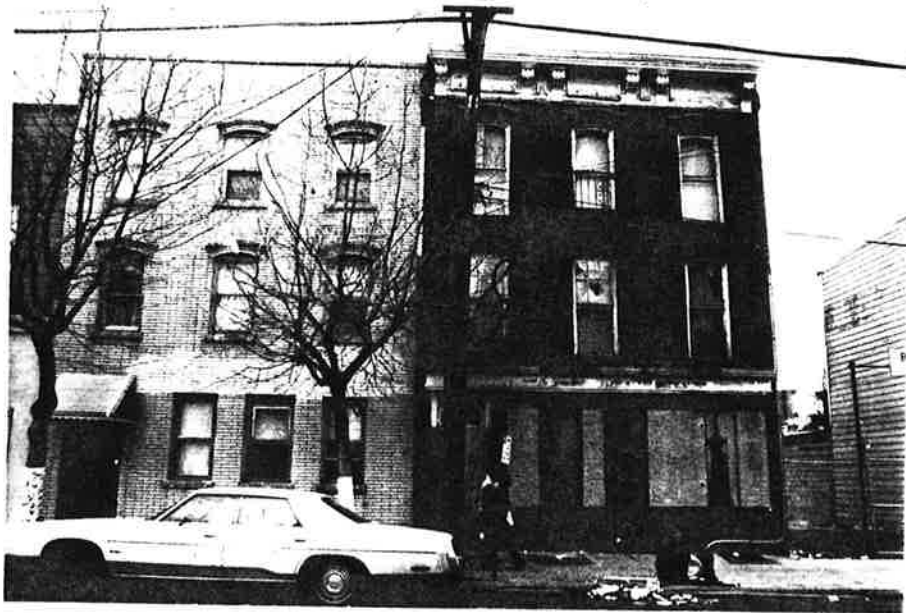
Site No. 0906 D5pal  
 439-441 Palisade  
 Avenue  
 Jersey City, NJ  
 Photo Neg. No. 13/18  
 Map No. 12

12.	439-441 Palisade Ave. Block 758	Btwn. 1873- 1887 (L.D. Fowler Map 1887)		G	R	Italianate; recessed rectangular plan; 3 stories 3 bays each; brick exteriors, 1/1, 1/6 wood double hung sash windows, shed roofs architraved and bracketed cornice atop #441; plain cornice above 1st story, segmental stone window heads and stone sills on both buildings, cornices appear to have been removed from #439 which also has underwent replacement brick work on its facade, all windows are broken on #441 which is vacant; 1st story windows are boarded up; recessed single wooden entry on #439; arched transom window above single door entry on #441; iron fire escape on facade of #441; major alterations on #439 and severe neglect evidenced on #441.	Contact 13/18

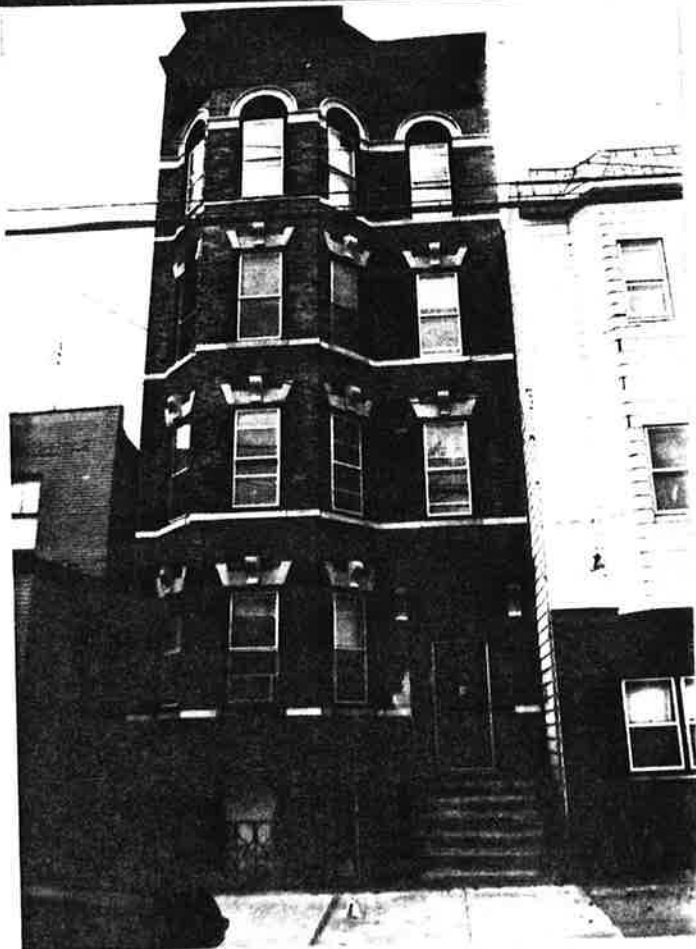
Site No. 0906-D5pal  
487 Palisade Avenue  
Jersey City, NJ  
Photo Neg. No. 242/8  
Map No. 16

16.	487 Plaisade Avenue Block 767	' Btwn. 1896- 1928 (G.M. Hopkins Map 1928)	P	G	R	Italianate; recessed rectangular plan with side and sunken basement entry; 4 stories; 2 bays, (projecting bay) brick building; 1/1 wood double hung sash windows, some aluminum replacement windows of same type; shed roof with architraved wood cornice with modillions, rounded stone arches above windows on 4th story; stone lintels with scroll like keystone, stone sills; stone water table; stone overdoor supported by scroll-like brackets; entry door surrounded by glass block; stone foundation, concrete stoop with wrought iron railings (original) leading up to single wooden entry door; sunken basement entry visible; no alterations.	Contact 242/8

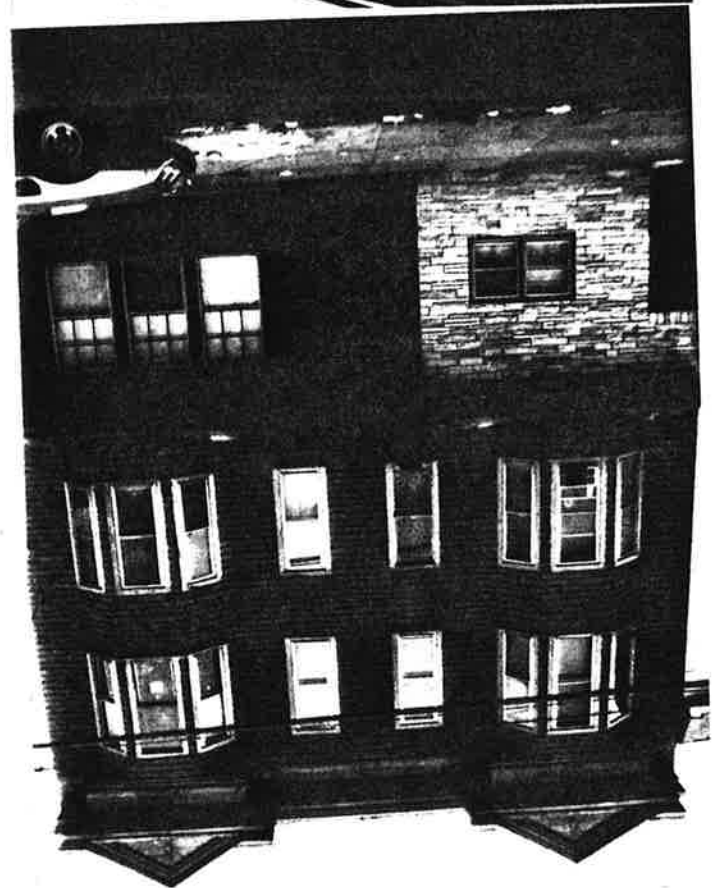
Site No. 1906-85 par  
 587 Palisade Avenue  
 Jersey City, NJ  
 Photo Neg. No. 242/30  
 Map No. 18

18.	507 Palisade Avenue Block 776	Btwn. 1873 1887 (L.D. Fowler Map 1887)	P	G	C/ R	Italianate; recessed rectangular plan with side entry; 3 stories; 3 bays; wood framed building; fish scale siding on exterior; shed roof with architaved wood cornice with brackets and modillions; 1/1 aluminum double hung sash windows (replacements) architaved cornice above 1st story; aluminum siding on 1st story central entry to storefront consist of a single wooden door with side lights, display windows in front, single wooden entry door (side) with transom light above minor alterations.	Contact 242/30

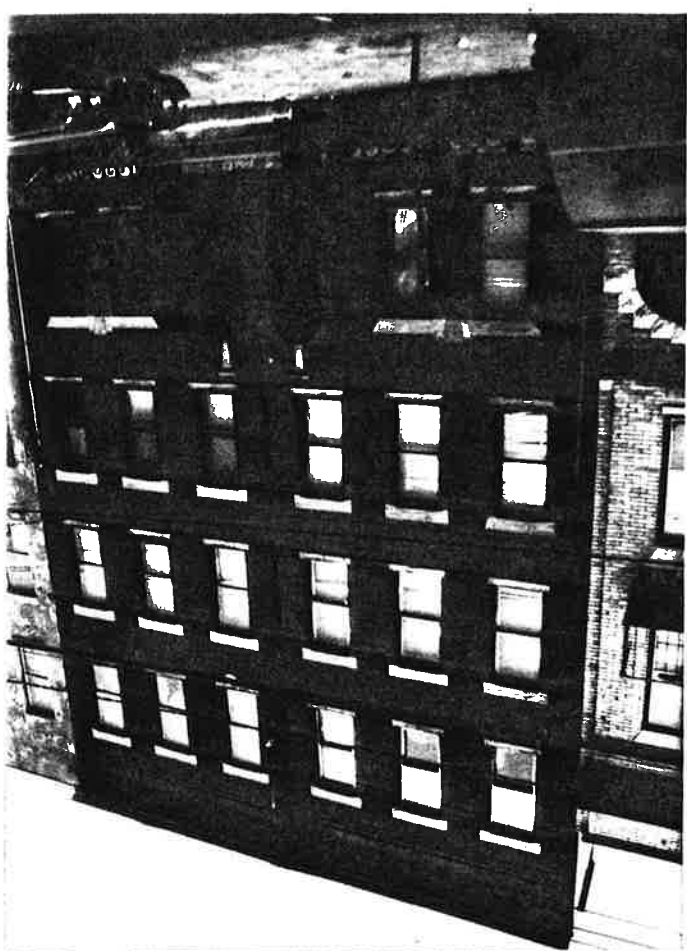
Site No. 0906-85 gal  
 513 Calver Avenue  
 Jersey City, NJ  
 Photo Neg. No. 242/31  
 Map No. 19

19.	513 Palisade Avenue Block 776	Btwn. 1896 1928 (G.M. Hopkins Map 1928)	P	E	R	Italianate; recessed rectangular plan with 2 side entries; 3 stories; 3 bays; projecting rounded central bay; brick exterior; 1/1 wood double hung sash windows; shed roof architaved wood cornice with modillions and dentils; molded panels on rounded bay; stone lintels with keystones; stone sills; architaved cornice above 1st story; rusticated stone voussoirs above rounded and flatted arches of 1st story; single wooden entry doors; semicircular transom light above right side entry; iron fire escape suspended from facade of building	Contact 242/31

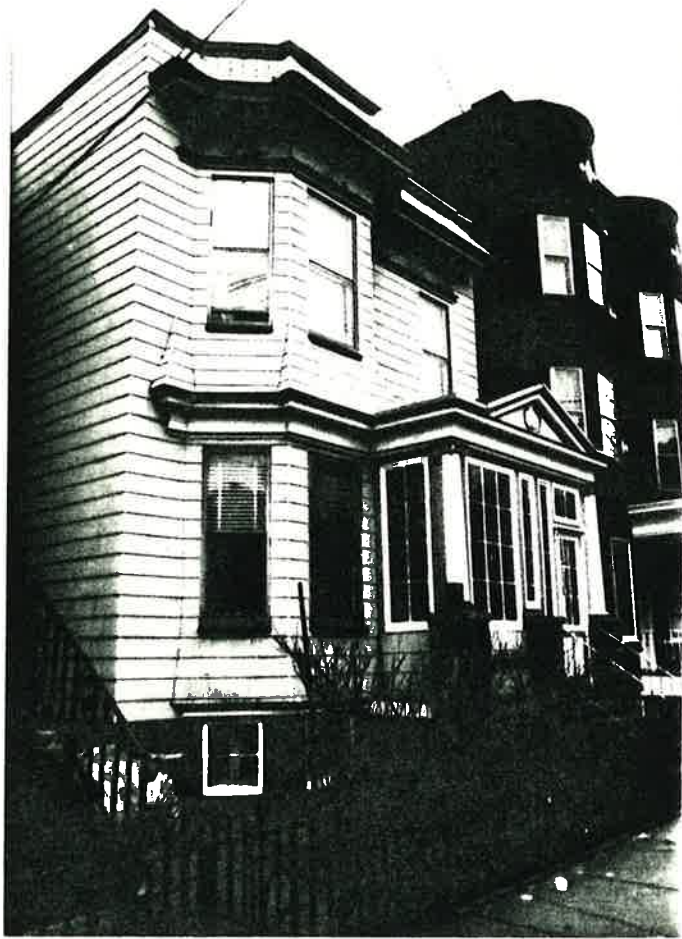
Site No. 0906-D5pal  
537 Palisade Avenue  
Jersey City, NJ  
Photo Neg. No. 242/34  
Map No. 22

22.	537 Palisade Avenue Block: 776 (Contact: 242/34)	Btwn. 1896- 1928 (G.M. Hopkins Map 1928)				Italianate; Recessed rectangular plan with side entry and projecting entryway; 2 stories; 2 bays; (1 projecting) 1/1 wood double hung sash windows; multi-lighted single paned windows on entryway of building; Shed roof; Architraved wooden cornice with modillions and dentils; Garland moldings on frieze; Gabled roof with Temple-like pediment on entryway; Leaf molding on tymponum; 2 columns; Each with Corinthian capitals flank entryway; Casement windows at basement level; Stone foundation with concrete stoop with iron railings lead up to single wooden entry door with transom lights above; Sunken basement entry at side of entryway; Only major alteration is the aluminum siding on exterior.	Contact: 242/34

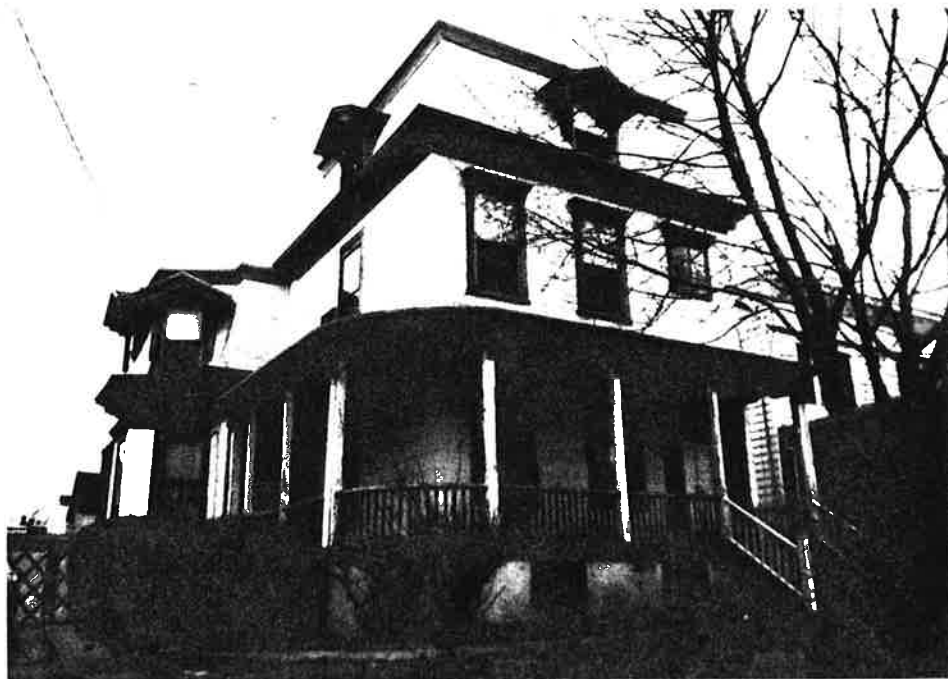
Site No. 0906-25 pal  
 631 Palisade Avenue  
 Jersey City, NJ  
 Photo Neg. No. 243/18A  
 (17A)  
 Map No. 27

MAP #	ADDRESS/LOCATION : PROPERTY NAME	DATE	Signifi- cance to D/S	Condition	USE	DESCRIPTION: Style, Ext. Wall Fabric, Fenestration, Form, Roof, Major Features, Alterations, Stories, etc.	NEGATIVE FILE #
27.	631 Palisade Avenue Block: 796 (Contact: 243/18A)	Ante 1873 (G.M. Hopkins Map 1873	P	G	R	Second Empire - recessed irregular rectangular plan with side entry side section of building projects outward forming an irregular plan; Wood framed building with wood board siding; Mansard roof with numerous dormers with pediments atop; Architraved wood cornice with modillions and dentils; Architraved wood window heads above 1/1 wood double hung sash windows; Casement windows at basement level wrap-around porch supported by wooden posts; Wooden entry doors with transom lights above; No visible alterations.	Contact: 243/18A

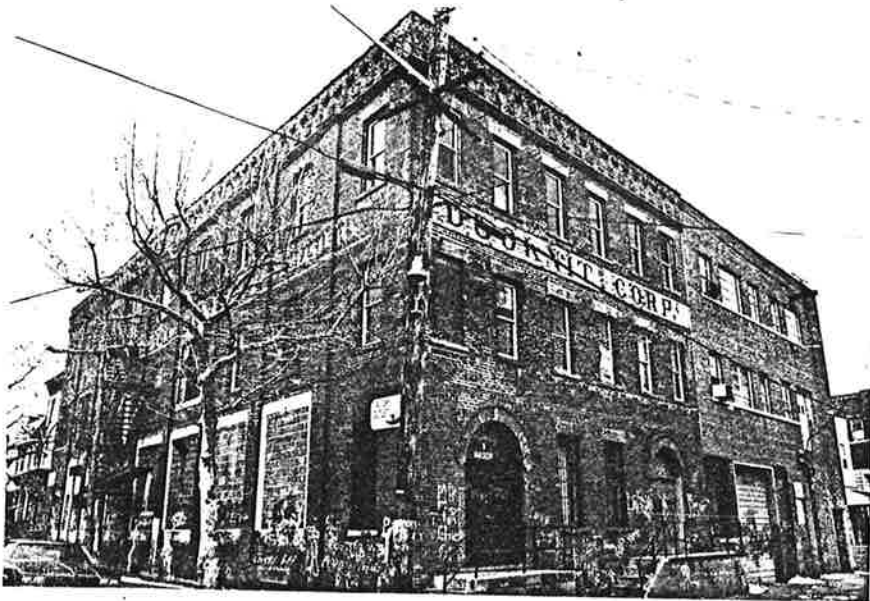
Site No. 0906-Ds she  
3-9 Sherman Avenue  
Jersey City, N.J.  
Photo Neg. No. 183/18  
Map No. 1

MAP #	ADDRESS/LOCATION : PROPERTY NAME	DATE	Signifi- cance to D/S	Condition	USE	DESCRIPTION: Style, Ext. Wall Fabric, Fenestration, Form, Roof, Major Features, Alterations, Stories, etc.	NEGATIVE FILE #
1	3-4 Sherman Avenue Block 734 Duoknit Factory (N.W. corner of Sherman Avenue and Ferry Street) Architect, Philip Weilbacher Source: 1909 R.E.R.	1909	P	F	C	Utilitarian/Romanesque; recessed rectangular plan with side entries, 3 stories; 6 bays; brick building with basement; 1/1 and multi-lighted window treatment on building; numerous window openings are filled in with concrete and cinderblocks; flat roof with brick parapet; brick moldings above 3rd story on parapet; stone lintels and sills; painted on buildings exterior are the words "Duoknit Corp." iron fire escape suspended from side of building; major side entries situated in rounded arched entryway with a segmental brick arch above; concrete stoops with pipe railings lead up to entries; moderate alterations.	Contact 183/18

"Duo-Knit" factory  
1909 (RER 6/26/09)  
Philip Weilbacher,  
Architect  
1909 Warehouse for  
Marina Goldberg, Inc.  
(wholesale grocers)

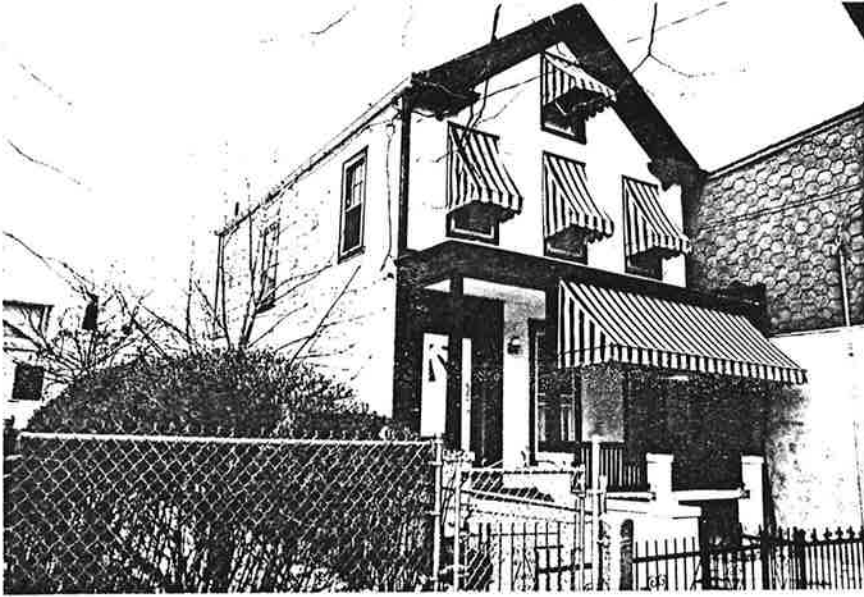
Site No. 0906-Ds she  
31 Sherman Avenue  
Jersey City, N.J.  
Photo Neg. No. 184/  
20  
Map No. 3

MAP #	ADDRESS/LOCATION : PROPERTY NAME	DATE	Signifi- cance to D/S	Condition	USE	DESCRIPTION: Style, Ext. Wall Fabric, Fenestration, Form, Roof, Major Features, Alterations, Stories, etc.	NEGATIVE FILE #
3	31 Sherman Avenue  Block 735	Ante 1873	P	E	R	Greek Revival; recessed rectangular plan with side entry; 2 1/2 story; 3 bay wood framed building; 1/1 wood double hung sash windows; gabled roof with architaved wooden cornice most of which is concealed by aluminum siding; aluminum siding now covers the exterior of building; brick stoop leads up to wooden porchsingle wooden entry door with transom light above; iron fencing in front; canvas canopies above 2nd and attic story windows and suspended from porch roof' porch roof is cupported by 4 wooden posts and has an architaved wooden cornice atop; moderate alterations.	Contact 12/15

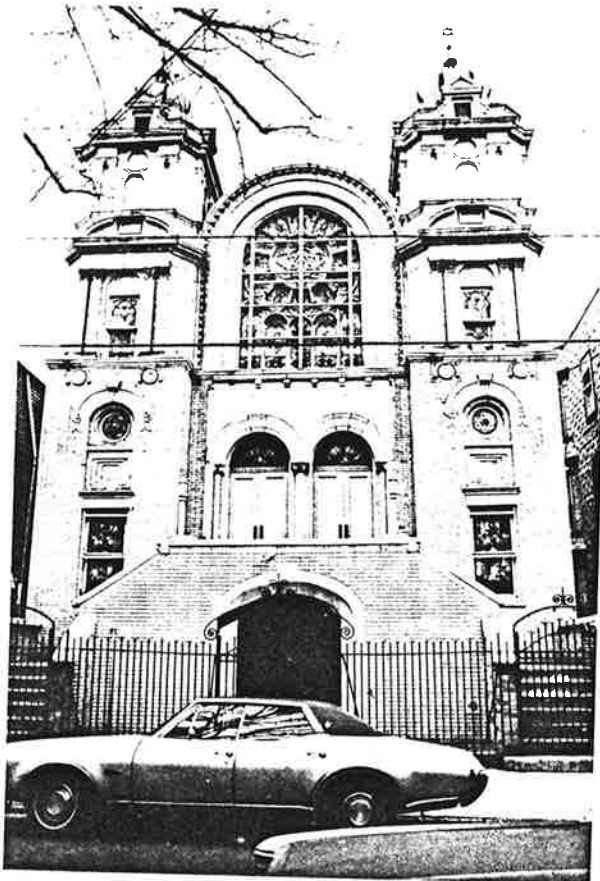
Site No. 0906-D5she  
128-130 Sherman Avenue  
Jersey City, N.J.  
Photo Neg. No. 13/29  
Map No. 10  
"Congregation Mount Sinai"  
cornerstone Sept. 20, 1968  
Architect, Eugene Ciccarella  
(Hoboken)  
RER 2/29/08

10.	128-130 Sherman Avenue  Block/765  Architect, Eugene Cicarelli  Source: R.E.R. 1908	1908	Y	E	T	Byzantine Style; recessed irregular rectangular plan with 2 bell towers; one at each side of facade; 1 story with basement but the equivalent of 2 1/2; brick exterior with stone moldings and trim; all windows on facade are stained glass 4 of which are in the 1/1 framing; a large arched sectional stained glass window exist on nave portion of building 12 stained glass panels surround a central "Star of David" modling; below which 5 panesl of stain glass exist; each tower is topped by an onion shaped dome with a "Star of David" finial atop each; all windows on tower are flanked by brick pilasters with Corinthian capitals; triangular stone pediment atop top most window architraved stone cornices above 2nd and 3rd stories of towers; stone moldings forms trim of arched nave housing stained glass windows; an oculus window with ornate segmental stone lintels with corbel keystone exist midway between 1st and 2nd stories on towers; 2 stone arches with colonettes with terra cotta capitals house 2 sets of double wooden entry doors; semicircular transom, lights above each set of doors; the engraving "Congregation Mount Sinai, Jersey City" exist both in English and Hebrew above arched entries, double brick and concrete stoops lead up to entries, basement entry;	Contact 13/29

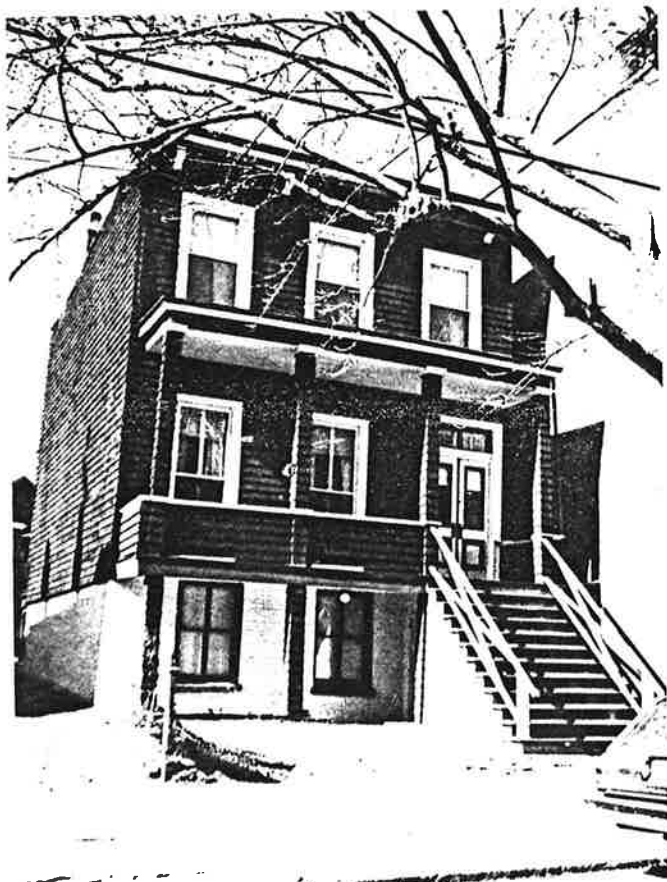
Site No. 0906-D5she  
221 Sherman Avenue  
Jersey City, N.J.  
Photo Neg. No. 217/35  
Map No. 19

MAP #	ADDRESS/LOCATION : PROPERTY NAME	DATE	Signifi- cance to D/S	Condition	USE	DESCRIPTION: Style, Ext. Wall Fabric, Fenestration, Form, Roof, Major Features, Alterations, Stories, etc.	NEGATIVE FILE #
19.	221 Sherman Avenue Block/773	Ante 1873	N	F	R	Greek Revival, recessed rectangular plan with side entry; 2 story wtih basement; 3 bays, wood framed building with brick foundation, 1/1 and 2/2 wood double hung sash window treatment; shed roof with brick chimney bracketed wooden cornice, a plain architraved wooden cornice on porch roof; 4 wooden posts support porch roof; wooden stoop with wooden railings lead up to panelled double wooden entry doors; a transom light exist above entry doors; wood shingle siding on buildings exterior, minor alterations.	Contact 217/35

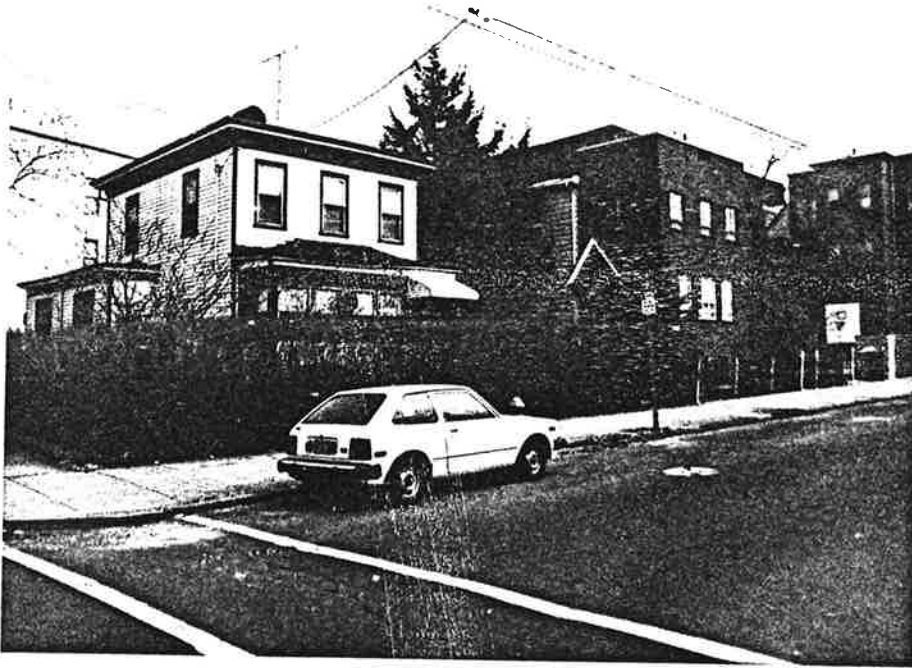
Site No. 0906-D5 ssw  
32-28 South Street  
Jersey City, NJ  
Photo Neg. No. 242  
Map No. 1 <sup>21</sup>

1.	32-28 South Street Block/786	Ante 1873	N	G	R	Italianate; (#32) recessed irregular rectangular plan with side entry; 2 story, 3 bays; projecting side wing and projecting 1st story sun room; wood framed building with clapboard siding; 1/1 wood double-hung sash window treatment; flat roof with brick chimney; architraved and bracketed wooden cornice; a plain architraved cornice exist just above 1st story on projecting portions of building; aluminum awning exist above single wooden entry door; minor alterations.	Contact 242/21

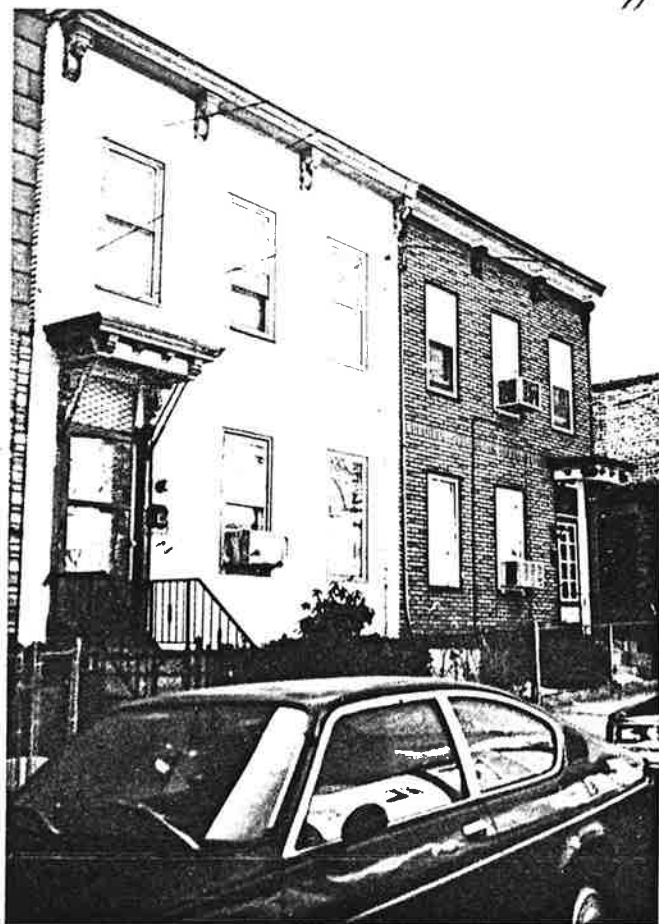
Site No. 0906-D5 sou  
69-71 South Street  
Jersey City, N.J.  
Photo Neg. No. 217/28  
Map No. 7

7.	69-71 South Street Block/773	Btwn. 1873- 1887 (L.D. Fowler Map 1887)	N	G/ F	R	Greek Revival; recessed rectangular plans; each with side entries; 2 story wood framed buildings; 2 bays each; 1/1 wood double hung sash windows; some wooden window types have been replaced with aluminum type windows; shed roofs; a continuous architaved wooden cornice exist at roof line; console brackets adorn cornice; small wooden overdoors each adorned with cornices and miniature brackets and modillions exist above each single wooden entry door; transom window above each entry; small concrete stoops with replacement iron railings lead up to entry facade of #69 has been resurfaced with brick facing; asphalt/fiber-glass siding on facade of #71; both buildings moderately altered.	Contact 217/28
