Bowers Street in East Hudson City Neighborhood of  
 Survey Area (Ward 8) 0906-05 bars, NY H.S.I. 0906  
 Jersey City, Hudson County

NEW JERSEY OFFICE OF CULTURAL AND ENVIRONMENTAL SERVICES  
HISTORIC PRESERVATION SECTION  
DISTRICT/STREETSCAPE CONTINUATION SHEET

N.J. HISTORIC SITES INVENTORY

District/Streetscape Continuation Page # 1 Inventory # 0906-D5-bow

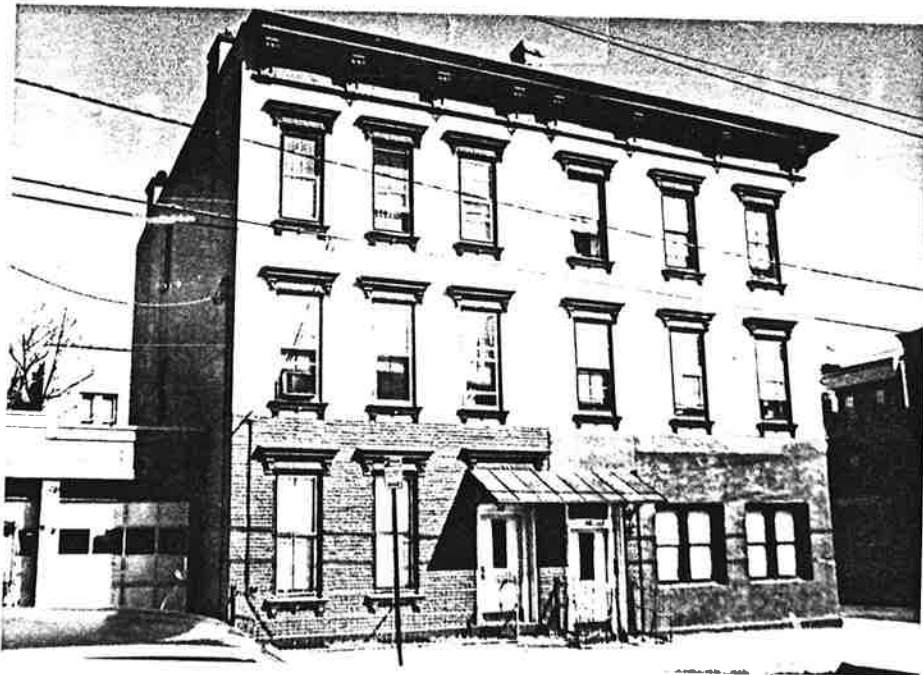
Site No. 0906-D5sou  
86-88 South Street  
Jersey City, NJ  
Photo Neg. No. 216/1  
Map No. 12

12.	86-88 South Street Block/782	Btwn. 1873- 1887 (L.D. Fowler Map 1887)	P Theme	G	R2	Italianate; recessed rectangular plan with side entries; 3 stories; 3 bays; brick building; 8 2/2 wood double hung sash windows per building; shed roofs with brick chimneys atop; architraved wooden cornice with console brackets; stone lintels and sills; lintels and sills on 1st story of #88 have been removed; some wooden windows on #86 have been replaced with aluminum types; single wooden entry door on each building; transom light above each door; wooden awning exost above each entry; iron fencing in front of #86; darker paint on 1st story of both buildings; 1st story of #88 resurfaced with stucco; moderate alterations.	Contact 216/7

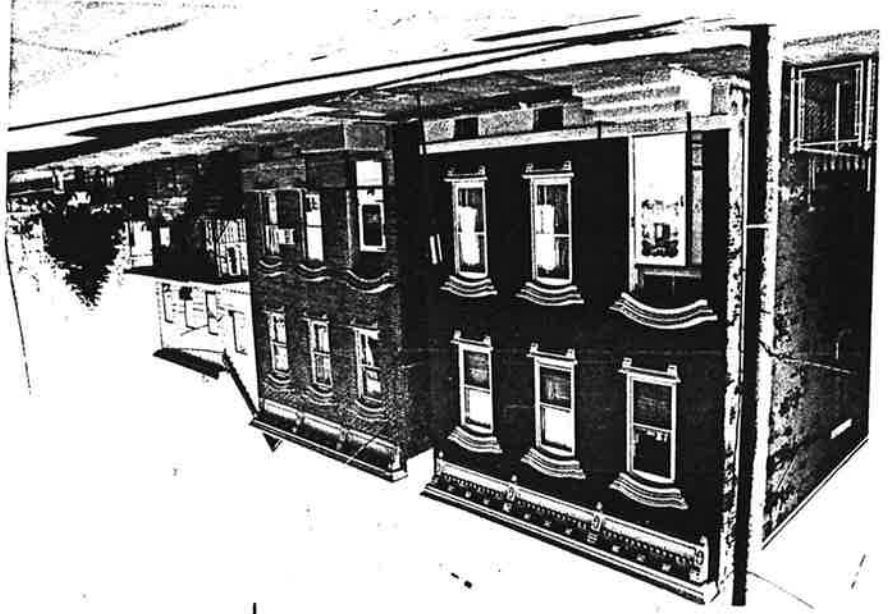
Site No. 0906-B5wb  
123-129 Webster Ave.  
Jersey City, N.J.  
Photo Neg. No. 12/11  
Map No. 2

2.	123-129 Webster Avenue  Block/746	#123, #125, #129 Btwn 1873- 1887 (L.D. Fowler Map #1887) Ante 1873 #127	P	E	R	Italianate; recessed rectangular plans with side entries; each 2 stories with basements; 3 bays; brick exteriors; 1/1 wood double hung sash windows casement windows at basement levels; shed roofs with architraved wooden cornices, both adorned with brackets, dentils and modillions, segmental stone lintels and sills on the facades of both buildings; stone water tables above basement levels of both buildings; small replacement concrete stoops lead up to single wooden entry doors; transom lights exist above each entry door; aluminum storm doors exist on both buildings; both buildings are excellent examples of this style.	Contact

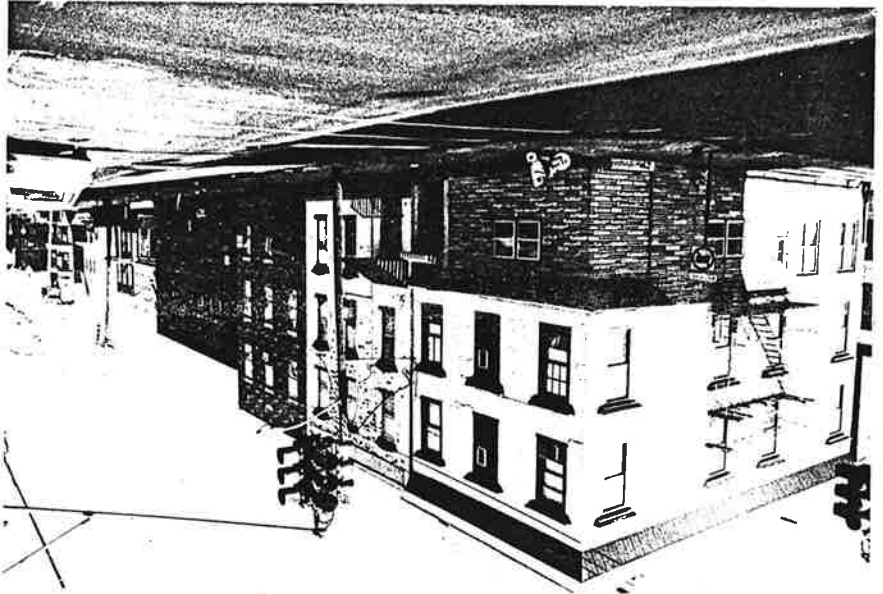
Site No. 0906-B5wb  
97-105 Webster Ave.  
Jersey City, N.J.  
Photo Neg. No. 12/10  
Map No. 1

1.	97-105 Webster Avenue  Block/748  On 1887 Map #101-105 listed as a fire engine house, same listed on 1873 Map as a police station	Ante 1873	N	F	R2	Italianate; recessed rectangular plan with side entries; each building approximately 3 stories in height; 3 bays, all of brick exterior with central entries; 1/1 wood double hung sash windows; 6/1 2/1 type windows can be found on #97; aluminum 1/1 replacements exist on 1st story of #97; exterior of 101 is resurfaced with asphalt/fiberglass siding; portion of #97's 1st story has asphalt/fiberglass siding; flat roofs, some with chimneys; cornices of #97-101 either covered over or no longer exist; a brick parapet roof exist on #105; stone lintels and sills on #'s 97 and 99 and 105; a small wooden cornice exist on #97, just above 1st story; aluminum awnings above entries of #97, 99 and 101; all entries are recessed single wooden door types; moderate to major alterations.	Contact 12/10

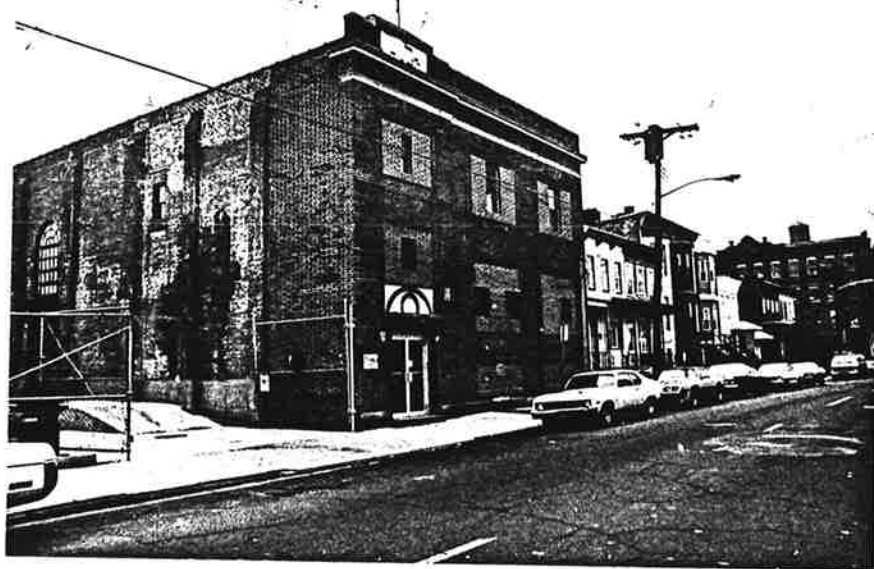
Site No. 0906-D5wb  
 158-136 Webster Ave.  
 Jersey City, N.J.  
 Photo Neg. No. 13/9  
 Map No. 9

#158 = Turnverein Hall  
 (German Gym, Clubhouse)  
 Built 1917 by Architect  
 William Neumann  
 (RER 1917)

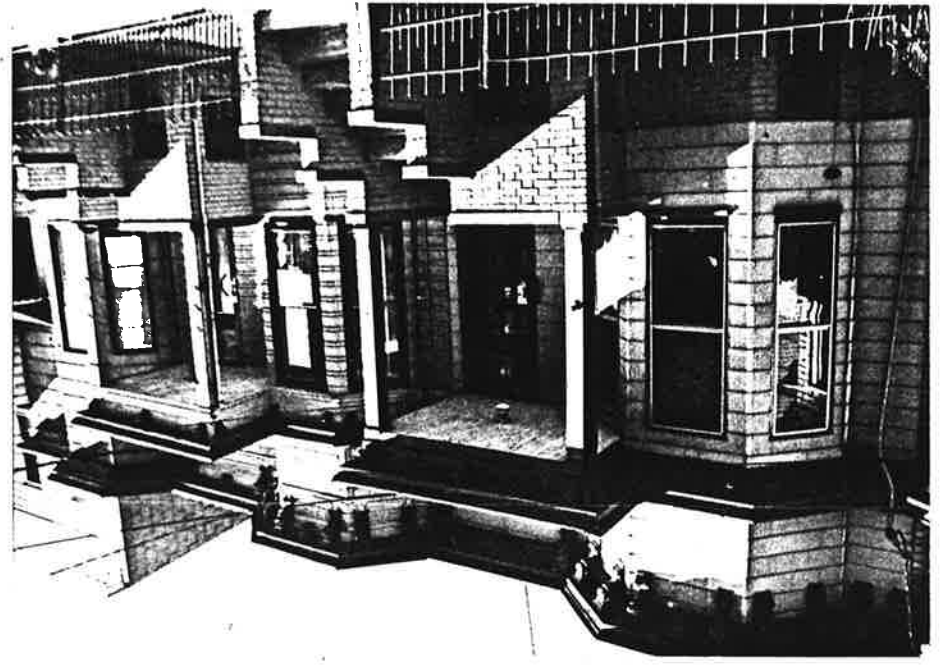
Site No. 0906-85wt  
 185-187 Webster Avenue  
 Jersey City, N.J.  
 Photo Neg. No. 198/34  
 Map No. 11

11.	188-186 Webster Avenue Block/766 3 rowhouses	Btwn. 1887- 1896 (San- born 1896)	P Theme	G	R	Italianate; recessed rectangular plans with projecting bays and porch roofs single story wood framed buildings; each attached to one another; each has a basement level with a sunken entry; 1/1 wood double hung sash window treatment on all three buildings; shed roofs with architraved wooden cornice continuous along roofs of all three buildings; console brackets and modillions adorn cornice exterior of buildings are resurfaced with aluminum siding; brick foundations porches and stoops exist on all buildings; a second architraved cornice with similar adornments; such cornices extend to porch roofs; each roof (2) supported by two wooden posts; entries consist of single wooden entry doors with transom light above; entry door on #188 has numerous window lights; aluminum awning above entry door of #186; minor alterations.	Contact 198/33

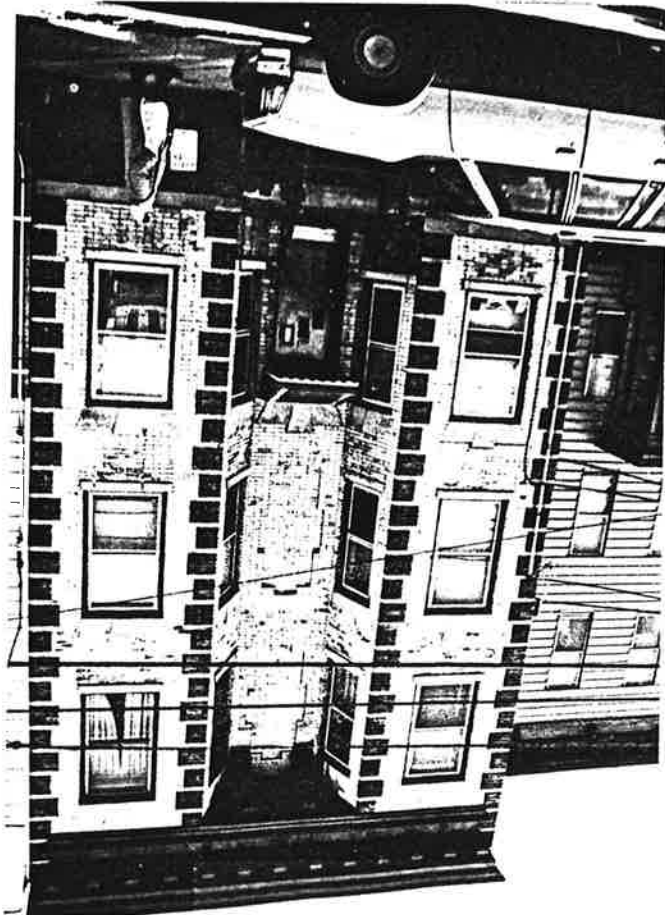
Site No. 0906-85 wt  
 211 Webster Avenue  
 Jersey City, N.J.  
 Photo Neg. No. 198/31  
 Map No. 12

12.	211 Webster Avenue Block/765	Btwn. 1896- 1928 (G.M. Hopkins 1928)	P Theme	G	R2	Neo Grec; recessed rectangular plan with central entry; projecting bays each housing 2 windows per story; brick exterior; aluminum double hung 1/1 sash windows (replacement) shed roof with architraved and modillioned wooden cornice; 2 console brackets exist on central portion of building; darker colored brick adorns corners of projecting bays to accentuate the corners much like quoins; stone lintels with keystones above each window; stone sills; stone water table; similar type windows exist at basement level; stone water table; aluminum awning above single wooden entry door; concrete stoop with wrought iron railings fronts entry; excepting replacement windows no other visible alteration.	Contact 190/31

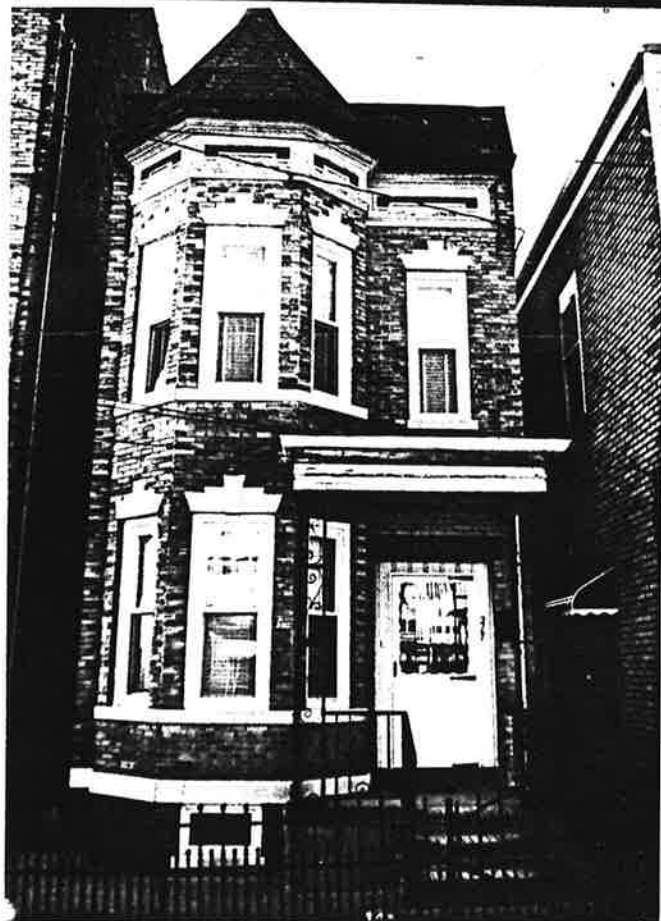
Site No. 0906-D5wb  
277 Webster Avenue  
Jersey City, N.J.  
Photo Neg. No. 198/27  
Map No. 17

17.	279 Webster Avenue Block/774	Btwn. 1887- 1896 (San- born 1896)	P Theme	E	R	Queen Anne; recessed rectangular plan with projecting left side bay; and side entry; 2 stories, 2 bays brick building with basement entry; 7 1/1 wood double hung sash windows, casement windows at basement level; shed roof with small tent roof atop projecting bay; architraved wooden cornice rectangular relief panels on frieze; stone lintels with keystones; stone sills; stone water table; small porch roof supported by iron posts; brick and concrete stoop and porch with replacement iron railings; single wooden entry door fronted by an aluminum storm door; iron fencing in front; minor alterations.	Contact 198/27

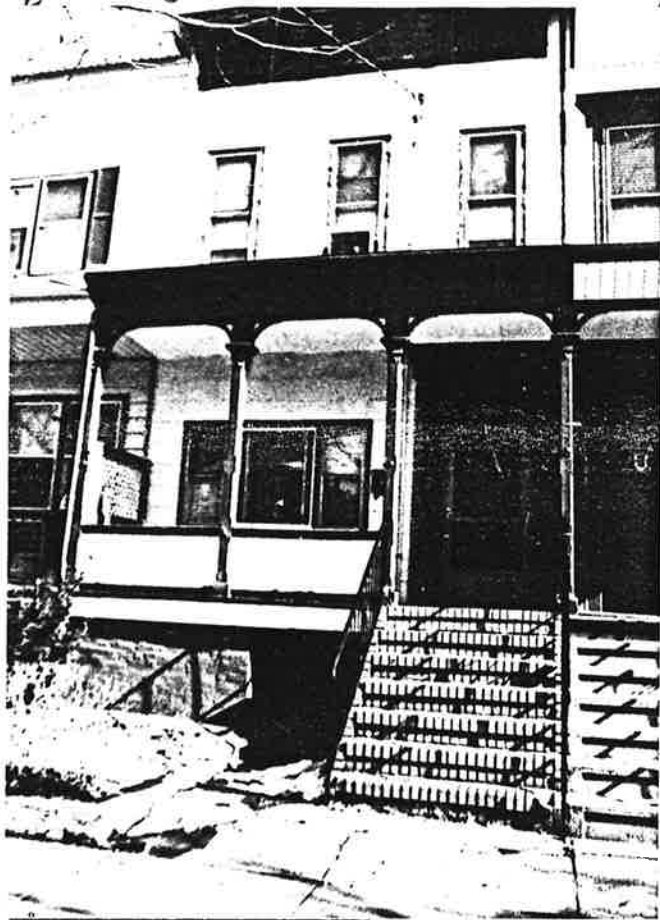
Site No. 0906-D5wb  
316 1/2 Webster Avenue  
Jersey City, N.J.  
Photo Neg. No. 198/18  
Map No. 24

24.	316 1/2 Webster Avenue Block/785	Btwn. 1873- 1887 (L.D. Fowler Map 1887)	P Theme	G	R	Italianate; recessed rectangular plan with side entry 2 stories; 3 bay wood framed building; 1/1 wood double hung sash windows; some aluminum replacements; shed roof with architaved wooden cornice adorned with brackets and modillions; cornice on porch roof adorned with modillions; 4 wooden posts support porch roof; brick stoop leads up to single wooden entry door which is fronted by an aluminum storm door exterior resurfacing constitutes a moderate alteration.	Contact 198/18

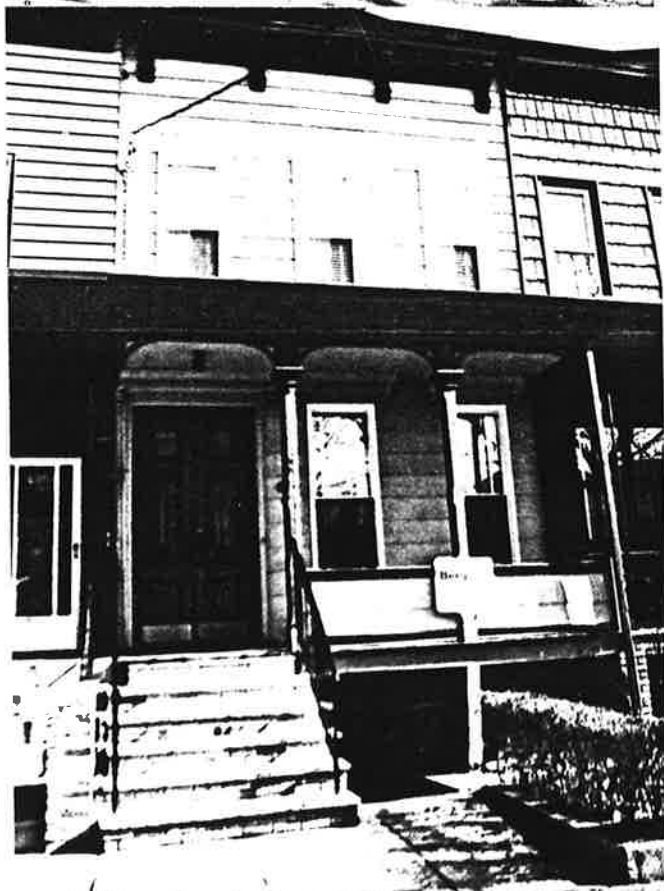
Site No. 0906-D5wb  
320 1/2 Webster Avenue  
Jersey City, N.J.  
Photo Neg. No. 198/17  
Map No. 25

25.	320 1/2 Webster Avenue Block/785	Btwn 1873- 1887 (L.D. Fowler Map 1887)	P Theme	G	R	Italianate; recessed rectangular plan with side entry; 2 story wood framed building with basement level; wood framed builing with vinyl siding; 1/1 wood double hung sash windows on 1st and 2nd stories; shed roof with architaved wooden cornice adorned with console brackets and modillions; 1st story porch roof has a second cornice adorned with modillions only; 4 wooden posts support porch roof; brackets atop support posts; replacement brick stoop leads up to paneled double wooden entry doors; all windows in wood framing; architrave wooden window leads above 1st story windows; sunken concrete stoop leads down to basement entry; not visible in photo; moderate alterations.	Contact 198/17

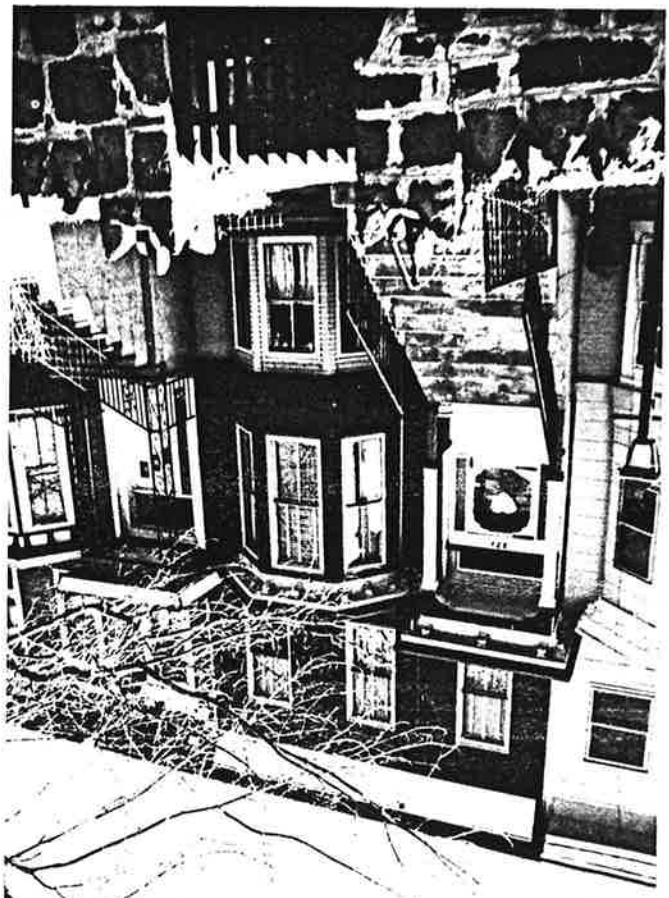
Site No. 0906-85wt  
 374-372 Webster  
 Avenue  
 Jersey City, N.J.  
 Photo Neg. No. 198/6  
 Map No. 35

35.	374-372 Webster Avenue Block/795	#372 Btwn 1896- 1928 (G.M. Hopkins 1928)  #374 Btwn. 1873- 1887 (L.D. Fowler Map 1887)	N	P	V	(a) Italianate; #374); recessed rectangular plan with side entry; 2 story wood framed building with brick porch; 3 bays; 1/1 and 2/2 wood double hung sash windows; shed roof with architraved wooden cornice adorned with brackets, modillions and dentils; dentil trim just above 1st story facade; building is fire damaged single wooden entry door with transom light above severely damaged.  (b) Early 20th Century Vernacular; recessed rectangular plan with a projecting 1st story; 2 stories brick single second story bay housing 3 windows; 1/1 wood double hung sash window treatment; single wooden entry soe qirh aluminum storm door in front; shed with a slight parapet; wooden knobs hang from cornice, no major alterations; builidng not particularly distinct.	Contact 198/9

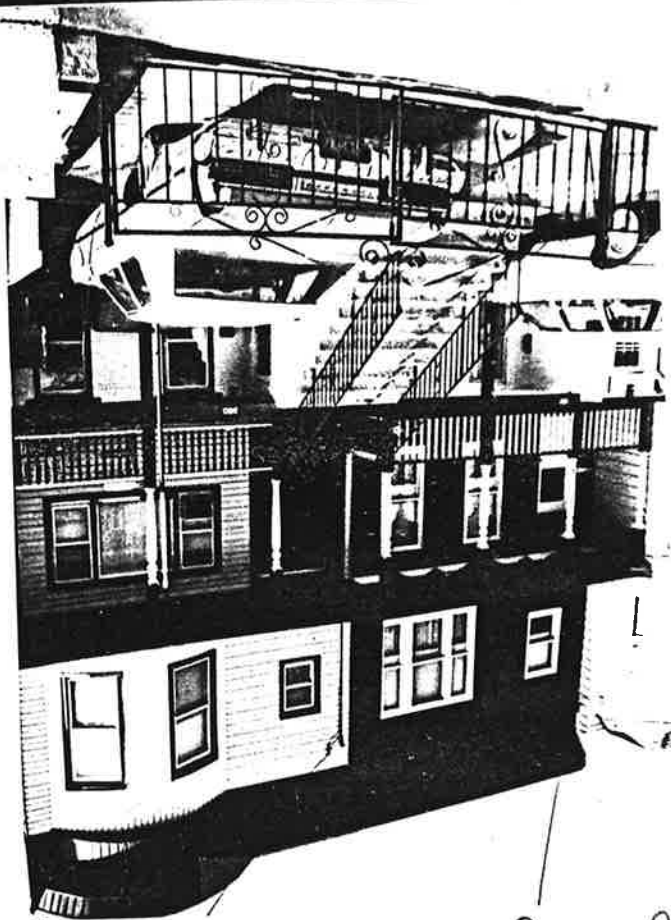
Site No. 0906-85wt  
 382-380 Wobaton Avenue  
 Jersey City, N.Y.  
 Photo Neg. No. 1987  
 Map No. 36

36.	382-380 Webster Avenue Block/800	Btwn 1887 1896 (San- born 1896)	N	F	R	Italianate; recessed rectangular plans with side entries; each 2 stories; 2 bays with basement levels; a rounded or bowed 2nd story bay on #380; 1/1 wood double hung sash windows on #380; 1/1 aluminum replacements on #382; shed roofs on both; architraved wooden cornice adorned with console brackets on #382; cornice concealed on #380; a plain (continuous on both buildings) porch cornice supported by rounded wooden posts; stoop removed on #382 to make use of an added basement entry; #382 has 2 single wooden entry doors, each fronted by aluminum storm doors; double wooden entry doors with transom light above on #380; basement entry of #380 situated at side rear of concrete stoop; both buildings severely altered.	Contact 198/7,8
