USHSI #0906  
D609  
Ogden Avenue  
(Washington Village Washington Road)  
Page 1 of 3 map pages

NEW JERSEY OFFICE OF CULTURAL AND ENVIRONMENTAL SERVICES  
 HISTORIC PRESERVATION SECTION  
 DISTRICT/STREETSCAPE CONTINUATION SHEET

N.J. HISTORIC SITES INVENTORY

Ogden Avenue in Washington Village Neighborhood  
of Survey Area (ward D6) N5H5I # 0906-D6 og,  
Jersey City, Hudson Co.  
Page 2 of 25 photo pages.

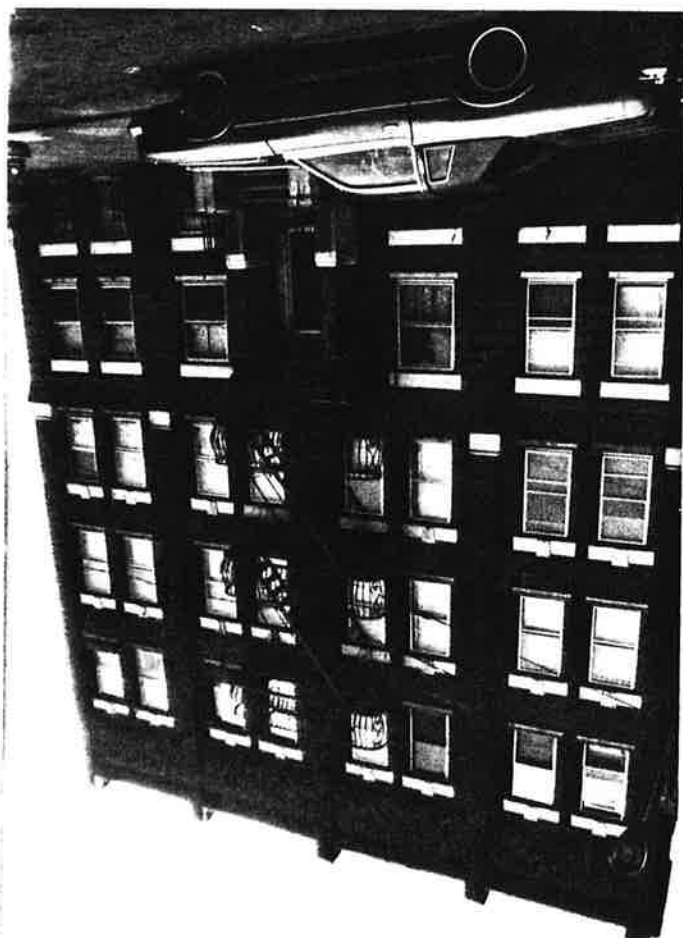
Site No. 0906-D6 og  
102-104 Ogden Avenue  
Jersey City, N.J.  
Photo Neg. No. 244/29  
Map No. 1  
(bet. 1908-1919)

1.	102-104 Ogden Avenue Block: 723 (Contact: 244/29)	Between 1908- 1919	P Dist.	G	R <sup>2</sup>	Decorated Brick, 4 stories with basement, 8 bays, brick, 1 main entry, I-shaped plan. GROUND STORY: Small porch carried on brick piers with stone bases is set before main entry; brick coursed to form horizontal bands; rectangular windows with stone sills and lintels. 2nd-4th STORIES: Rectangular windows with stone sills and lintels with keystone; all windows with 1/1 sash; brick pilasters with stone bases divide facade into sections of 2 bays each; pilasters form turrets above roofline; decorative brick band above 4th story windows.	Contact: 244/29

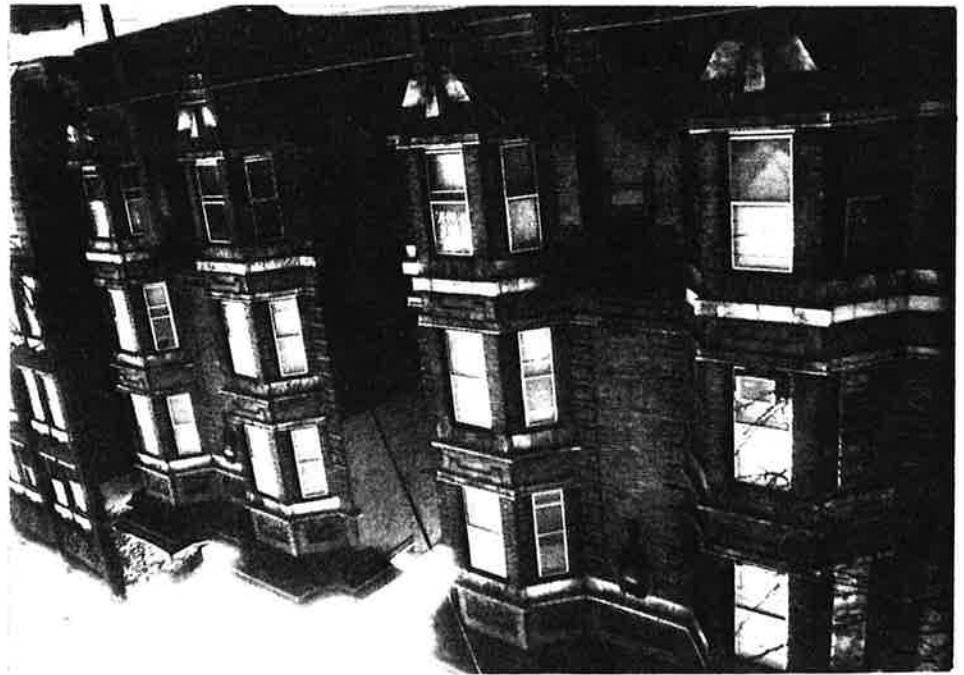
Site No. 0906-D6 og  
108-110 Ogden Ave.  
Jersey City, N.J.  
Photo Neg. No. 244/28  
Map No. 2  
(bet. 1896-1908)

2.	108-110 Ogden Avenue Block: 723 (Contact: 244/28,30)	Between 1896- 1908	P Dist.	G/ E	R <sup>2</sup>	2 matching Italianate Variant buildings, 3 story with basement, brick, each with 1 main entry and rectangular plan. Main entries with bracketed stone overdoors; each entry flanked by tripartite projecting bay rising height of building; rectangular windows with 1/1 sash and continuous stone lintels and sills; cartouche on 3rd story above entry; decorative panelling above 3rd story windows; bracketed cornice with dentils; intricate metal railings down steps and along sidewalk.	Contact: 244/28,30

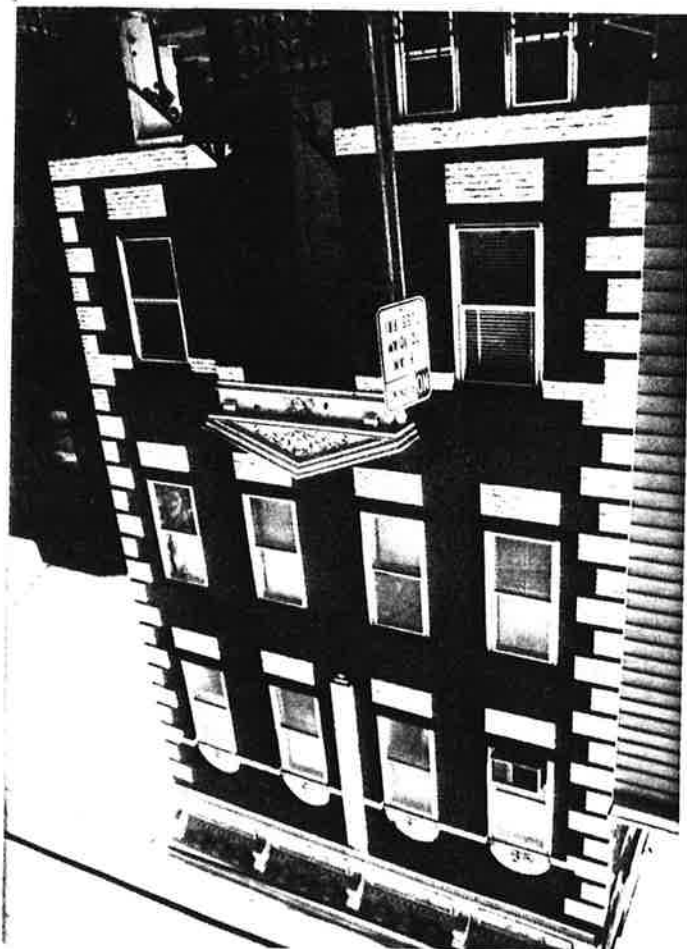
Site No. 0906-D609  
 120 Opden Avenue  
 Jersey City, N.J.  
 Photo Neg. No. 244/26  
 Map No. 4  
 (bet. 1887-1896)

4.	120 Ogden Avenue Block: 723 (Contact: 244/26)	Between 1887- 1896	P Dist.	E	R <sup>2</sup>	Italianate Variant, 3 stories, frame, 1 main entry, rectangular plan with rear extension. Porch with bracketed pent roof is set on turned posts before main entry; entry flanked by 2 bay projections rising height of building; rectangular windows with 1/1 sash; bracketed pent roofs above each story of projections; building terminates in continuous bracketed pent roof with modillions and swag decorated frieze. Building has been resurfaced.	Contact: 244/26

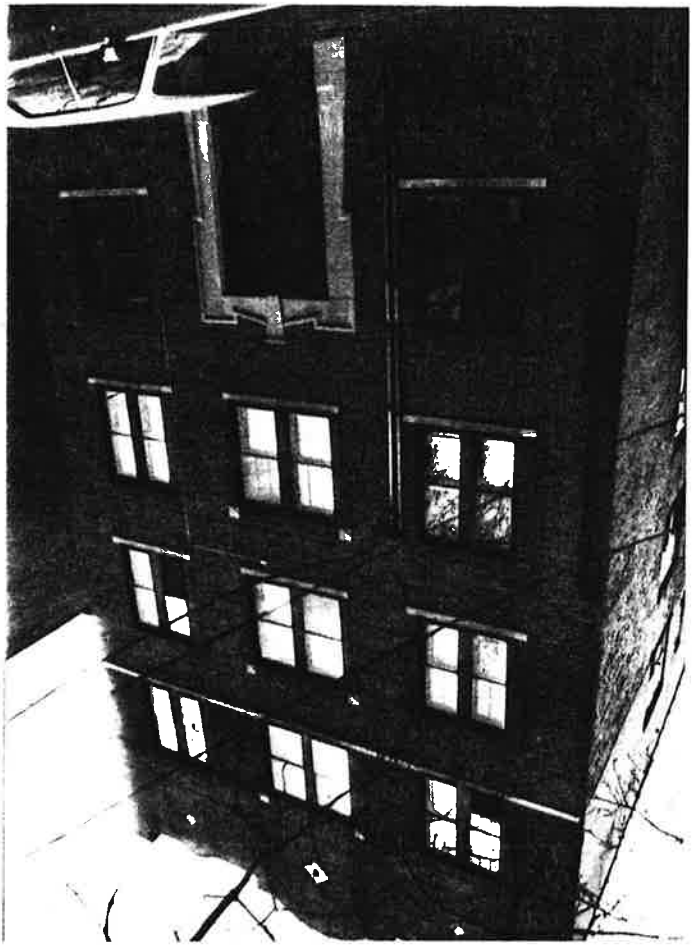
Site No. 0906 - D6 og  
 163-165 Ogden Ave.  
 Jersey City, N.J.  
 Photo Neg. No. 244/21  
 Map No. 9  
 (bat. 1887-1896)

9.	163-165 Ogden Avenue Block: 739 (Contact: 244/21)	Between 1887- 1896	P Dist.	G	C/R	Italianate, 2 stories, brick, 2 entries, rectangular plan. GROUND STORY: Excluding modern garage door, segmentally arched brick window and portal heads; windows with stone sills; stone belt course with brick dentils at top of story. 2nd STORY: Central triple window: long central window with bracketed triangular pedimented head flanked by windows with bracketed cornice heads; remaining single windows with bracketed triangular pedimented heads; all windows rectangular with 1/1 sash; stone belt course forms continuous sill. Area between 2nd story windows and roof line has been covered with modern siding.	Contact: 244/21

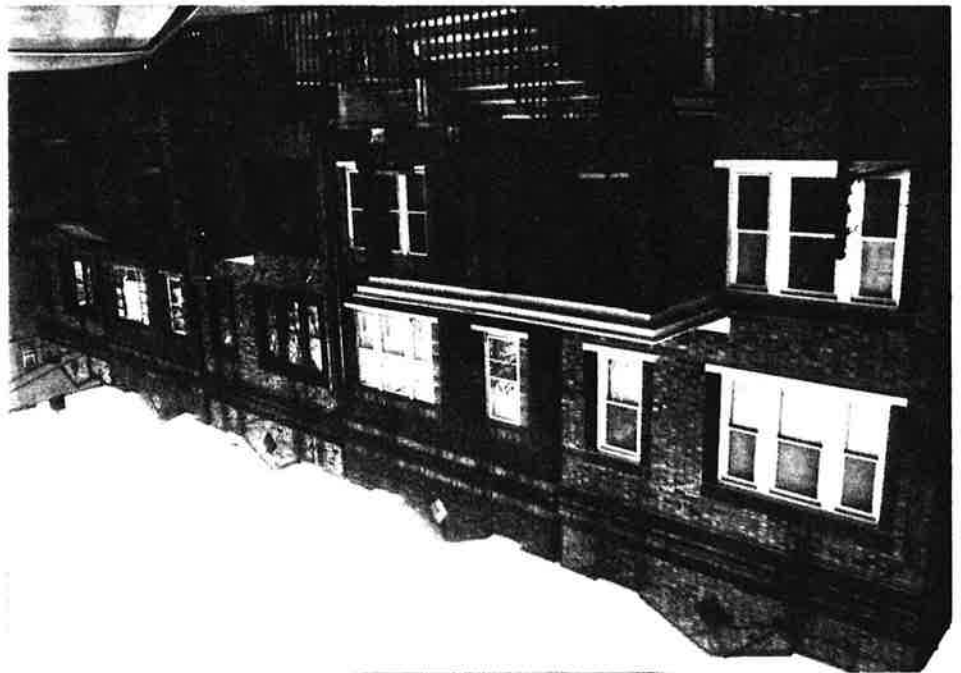
Site No. 0906 - D6 og  
 164 Ogden Avenue  
 Belvedere Apartments  
 Jersey City, N.J.  
 Photo Neg. No. 244/22  
 Map No. 10  
 (bat. 1919-1928)

10.	164 Ogden Avenue Belvedere Apartments Block: 740 (Contact: 244/22)	Between 1919- 1928	P Dist.	G	R <sup>2</sup>	Decorated Brick, 4 stories with basement, 3 bays, brick, 1 main entry, rectangular plan. Main entry with stone surround; double windows with 3/1 or 2/1 sash and continuous stone sills; curvilinear brick parapet.	Contact: 244/22
