Audubon Avenue in State College Neighborhood of Survey Area (Ward B3), NJ HSI: 0906, Jersey City, Hudson County

NEW JERSEY OFFICE OF CULTURAL AND ENVIRONMENTAL SERVICES
HISTORIC PRESERVATION SECTION
DISTRICT/STREETSCAPE CONTINUATION SHEET

N.J. HISTORIC SITES INVENTORY

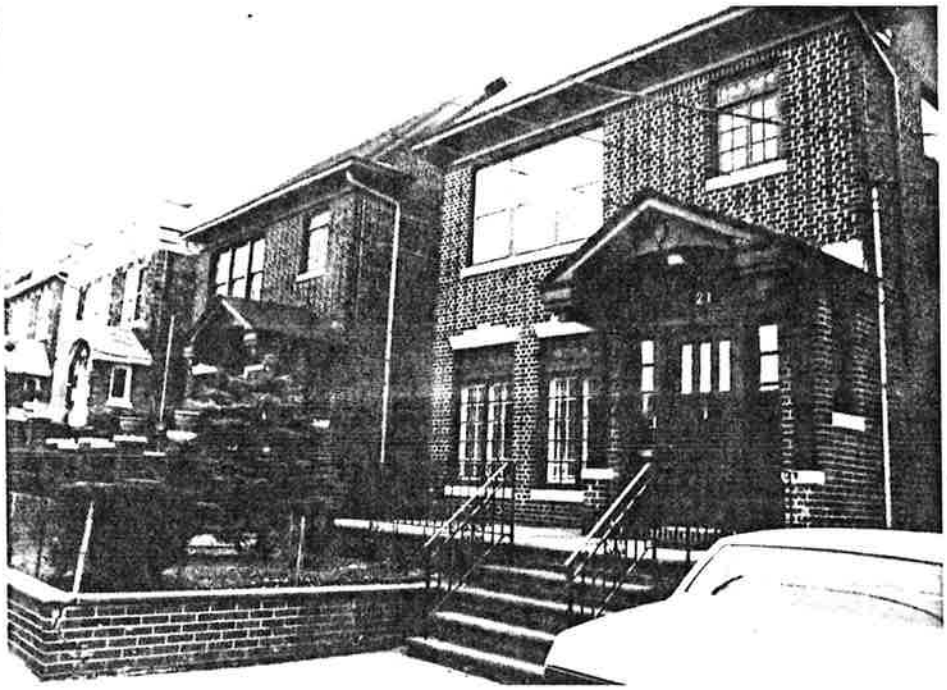
Site No. 0906-B3bro
21-15 Broadman Parkway
Jersey City, N.J
Photo Neg. No. 228/14
Map No. 2

2.	21-15 Broadman Parkway Block/1300 A	c 1920's	P Prairie Style Theme	E	R	Prairie Style, recessed rectangular plan with side entry; 2 stories, 2 bays; brick buildings, multi-lighted windows; gabled roofs, architraved and modillioned cornice dormer windows atop roof of #15 and #17, gabled porch roofs or overdoor, wooden pilasters exist on buildings exterior stone lintels and sills on these particular buildings; concrete and brick stoops and porches lead up to single wooden entry doors; side lights flank each entry door; above each door is a semicircular transom light; buildings are in excellent condition; no visivle alterations.	Contact 228/14

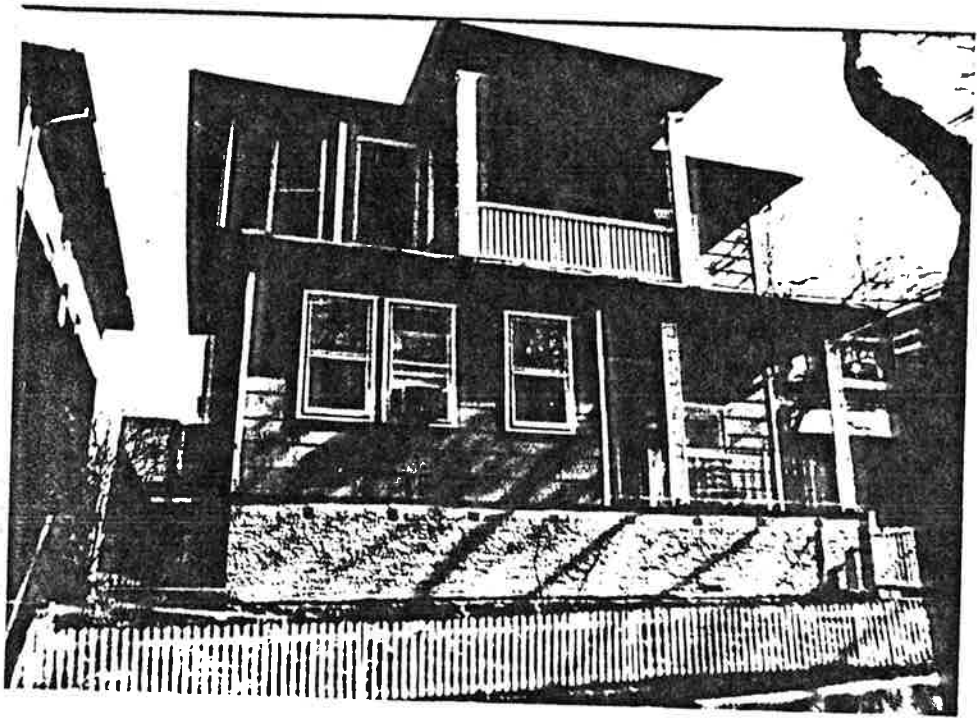
Map No. 1

AP #	ADDRESS/LOCATION : PROPERTY NAME	DATE	Significance to D/S	Condition	USE	DESCRIPTION: Style, Ext. Wall Fabric, Fenestration, Form, Roof, Major Features, Alterations, Stories, etc.	NEGATIVE FILE #
1,2	270,272,274 Fulton Avenue Block 1281	c1920's	P theme	G	R[1]	Classical Revival; frame; shingle; 9 over 1 ; detached 2 1/2 story residences; similar, symmetrical arrangement, with full front porches with flat roofs, supported by Ionic columns or square columns (at # 270); central dormer at # 272, central second story balconies at # 270 and 274 (where balcony has been enclosed); entry through glazed double-doors; homes are on inclined sites and have terraced front yards; # 270 has partially-enclosed front porch.	Contact 228/33-32
3	309-311 Fulton Avenue	Early 20th Cent.	P	G	R	2 story, attic, basement, wood frame; Period style (Early American Revival); shed roof, gambrel pediment, 2 stor projecting porch on columns; projecting side bay; 6 step stoop; set back; detached.	Contact

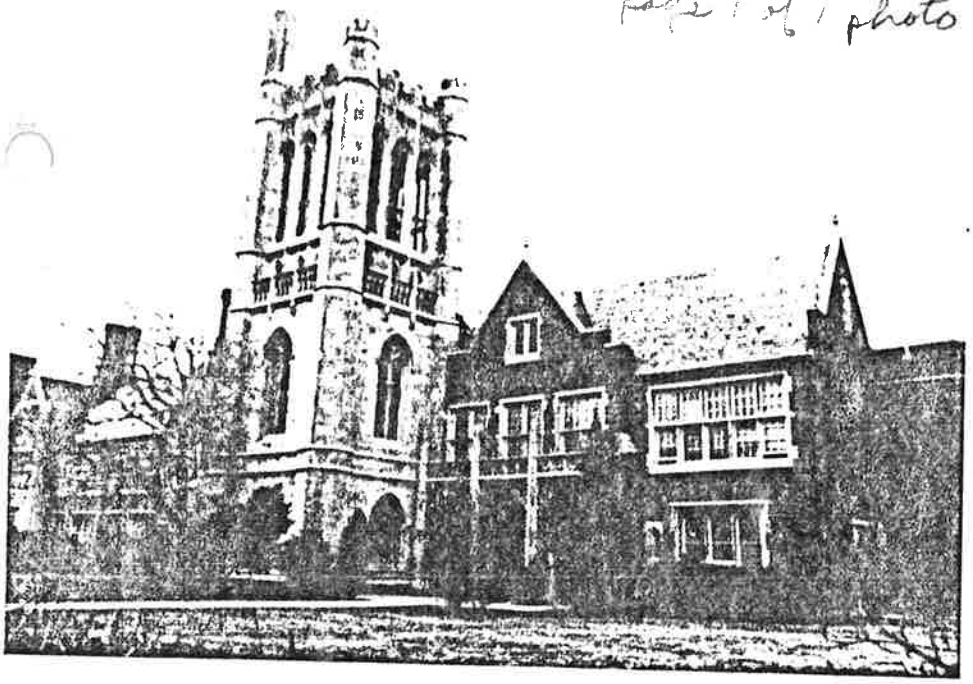
Map 1
Jersey City State College
2051-2057
contact 228/17

MAP #	ADDRESS/LOCATION : PROPERTY NAME	DATE	Significance to D/S	Condition	USE	DESCRIPTION: Style, Ext. Wall Fabric, Fenestration, Form, Roof, Major Features, Alterations, Stories, etc.	NEGATIVE FILE #
1.	JerseyCity State College 2051-2057 Kennedy Blvd.	1929	Y 1920's Theme	G	E	2 1/2 - 3 1/2 story, brick and stone, Beaux Arts/Gothic College. 8 bays, of a series of banks of casement windows of 9/9. Pitched roof (tile) pointed arches over main entrance and over openings of campanile. These are the main buildings of a larger campus built 1963-1974.	Contact 228/17, 19,21

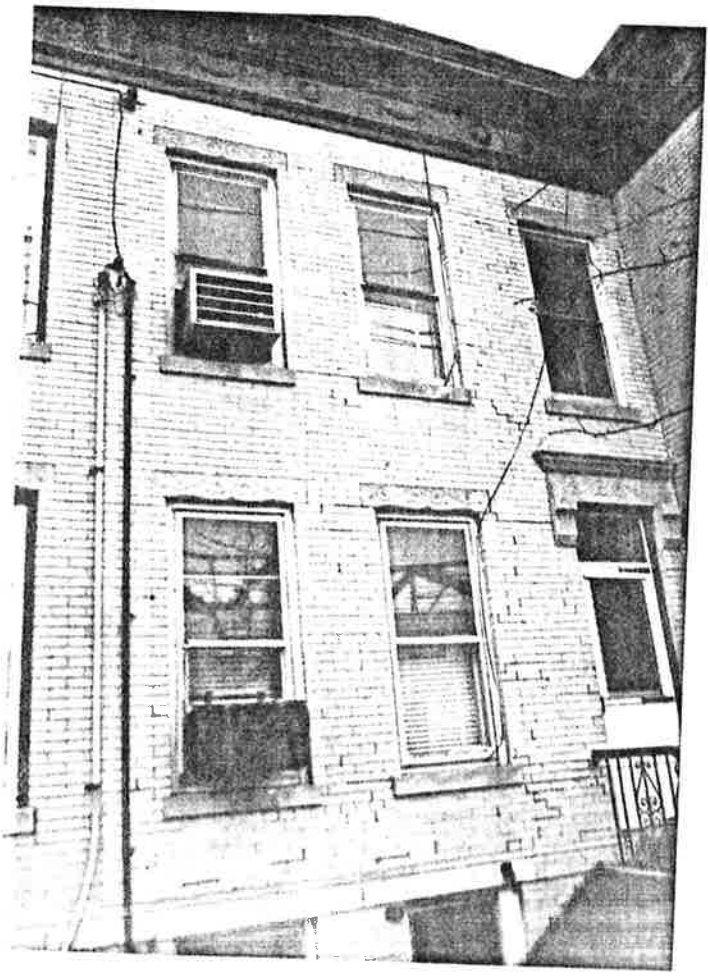
Site No. 0906-B3ws
130 West Side
Avenue
Jersey City, N.J.
Photo Neg. No. 228/3
Map No. 1

1.	130 WEst Side Avenue Block/1280A NE corner Armstrong Ave. looking north "O'Day's PUB"	late 19th cent. - early 20th cent	N	F	C/R	Italianate, recessed rectangular plans with corner and side entries, 2 stories, 4 bays, (Armstgrng Avenue) 4 bays (West Side Avenue), brick building, 1/1 wood double hung sash window treatment, shed roof with architraved wooden cornice. gar;amd amd rosette, moldings on frieze, stone lintels and sills, 1st story tavern, single wooden entry doors serves as entries, brick chimney atop roof, projecting 2nd story corner bay, moderate alterations.	Contact 228/3

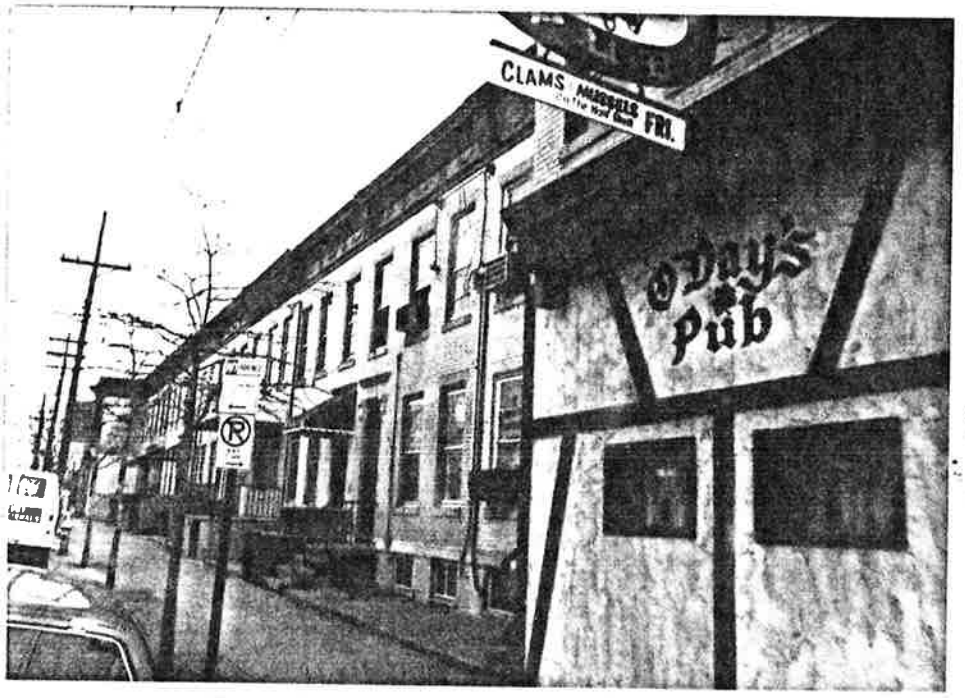
Site No. 0906-B3 WS
132-148 West Side Avenue
Jersey City, N.J.
Photo Neg. No. 228/4
Map No. 2

2.	132-148 West Side Avenue Block/1280A Looking North	late 19th - early 20th cents.	P Theme	G	R	Italianate, recessed rectangular plan with side entry, 2 stories, 3 bays, brick buildings, 1/1 wood double hung sash window treatment, shed roofs with architraved wooden cornice, garland and rosette moldings adorn frieze, stone lintels and sills, stone water table; stone overdoors, concrete stoops with iron railings lead up to single wooden entry doors with aluminum storm door in front; some buildings in row have aluminum awnings above entry doors, casement windows situated at basement levels, minor alterations.	Contact 228/4

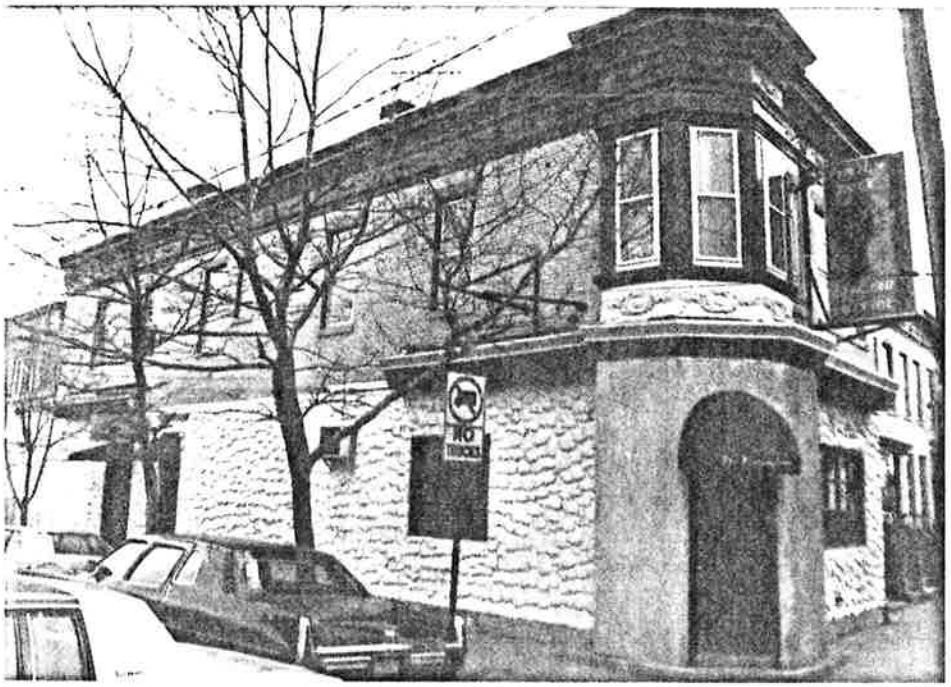
Site No. 0906-B3 WS
150 West Side Avenue
Jersey City, N.J.
Photo Neg. No. 228/6
Map No. 3

3.	150 West Side Avenue Block/11280A	late 19th - early 20th cents.	N	F	G/R	Italianate, recessed irregular rectangular plan with side and corner entry; 2 story multiple bay; brick exterior, 1st story resurfaced with stucco; 1/1 wood double hung sash windows on 2nd story; multi-lighted replacement windows on 1st story, flat roof with brick chimneys atop; architraved wooden cornice, garland and rosette moldings adorn frieze of cornice, concrete garland moldings atop 1st story corner entrance; a small cornice concealed by aluminim exist above corner entrance canvas canopies exist above all entries to building, a restaurant exist on 1st story level, single wooden entry doors, 3 in number provides access to the building.	Contact 228/6

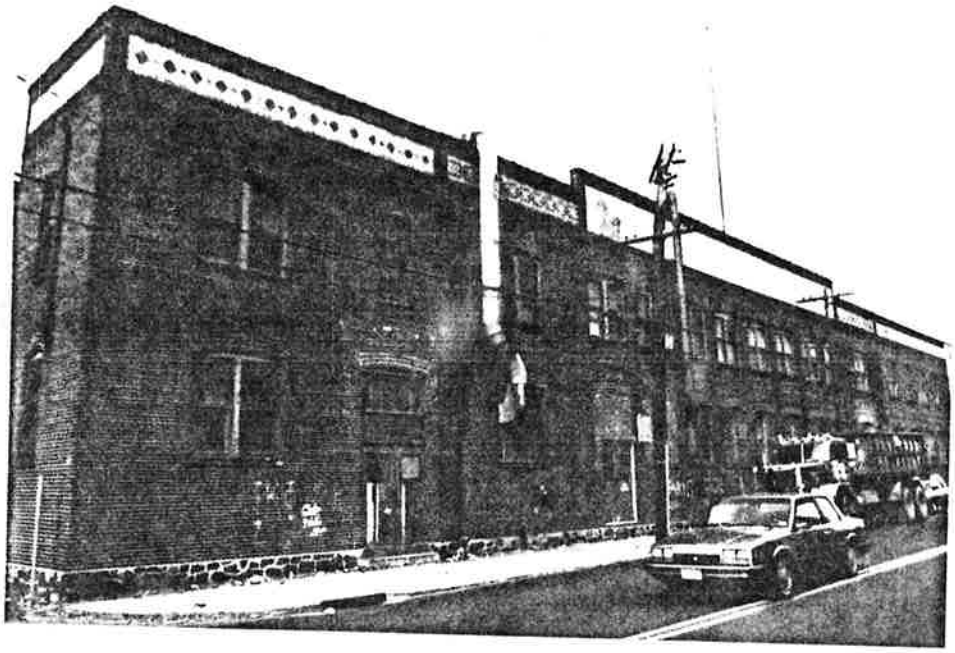
Site No. 0906-B3WS
155-165 West
Side Avenue
Jersey City, N.J
Photo Neg. No.
228/7

4.	155-165 West Side Avenue Block 1275. "Protex Home". (Accessories)	late 19th - early 20th cents.	N	F	C I	Utilitarian, recessed rectangular plan with numerous central locations on facade; brick factory building with 6/6, 6/1 and other multi-lighted window treatments; flat roof with brick parapet; terra cotta moldings just above 2nd story, 2 stories, numerous bays, double wooden and some double steel doors provide access to building; multi-lighted windows exist above some entry doors others are bricked-in; minor alterations.	Contact 228/7

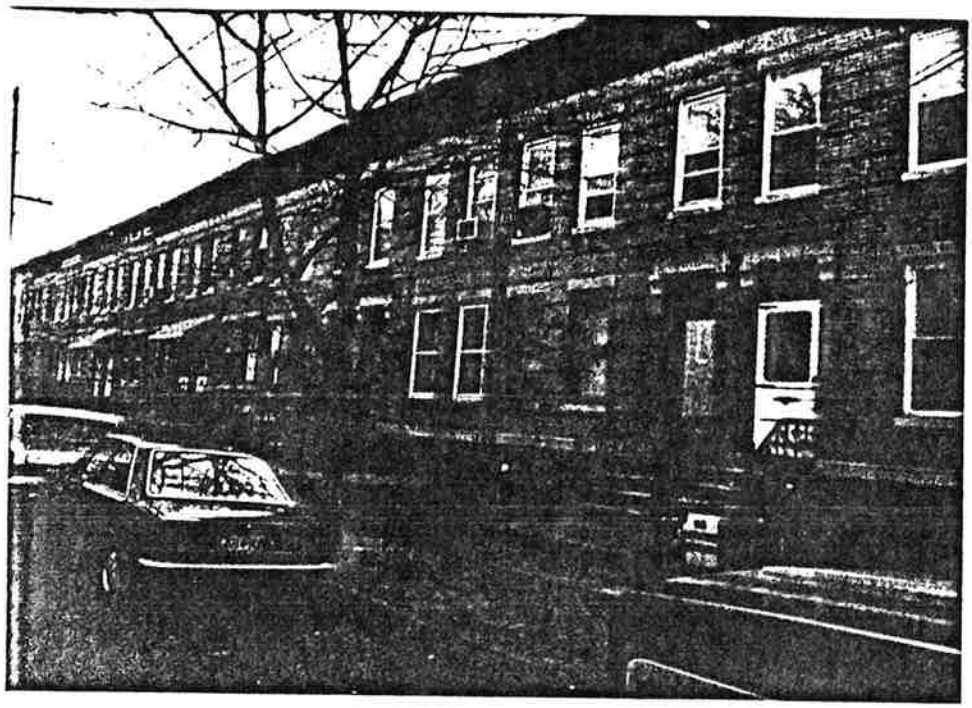
Map No. 1

MAP #	ADDRESS/LOCATION : PROPERTY NAME	DATE	Significance to D/S	Condition	USE	DESCRIPTION: Style, Ext. Wall Fabric, Fenestration, Form, Roof, Major Features, Alterations, Stories, etc.	NEGATIVE FILE #
1-2	389-407 Woodlawn Avenue (Block 1280a)	late 19th – early 20th cents.	P theme	G	R[1]	Streetscape: Classical Revival; light brick; 1 over 1 windows; flat roofs, row-houses; 2 stories, 3 bays wide, with tin cornices (continuous) with Adamsesque wreaths and festoons, window and door lintels are of a light stone with incised ornament; door lintels and every 3 bays at cornice level have consoles; brick of facades is laid with recessed horizontal bandcourses at every 6th course, giving effect of rustication; stone watertable and entry set atop low stoops, with iron newell posts and cast iron curvilinear railings complimenting lintel ornament; the entries are paired, i.e., each building has an individual entry, with its stoop spanning the entry of the neighboring building; railings divide the entries; the alternation of entry placement produces a visually unified streetscape.	Contact 228/8, 10,9

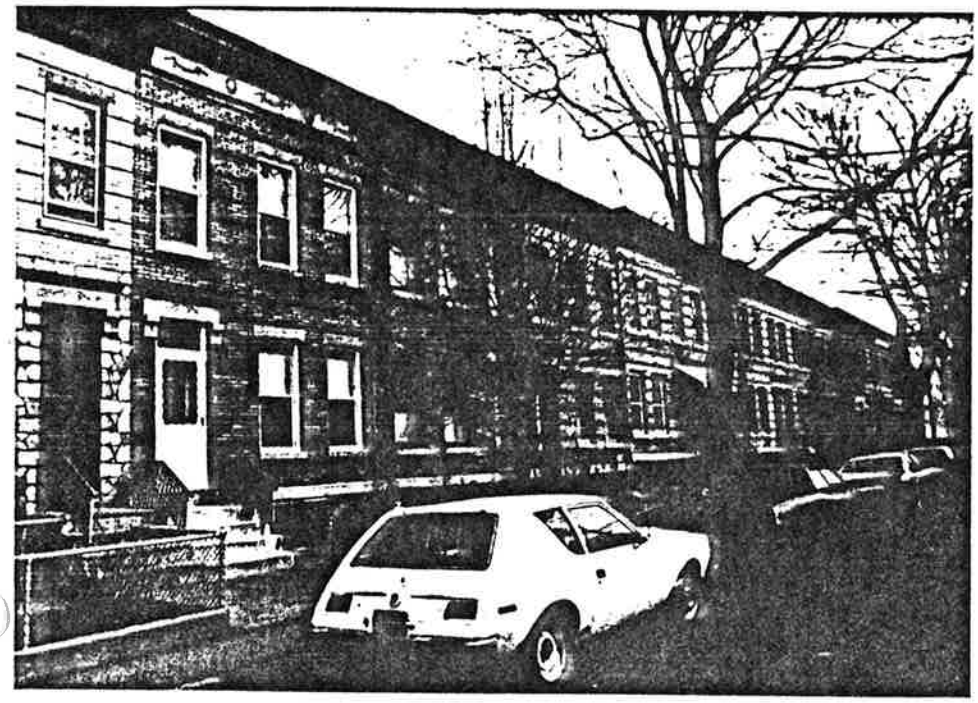
Map No. 3

3	388-408 Woodlawn Avenue (Block 1281b)	late 19th – early 20th cents.
