LINCOLN PARK NEIGHBORHOOD OF SURVEY

BELMONT AVENUE IN LINCOLN PARK NEIGHBORHOOD OF SURVEY AREA (WARD) B

NEW JERSEY OFFICE OF CULTURAL AND ENVIRONMENTAL SERVICES
HISTORIC PRESERVATION SECTION
DISTRICT/STREETSCAPE CONTINUATION SHEET

N.J. HISTORIC SITES INVENTORY

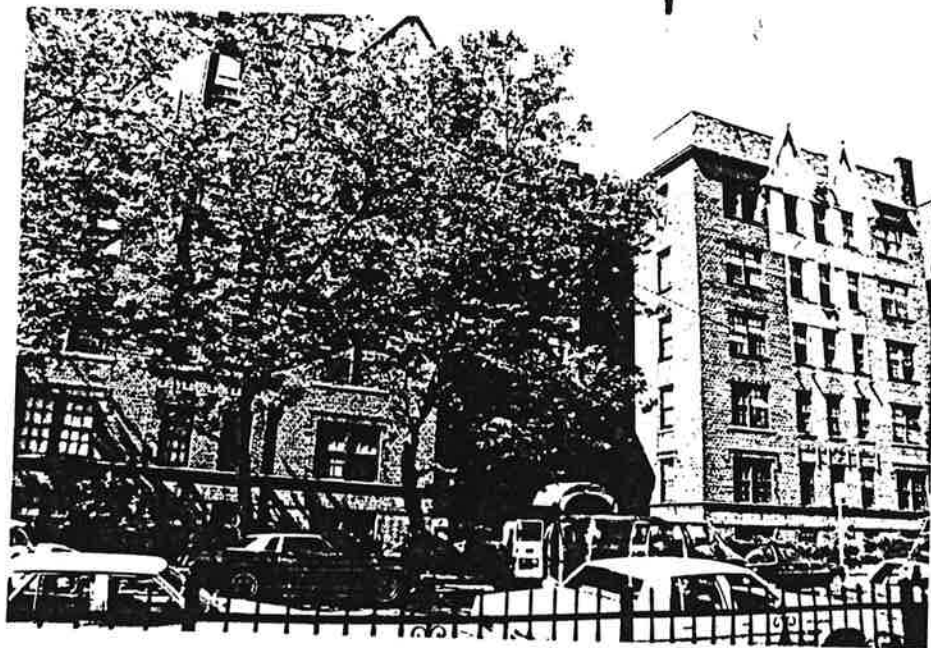
Map No. 1

MAP #	ADDRESS/LOCATION : PROPERTY NAME	DATE	Signifi- cance to D/S	Condition	USE	NEGATIVE FILE #
1.	135 Belmont Avenue (SW corner Bergen Avenue) Block: 1816 "Royal Apartments" (WBHD)	c1910	Y Dist.	E R ²	Proto-Moderne/Patterned Brick Apartment with Elizabethan Style motifs; brick walls, concrete, metal, terra cotta or stucco; 3 bays: 6/6; "E" form; flat; basement plus 5 stories. Deeply recessed central entrance courtyard, replacement door. Patterned brick work forms lintels and designs around windows. Sections of timbering simulated by stucco or terra cotta and brick work and end in gablets in parapet area. Slate facing on parapet.	203/24
2	140-Belmont Avenue Block 1819	1872	Y theme	G O	Emory Methodist Episcopal Church Sunday School; Gothic Revival; brick; arched and rectangular windows; rectangular plan; roof with central, 3 story high round dome; main entry set within a 2 story high arch, with glazing at second story level; peaked gable end over entry bay with corbelled brick under parapet, extending to outer bays, which have arched windows at second story level and rectangular windows at first story level; 2 1/2 stories, plus high basement. Originally used as church, until 1905.	Contact 204/7A

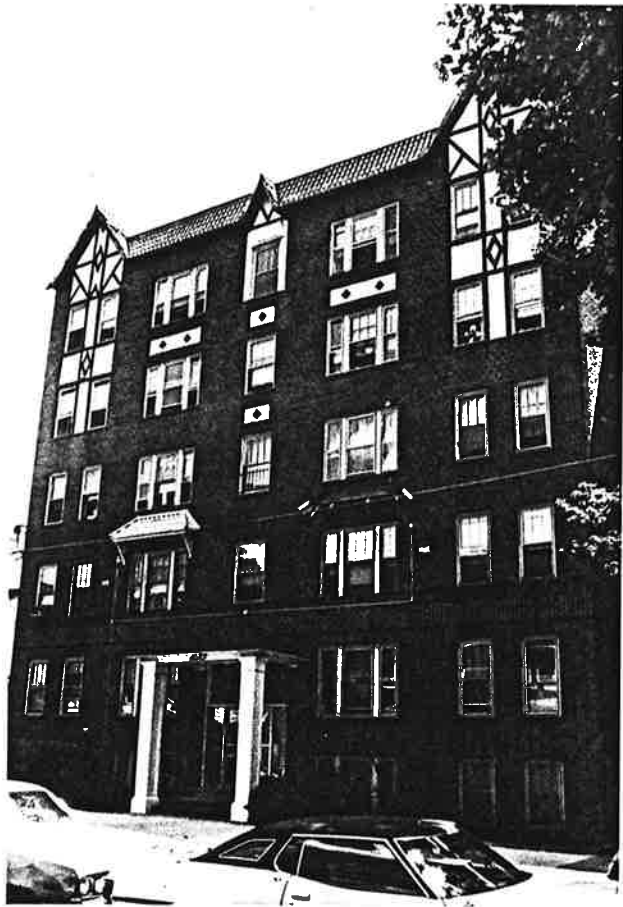
Site #0906-B5 Len
27-29 Bentley Ave.
Bentley Arms Apartments
Photo Neg. 202/19A
Map #4

4.	27-29 Bentley Avenue Block: 1810 Bentley Arms Apartments (WBHD)	c1910- c1930	Y Dist.	E	R2	Proto-Moderne/Pattern Brick Apartments with Elizabethan Timbering motifs; brick walls, stucco tiles; 5: 6/1; rectangular; flat; basement plus 5 story. 1 bay entrance porch with square piers. Replacement door. 2 side simplified pavilions with stucco and brick timbering and gablets.	202/19a

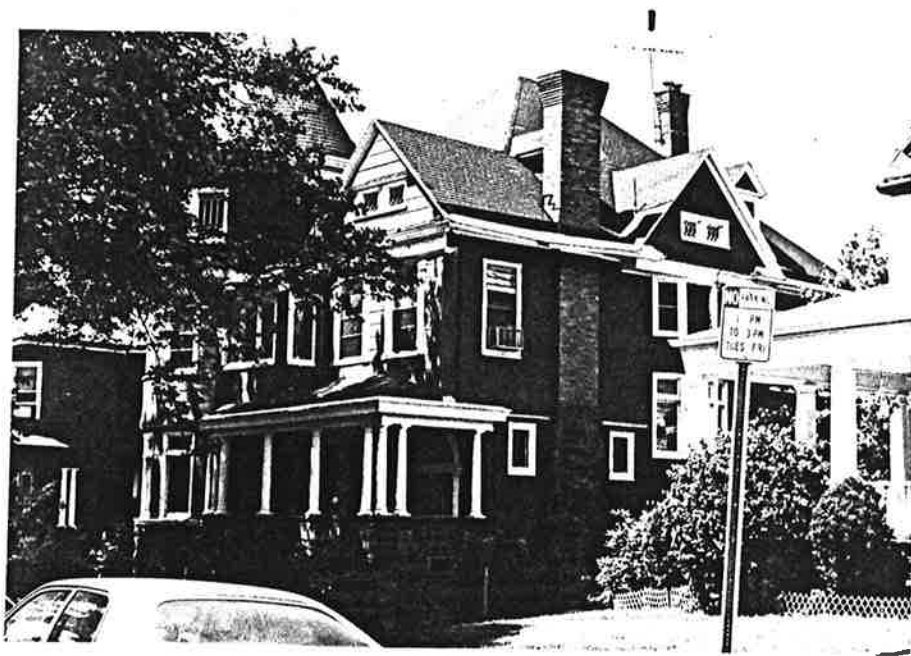
Photo Neg. 202/224
Map # 7

7.	34 Bentley Avenue Block: 1815 (WBHD)	<i>late</i> <i>19th</i> <i>early</i> <i>20th</i> <i>cont</i>	Y Dist.	E Dist.	R		Queen Anne; frame, wood shingles; 3 bays: 1/1; basically rectangular with large round corner tower on west side of facade; hipped; 2½. 3 bay porch with plain round columns on solid rusticated stone base. Early door with arched molding of fanlight supported by pilasters. Large round tower has conical roof. Lattice windows in gablet ends. Retains early chimneys.	202/22a

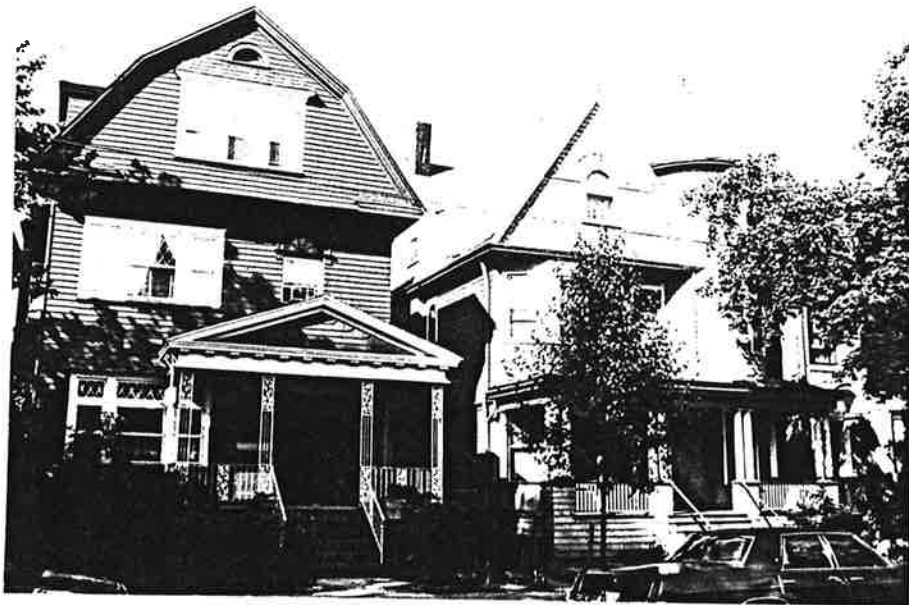
left: 39 Bentley Ave.

9.	39 Bentley Avenue Block: 1810 (WBHD)	<i>late</i> <i>19th</i> <i>early</i> <i>20th</i> <i>cont</i>	Y Dist.	E Dist.	R		Queen Anne; frame, wood shingle; 2 bay: variable sash, lattice or diamond/1, etc.; rectangular; flat with facade gambrel; 3 bay porch with replacement posts early pediment with exposed eaves, brelette has paired brackets. Palladian window and lunette in gambrel end. altered.	203/1

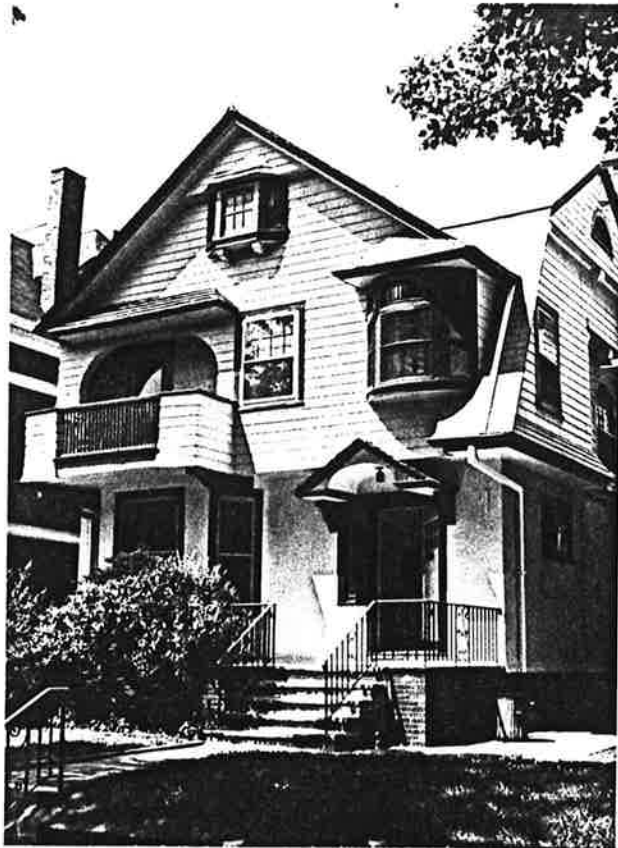
100 Bentley Ave.

23.	100 Bentley Avenue Block: 1814 (WBHD)	<i>late 19th - early 20th cents</i>	Y Dist.	E	R	Queen Anne; frame, replacement stucco. 1st story, wood shingles; 2-3 bays: variable; rectangular; gambrel with facade gable; 2 $\frac{1}{2}$. Replacement stoop and railing. 2nd story has porch and oriel window.	202/28a

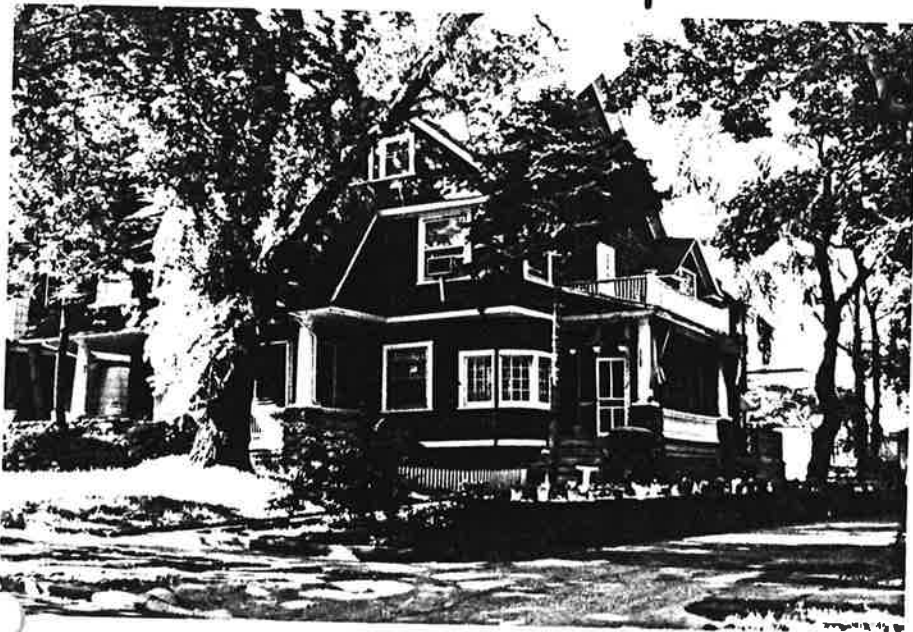
115-117 Bentley Ave.

26.	115-117 Bentley Avenue Block: 1811 (WBHD)	<i>late 19th - early 20th</i>	Y Dist.	E Dist.	D	D	Shingle Style; frame, wood shingles; irregular; basically rectangular; gable; 2½. 3 bay porch with round columns on stone pylons, also porch and separate entrance on west side of house. Rubble stone foundation. This house with it's characteristic shingle siding, irregular form and fenestration, and varied roof lines, is a handsome example of the Shingle style in Jersey City.	203/10

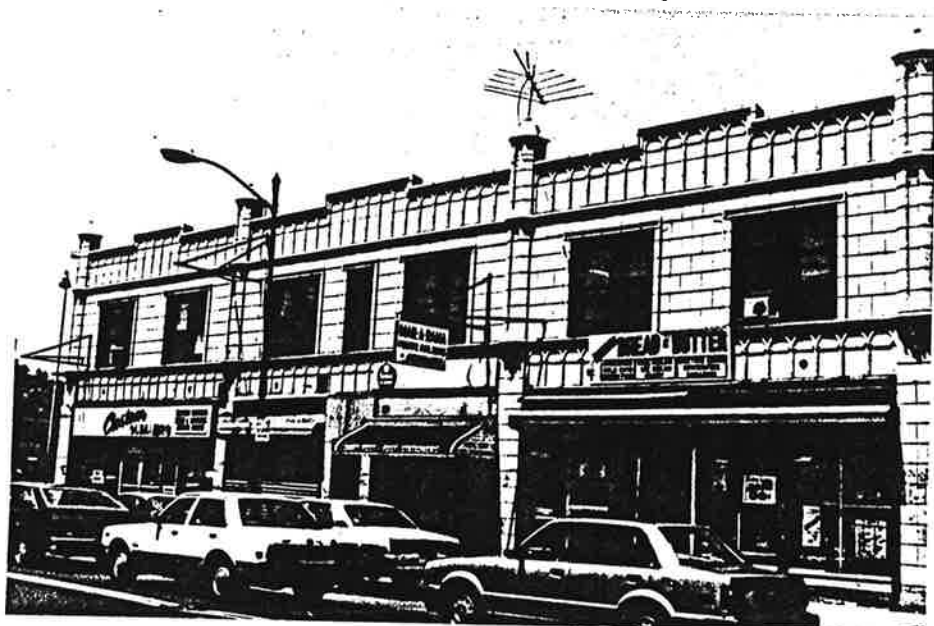
Map No. 1

MAP #	ADDRESS/LOCATION : PROPERTY NAME	DATE	Signif. D/S	Condition	USE	DESCRIPTION: Style, Ext. Wall Fabric, Fenestration, Form, Roof, Major Features, Alterations, Stories, etc.	NEGATIVE FILE #
1	519-529 Bergen Avenue Block	early 20th cent	P theme	G C		2 story, terracotta detached commercial building with Romanesque details in parapet, storefront cornice and piers; ground floor commercial, with severely altered storefronts; second floor has 7 bays with 1 over 1 windows in pairs, and singly at center of grouping; effect of terracotta facade resembles that of ashlar.	Contact 200/29A
2	531-533 Bergen Avenue Block	1928	Y theme	G C		2 story semi-detached corner building of the Provident Institution for Savings (inscribed in frieze); with 3 bays on Bergen; exterior rusticated limestone; Classical Revival bank building with central, monumental entry, flanked by pilasters with Composite capitals; to either side of the entry are large, fixed frame windows with full enframements and architraves; above frieze is an unornamented cornice.	Contact 200/28A

519-529 Bergen Ave.

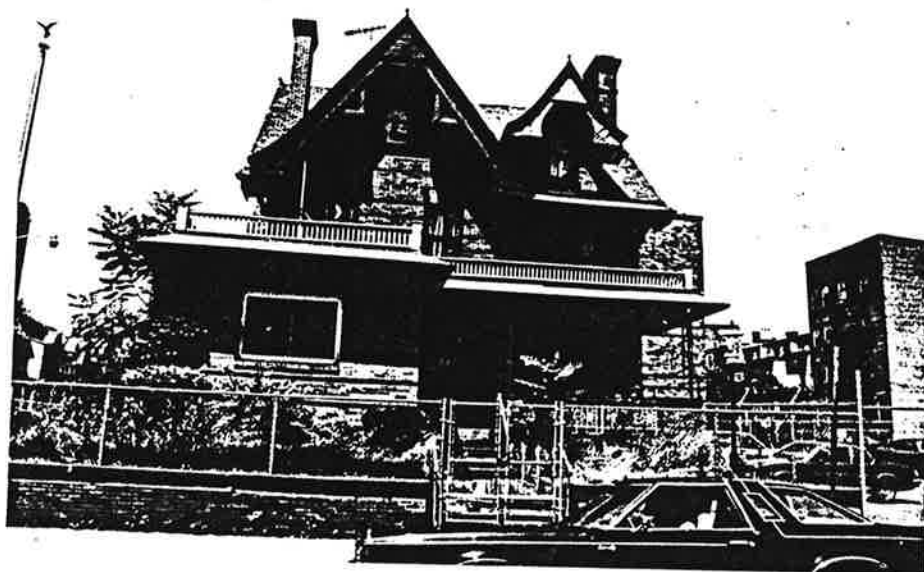
Map No. 3

3-	535-543 Bergen Avenue	late 19th cent	P theme	G C		Now in commercial use, this building appears to have originally been a residence; 2 1/2 story, brick detached Queen Anne structure with peaked roof pierced by peaked gable and peaked dormer, both with stylized vergeboards; brick band-coursing on first and second stories; 1 over 1 windows; 2 prominent chimneys; recessed main entry with second story roof deck overhang; Japanese-inspired metal cresting at ridges of dormer, gable and roof; brick retaining wall surrounds raised site; side street has main entry.	Contact 200/25A- 24A
4	Block	early 20th cent

535-543 Bergen Ave.

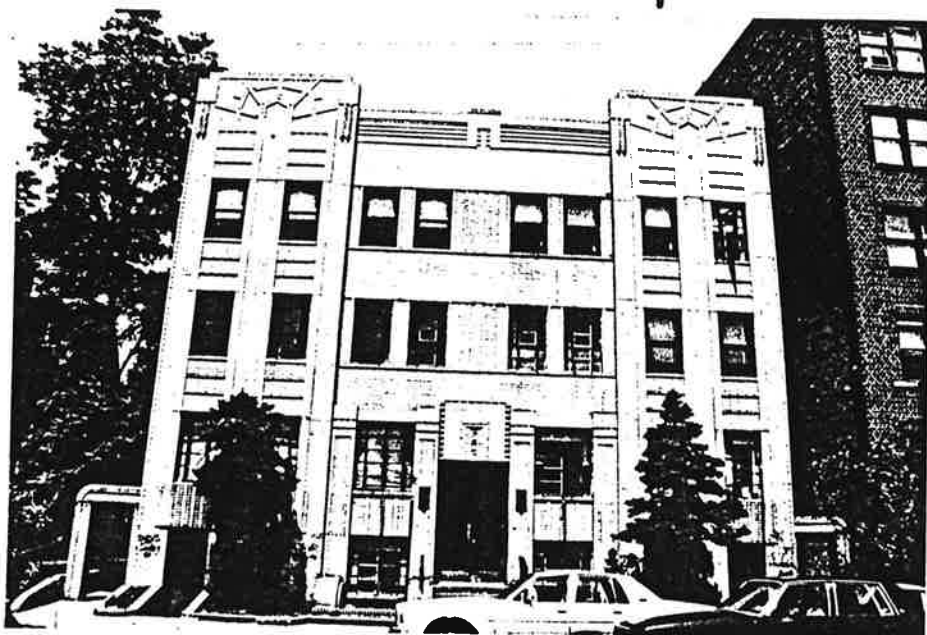
Map No. 5

MAP #	ADDRESS/LOCATION : PROPERTY NAME	DATE	Sign to D/S	Condition	USE	DESCRIPTION: Style, Ext. Wall Fabric, Fenestration, Form, Roof, Major Features, Alterations, Stories, etc.	NEGATIVE FILE #
5	585 Bergen Avenue Block	1930	P theme	G	R	3 story, detached, light brick Art Deco apartment house, with central entry, and use of brick for surface ornamentation, most noteworthy as panelled pilasters flanking entry, and in ground floor window bays, and in spandrels and parapet, where the end bays are surmounted by a geometric radiating pattern; casement windows with fixed sidelights and transoms with an almost equal number of windows replaced by 1 over 1 infill.	Contact 200/19A
6	597-603 Bergen Avenue Block	1904 corner-stone	Y theme	G T		Now the Metropolitan African Methodist Episcopal Zion Church, originally built as Emory Methodist Church; 2 1/2 story, 3 bay, light, rock-faced masonry Gothic Revival church with 3 1/2 story high square tower at south bay of facade; asymmetrical plan, with main entry through 3 equally-sized arched entries with pointed lintels, each surmounted by a stone finial; entry doors of wood with original metal strapwork; centered over entries, at second story level is an arched stained glass window with stone tracery; square bell tower features lancet windows and corner bartizan; hexagonal turret to south has smaller lancet windows, crenellated parapet and pointed, slate roof; central bay has peaked parapet; stone coping, 3 central lancet windows and central finial in middle bay. See # 140 Belmont Ave. for Romanesque Revival Sunday School. Present church site acquired in 1870. Since 1967, the A.M.E. Zion Church, org. in 1847.	Contact 15/20

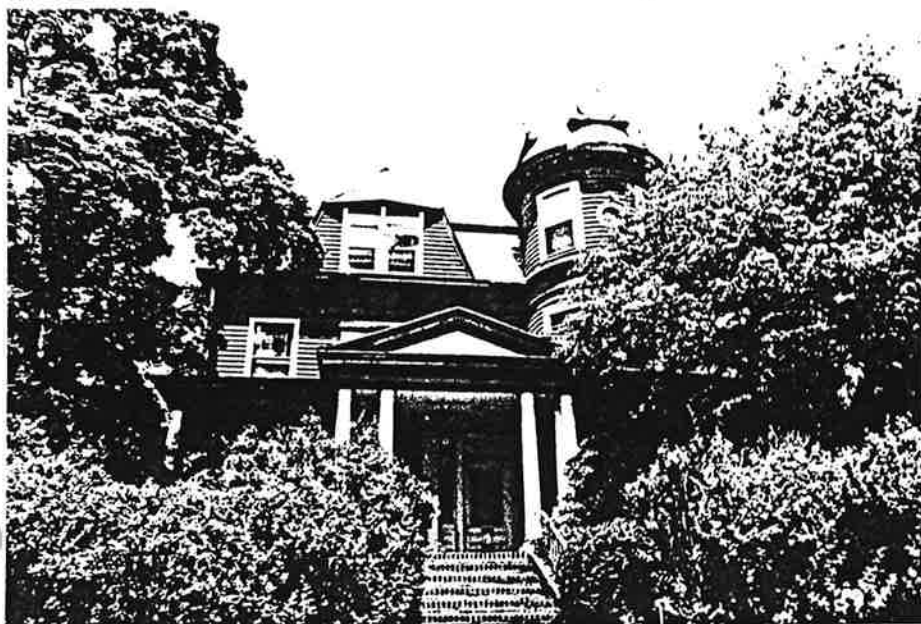
Map No. 7

MAP #	ADDRESS/LOCATION : PROPERTY NAME	DATE	Significance	Condition	USE	DESCRIPTION: Style, Ext. Wall Fabric, Fenestration, Form, Roof, Major Features, Alterations, Stories, etc.	NEGATIVE FILE #
7	613 Bergen Avenue Block	<i>late 19th - early 20th cents</i>	Y theme	G R ¹		3 story, detached, 3 bay Queen Anne residence with asymmetrical plan; central pedimented entry, supported by round wood columns in pairs; full front porch; 3 1/2 story high round turret with an acorn-shaped, shingled roof; gambrel-shaped gable at third story; 1 over 1 windows and smaller, round windows on turret; bracketed cornice; shingle exterior.	Contact 200/16A
8	617 Bergen Avenue Block	<i>late 19th cent</i>	Y theme	E R ¹		3 story, detached, 7 bay Queen Anne frame residence with asymmetrical plan; partial front porch with pedimented entry, supported by pairs of round wood columns; hipped roof pierced by central, gambrel-shaped gable in bay over entry and flanked by 2 dormers; a corner turret with conical roof reaching to 3 1/2 story level; a second, 2 1/2 story high tower is comparatively wider; exterior features shakes and fishscale shingles, stained glass, oval and round windows with elaborate wood enframements; denticulated cornice with swags in frieze, and roundels at secondstory level of turrets; shingle roofing; remarkably intact building of this type and style.	Contact 200/15A

613 Bergen Ave.

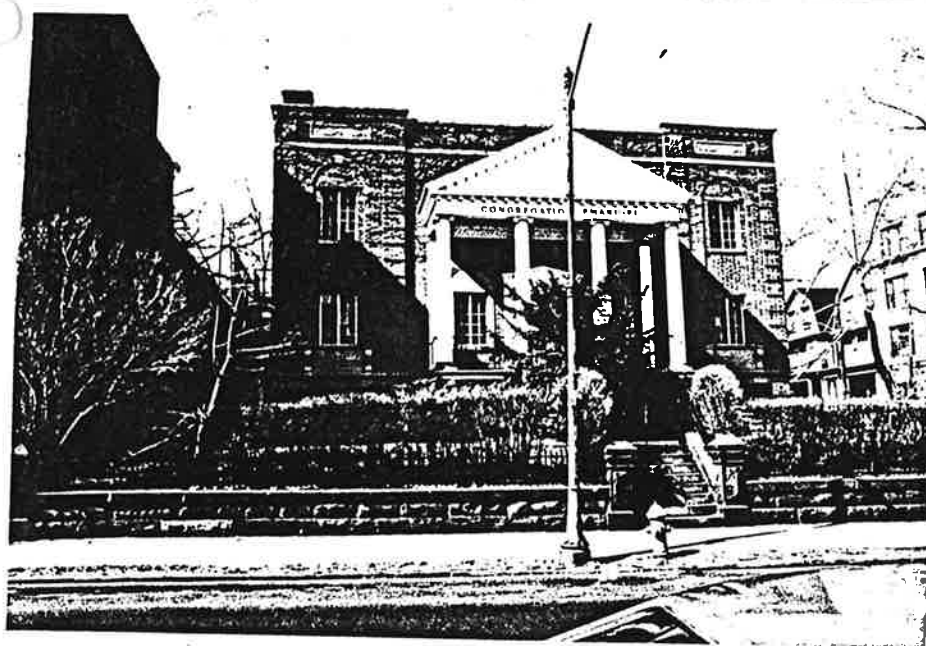
Map No. 9

MAP #	ADDRESS/LOCATION : PROPERTY NAME	DATE	Sign. to D/S	Condition	USE	NEGATIVE FILE #
9	633-635 Bergen Avenue Block	1948	P theme	G T	2 story, 3 bay, brick, detached Georgian Revival synagogue of Congregation Emanuel, central pediment supported by 6 Ionic columns, and with pedimented, recessed entry; entry bay flanked by window bays, with multi-paned casements; corner brick quoins; parapet has inset plaques with swags and limestone bandcourse below; rock-facade masonry retaining wall surrounds property.	Contact 15/29
10	637-641 Bergen Avenue Block AKA 118 Jewett Ave.	c1910- c1930	P theme	G R2	4 story, 5 bay, brick detached apartment house in the Classical Revival style, with limestone foundation, bandcourse, keystone on first story windows, and inset plaques at parapet; 1 over 1 windows in groups of 3 (may have had 3 and 6 over 1 pattern, as indicated by surviving sash); central, recessed entry. "Marble Court" flats.	Contact 200/12A

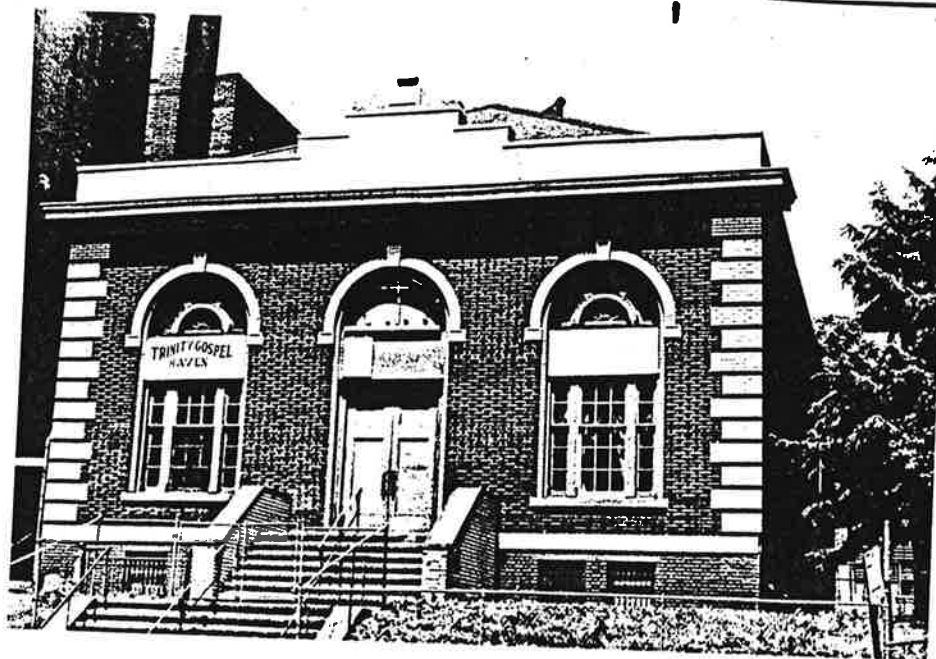
Map No.12

P #	ADDRESS/LOCATION : PROPERTY NAME	DATE	Significance	Condition	USE	DESCRIPTION: Style, Ext. Wall Fabric, Fenestration, Form, Roof, Major Features, Alterations, Stories, etc.	NEGATIVE FILE #
12	651 Bergen Avenue Block	<i>early 20th cent</i>	Y theme	G	0	2 story, 3 bay, detached, Georgian Revival Bergen Lyceum; brick exterior; pyramidal roof; central, arched entry with double doors, set atop an elevated site, and flanked by 2 arched window bays of equal height, each with central, 9 over 9 windows flanked by 3 over 3 windows, surmounted by fanlights; brick soldier-coursing of arched lintels, keystone and impost blocks, and water table in contrasting light color to facade brick; limestone parapet has central, stepped pediment with finial at apex.	Contact 20/1
13	657-659 Bergen Avenue Block	<i>late 19th - early 20th cent</i>	P	G	0	3 story, detached, stucco over brick, Greek Revival Home for Aged Women; with 8 over 1 windows with continuous sills at third floor, stone cornice with modillions; entry through (aluminum) double doors with door hood, rectangular door enframingent, set-back entry; stepped parapet with limestone coping.	Contact 200/10A

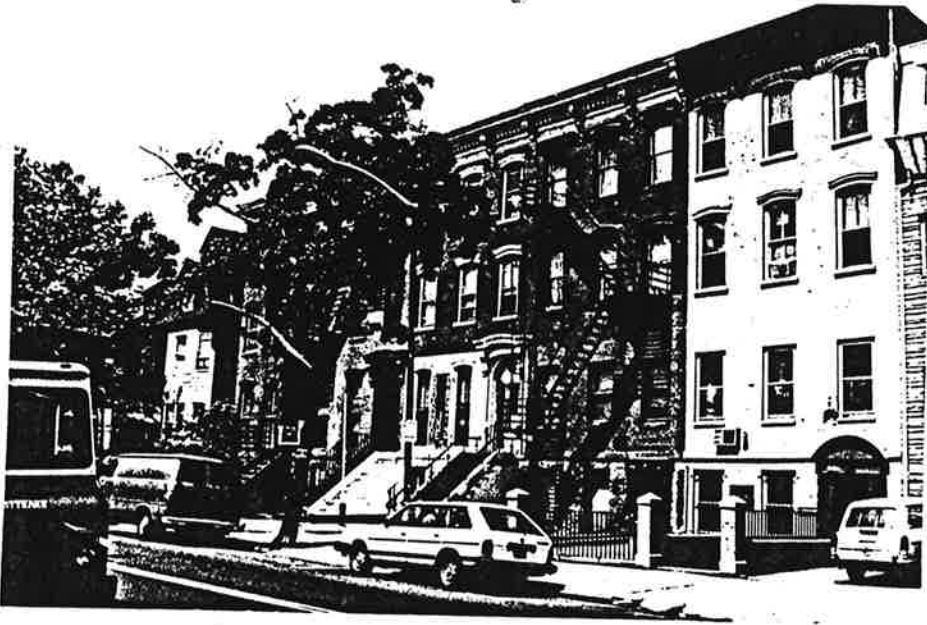
Map No. 14

14	673-681 Bergen Avenue Block	<i>late 19th cent</i>	P theme	F R2 /C		Series of 5, 3 story plus high basement 3 bay, brick Italianate rowhouses, with segmentally-arched lintels at windows and entries, some 2 over 2 windows surviving where not replaced by 1 over 1; high entry stoops survive at 675-677; entries have been removed to basement level at 679 and 681, where parlor floor windows have been shortened; continuous denticulated and bracketed cornices remain intact throughout grouping.	Contact 200/0A

673-681 Bergen Ave.

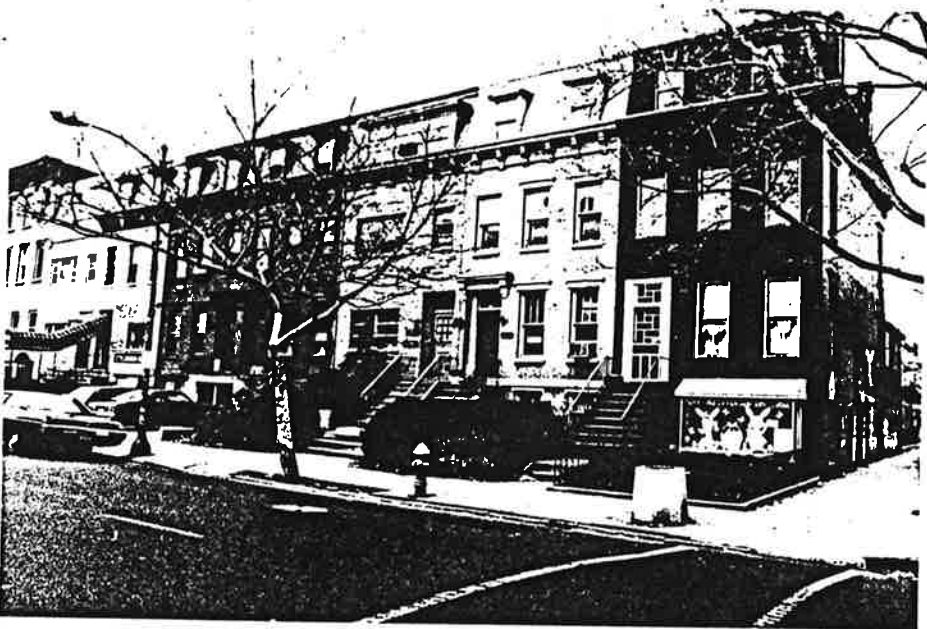
Map No. 15

MAP #	ADDRESS/LOCATION : PROPERTY NAME	DATE	to S/S	Condition	USE	DESCRIPTION: Style, Ext. Wall Fabric, Fenestration, Form, Roof, Major Features, Alterations, Stories, etc.	NEGATIVE FILE #
15	685-695 Bergen Avenue Block	19th cent	P G R ² theme			Series of 3 story, 3 bay, brick rowhouses with high basements, and mansard roofs, pierced by 2 dormers; entries paired to give mirror-image effect, however only # 687 and 689 are surviving examples; 3 over 1 windows survive where not replaced by 1 over 1 windows; continuous, bracketted cornice above second story level; window lintels with drip moldings remain in 3 of the buildings; landscaped front yards also survive at some sites; entry doors, stoop orientation, and surface of facades, shape of dormers have been altered as well.	Contact 35/37

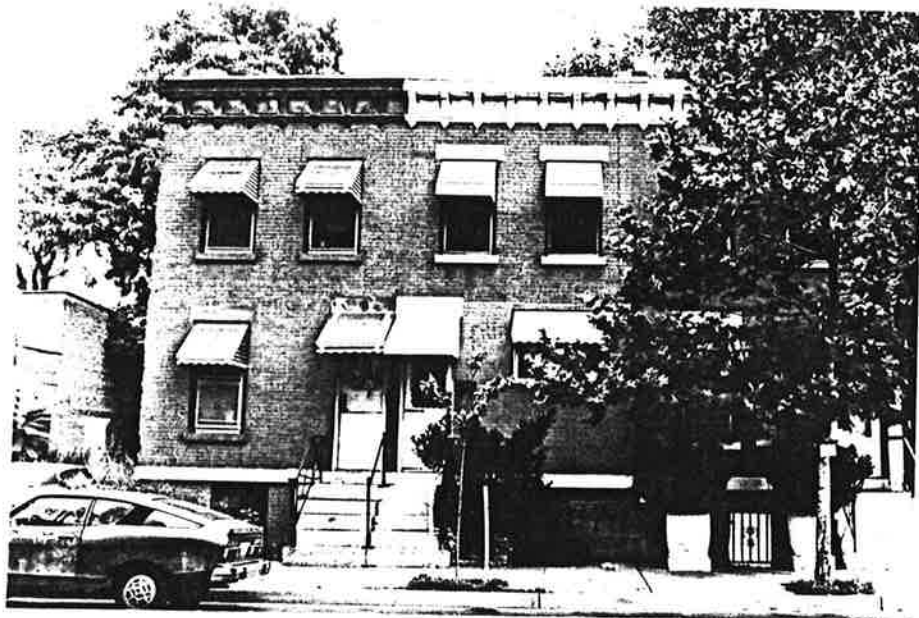
Map No. 1

MAP #	ADDRESS/LOCATION : PROPERTY NAME	DATE	Significance to D/S	Condition	USE	DESCRIPTION: Style, Ext. Wall Fabric, Fenestration, Form, Roof, Major Features, Alterations, Stories, etc.	NEGATIVE FILE #
1	682-686 Communipaw Avenue Block 1808	<i>late 19th - early 20th cent</i>	P theme	G R ¹		2 of a grouping of 3, 2 story, 2 bay Brick, Neo Grec rowhouses, with stone stoops, incised, foliate design in flush entry lintel, 1 over 1 windows, contiguous cornices with incised, stylized brackets, stone water table; alterations include raised parlor floor window and aluminum fixed awnings.	Contact 143/0
2-3	678-706 Communipaw Avenue Block 1808	<i>late 19th - early 20th cent</i>	NA	G U/ R ²		A series of 1 story brick garages, with # 704 a 2 story with high basement, 5 bay brick Greek Revival building, with central, main entry set atop an L-shaped (in plan) stoop); 1 over 1 aluminum replacement windows, wrought-iron railings simple unornamented cornice; set-back from building line.	Contact 143/4-3

682-686 Communipaw Ave.
Block 1808

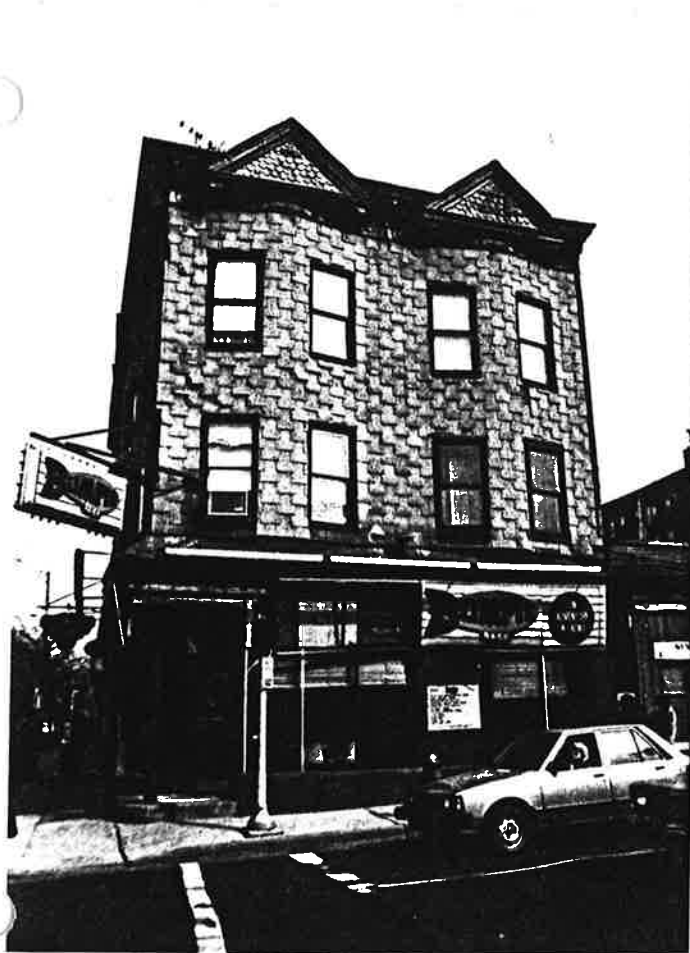
Map No. 4

4	800 Communipaw Avenue Block 1807	<i>late 19th cent</i>	P theme	F C/ R2		3 story, 2 bay Queen Anne corner frame building, with ground floor commercial use and storefront with altered bulkhead and windows, still retaining chamfered entry and column; window bays are surmounted by wood pediments clad in fishscale shingles; remaining portions of facade covered by asphalt shingles.	Contact 227/9

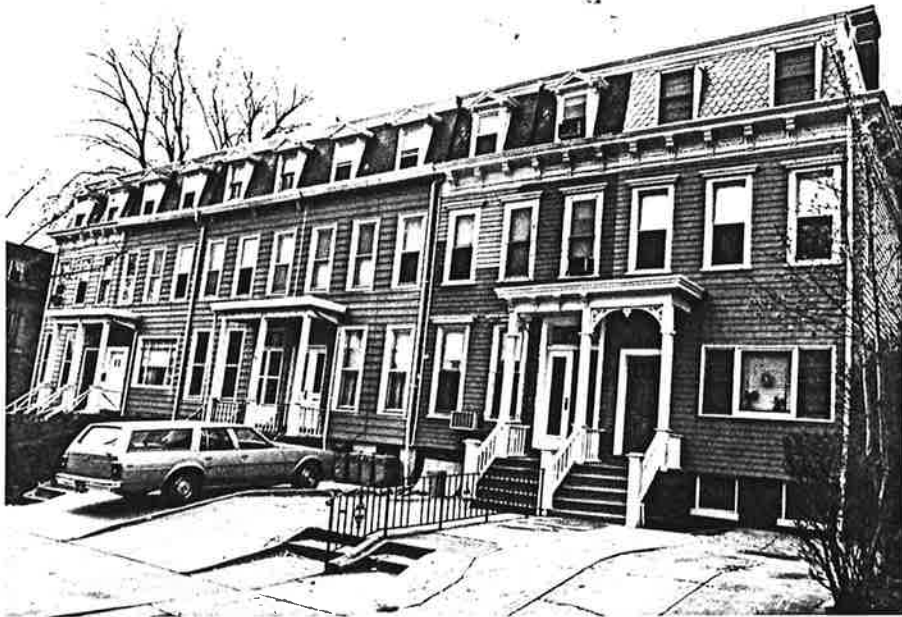
Map #1

1.	9-19 Duncan Avenue Block: 1824 6 attached rowhouses (WBHD)	1887 Map	Y Dist.	E	R	Second Empire; frame, clapboard, replacement aluminum; 3 bays each: 1/1; rectangular; mansard; 2 plus mansard (2½). 3 duplexes. Each entrance has paired stoops with early wood railings, 2 bay porch (only #17 & 19 retain early posts, brackets and cornice). #17 retains early double glazed door and transom. #9 and 17-19 retain original entablatures with carved brackets and frieze. Gable dormers.	35/9

9-19 Duncan Ave.

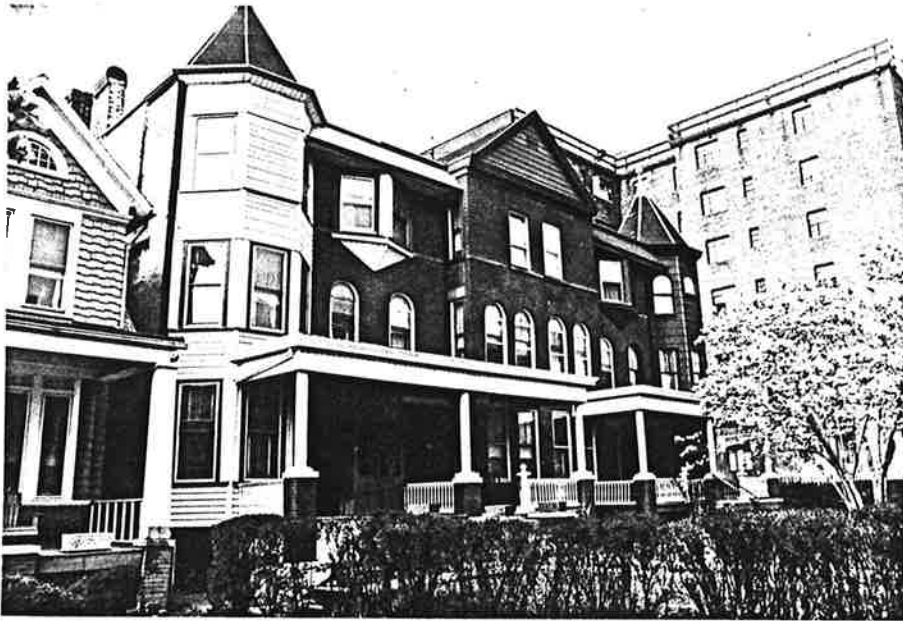
3.	27-33 Duncan Avenue Block: 1824 Group of 2 attached duplexes (4 units) (WBHD)	<i>late 19th cent</i>	Y Dist.	E	D	Queen Anne; brick walls, tripartite pavilions have wood shingles and replacement aluminum; 5 bay (overall): 1/1 and 2/1; see map; flat; 3. This unusual Queen Anne style duplex has a central projecting rectangular-in-plan pavilion with gablet and 2 side projecting tripartite pavilions with pent roofs and turrets. Each duplex has a wide 2 bay porch with round posts on brick piers and wood porch railing. The eastern duplex (#27 & 29) has been altered with aluminum siding.	35/13

Site No. 0906 B5 dun
27-33 Duncan Ave.
Photo Neg. 35/3
Map #3

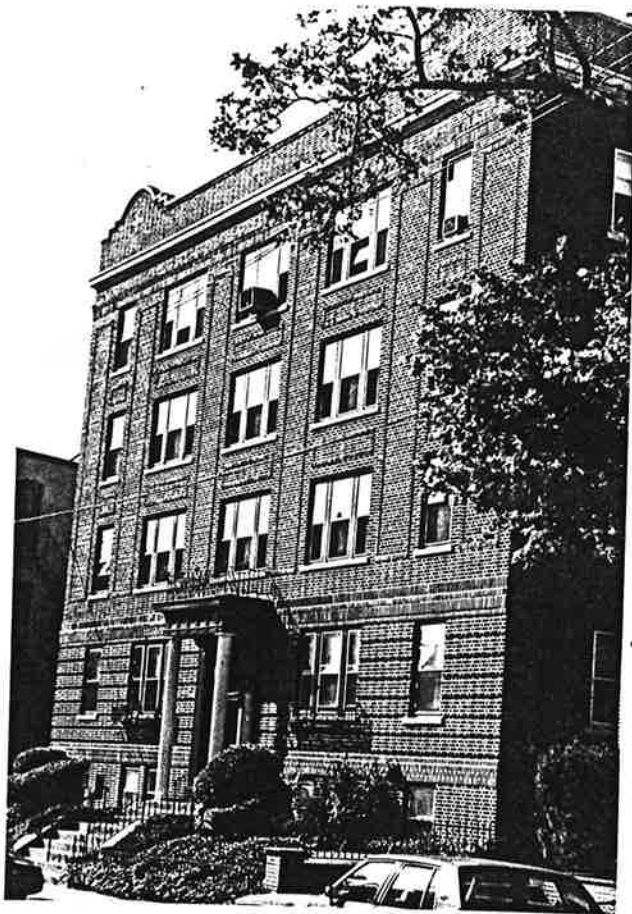
MAP #	ADDRESS/LOCATION : PROPERTY NAME	DATE	Signifi- cance to D/S	Condition	USE	DESCRIPTION: Style, Ext. Wall Fabric, Fenestration, Form, Roof, Major Features, Alterations, Stories, etc.	NEGATIVE FILE #
1	73-75 Fairview Avenue Block 1823	<i>c 1910- c 1930</i>	P	G R ²		4 story, 5 bay detached, eclectically-styled brick apartment house, with central entry set atop a narrow, terraced and landscaped yard; 1 over 1 windows, singly or in groupings of 3; unornamented limestone parapet coping and window sills; use of patterned brick between stories and in spandrels enlivens facade. "Allerton Hall" Apartments..	Contact 205/8A
2	74-76 Fairview Avenue Block 1824	1918	P	G R ²		4 story, 6 bay, Classical Revival brick apartment house, with semicircular entry portico supported by round columns; entablature with modillions; principal cornice with modillions and dentils; use of patterned brick to create a cross pattern; on first story, limestone window enframement with keystone flanks entry bay; windows 9 over 1 singly, and in pairs. Architect Nathan Welito.	Contact 205/2A

Site No. 0906-B5 fai
 73-75 Fairview Avenue
 Jersey City, N. J.
 Photo Neg. No. 205/8A
 Map No. 1

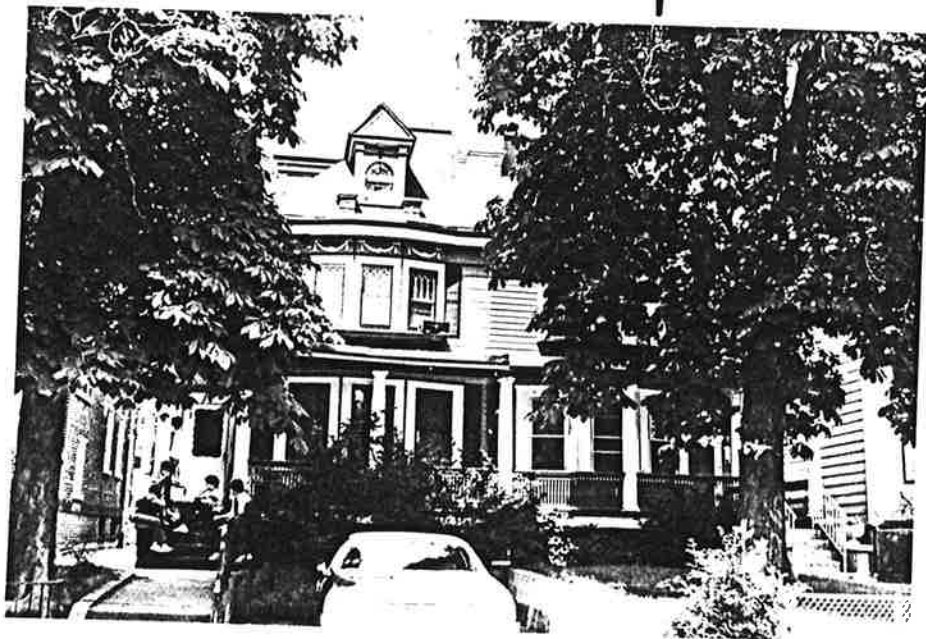
Site No. 0906-B5 fair
84-82 Fairview Avenue
Jersey City, N. J.
Photo Neg. No. ²⁰⁵/_{1A}
Map No. 3

3	82-84 Fairview Avenue Block 1824	<i>early 20th cent</i>	P	G R ¹		2 1/2 story, 4 bay Queen Anne double-houses, with contiguous front porches with flat roofs, supported by round wood columns; spindle porch railings intact; individual entries placed at end bays; 3 sided bay flanks each entry; central dormer over bay window; Adamesque swags in frieze of cornice.	Contact 205/1A

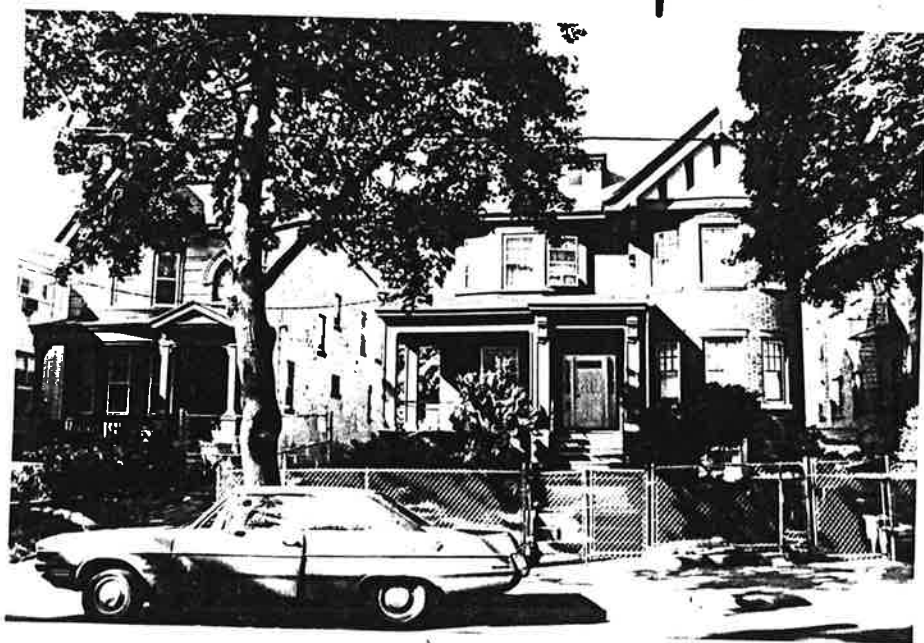
Site No. 0906-B5 fair
85-89 Fairview
Avenue
Jersey City, N. J.
Photo Neg. No. ²⁰⁵/_{1A}
Map No. 4

MAP #	ADDRESS/LOCATION : PROPERTY NAME	DATE	Fig. 8 D/S	Condition	USE	DESCRIPTION: Style, Ext. Wall Fabric, Fenestration, Form, Roof, Major Features, Alterations, Stories, etc.	NEGATIVE-FILE #
4	85, 89 Fairview Avenue Block 1823	early 20th cent	NA	G R1		2 1/2 story, similar 2 bay brick, English Tudor detached houses, with uniform setbacks, partial front porches, supported by square wood columns; half-timbering in gables; 3 sided bays; at # 89, the wider home, a rounded 2 story bay flanks the entry bay and has 6 over 1 windows.	Contact 205/7A
5	93-97 Fairview Avenue Block 1823	c1910- c1930	P theme	G R2		5 story plus high basement, 5 bay, English Tudor brick apartment house, with recessed entry; windows 8 over 1 singly, in pairs 6 over 1, and in the central bays, grouped as 4 casements with fixed transoms above; central bays project slightly, and have half-timbering above the second floor; limestone quoining in end bays from basement to first floor, and surrounding the fifth floor windows; crenellated parapet pierced by peaked, half-timbered central bay. "Wales Court" Apartments.	Contact 205/6A

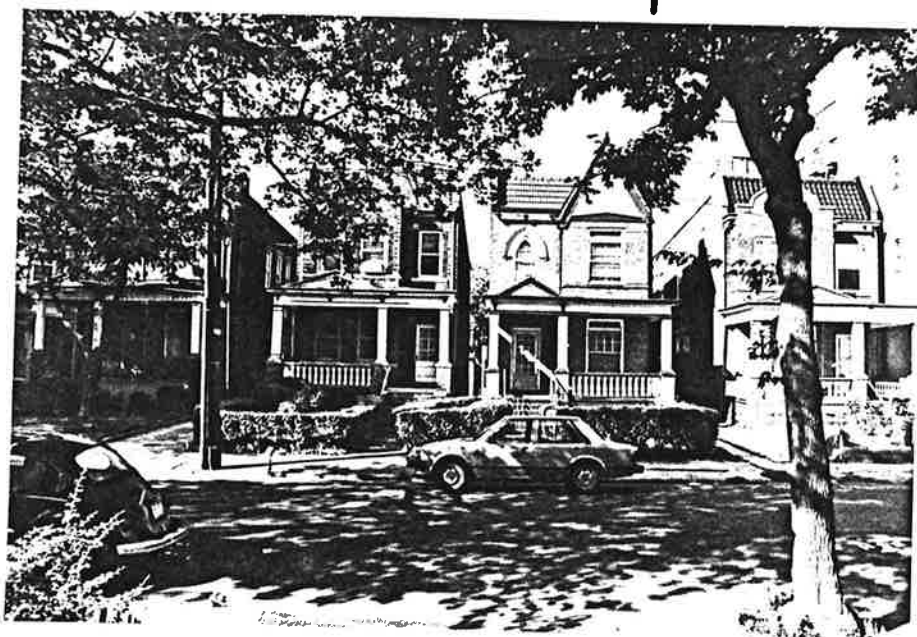
MAP #	ADDRESS/LOCATION : PROPERTY NAME	DATE	Significance	Condition	USE	DESCRIPTION: Style, Ext. Wall Fabric, Fenestration, Form, Roof, Major Features, Alterations, Stories, etc.	NEGATIVE FILE #
9	107-113 Fairview Avenue Block 1823	early 20th cent	NA	G R-1		Series of detached, 2 story, 2 and 3 bay eclectically-styled houses, including Mission (#107), English Tudor (#109), and Classical Revival (#111), unified by identical size and scale, and by uniform setbacks with landscaped front yards; full front porches; pedimented porch entry bays, projecting second story bays, and false mansard roofs.	Contact 205/5A
10	115 Fairview Avenue Block 1823	c1910- c1930	P theme	G R-2		5 story, 7 bay Mission style brick apartment house, with central, projecting entry with shaped parapet, similar to building's principal parapet; windows in groups of 2 (6 over 1) and 3 (6- and 9 over 1); corbelled brick below iron window balconies on first, second and fifth floor outer bays. "Mayfair" Apartments.	Contact 205/4A

Site No. 0906-B5 fair
 113, 111, 109, 107 Fairview
 Avenue
 Jersey City, N. J.
 Photo Neg. No. 205/5A
 Map No. 9

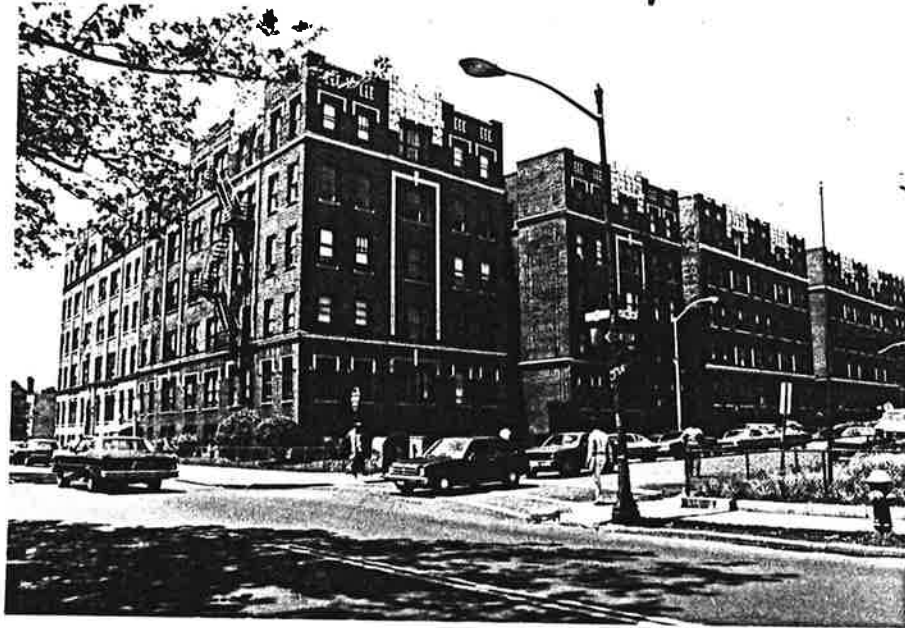
left: 7-9 Gifford Ave, Gifford Court Apts
Map #1

1.	7-21 Gifford Avenue (SW corner Bergen Avenue) Block: 1815 Gifford Court Apartments (W.B.H.D.)	c1910- c1930	Y Dist.	E	R2	Proto-Moderne Apartment with Gothic Revival motifs; brick walls, concrete, steel, metal, terracotta; 13 bays (Bergen Ave.), 5 bays each facade on Gifford Avenue; 2 attached "H" form buildings; flat; 5 story. Deeply recessed entrance on Gifford Avenue side. String course moldings. Label hood moldings above 1st and 5th story windows. Scalloped terracotta pinnacles and crenelles and merlons in area of parapet.	200/20a

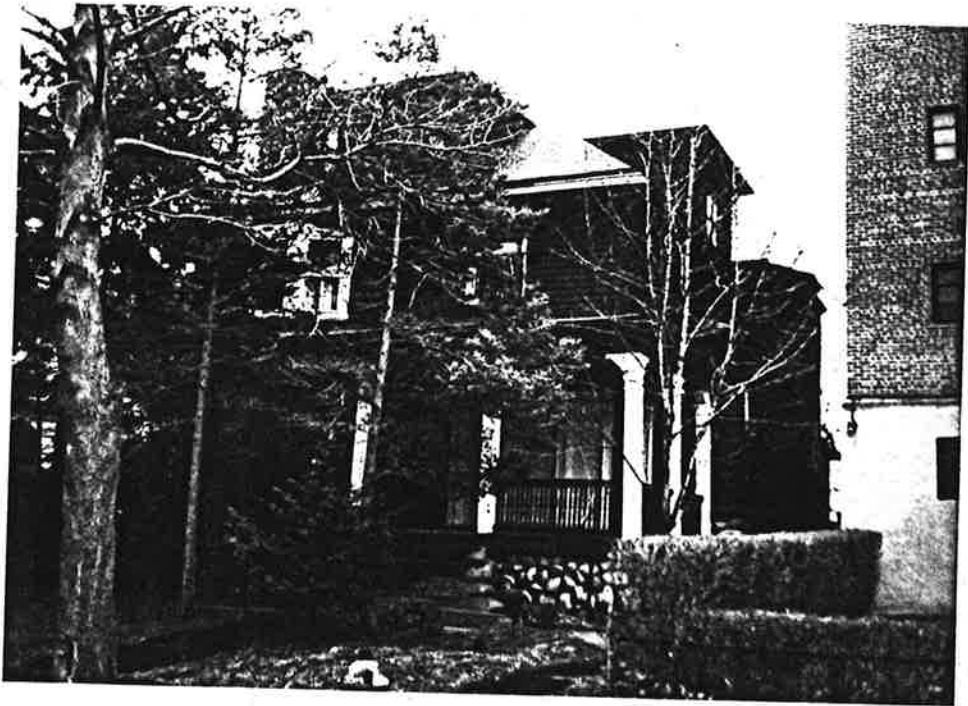
Site No. 0906 B5-gif
80 Gifford Ave.
Photo Neg. ^{245/11} (204/2A)
Map # 13

13.	80 Gifford Avenue Block: 1817 (W.B.H.D.)	early 20th cent	Y Dist.	E R	Shingle style; frame, wood shingles, high rubble foundation; 2 bay: variable sash; rectangular; hipped; 2 1/2. Attractive 3 bay porch with carved square posts and brackets. Early turned spindle railing. Elaborate tripartite entrance doorway; panelled door, pilasters and side lights which are boarded up. Clipped gable dormers.	245/11 (204/2a)

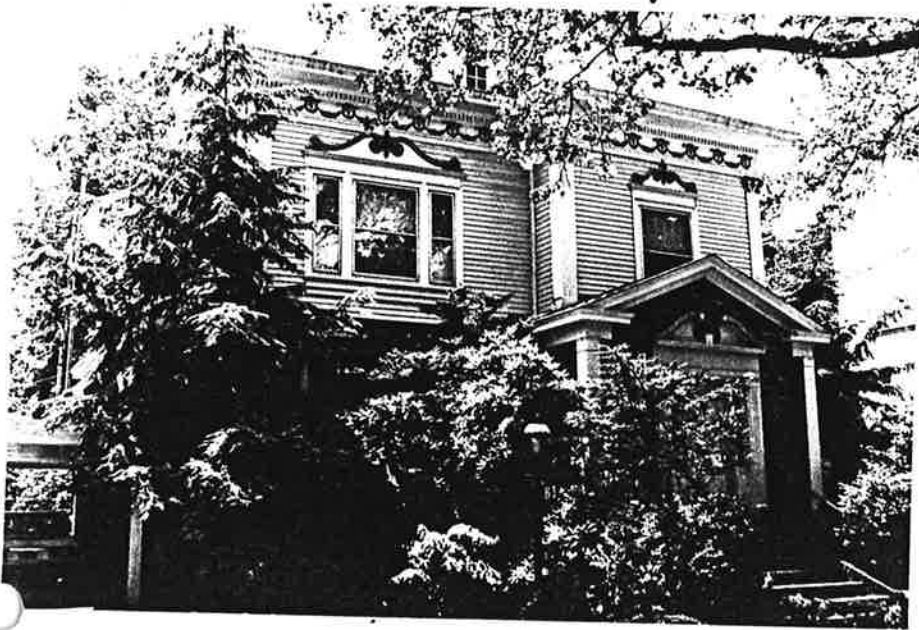
Site No. 0906 B5 gif
81 Gifford Ave.
Photo Neg. 204/1A
Map # 14

14.	81 Gifford Avenue Block: 1814	early 20th cent	Y Dist.	E R	Colonial Revival; frame, clapboard, brick portico, replacement aluminum; 2 bay: replacement sash and some early leaded windows; basically rectangular; 2 1/2. Altered 1st story, recent enclosure of 1 bay porch with brick and entrance door. 2nd story retains early clapboard siding, corner pilasters, carved curvilinear lintel decoration, frieze with wreath and garland designs, dentil molding and projecting cornice. gable dormers.	204/1a

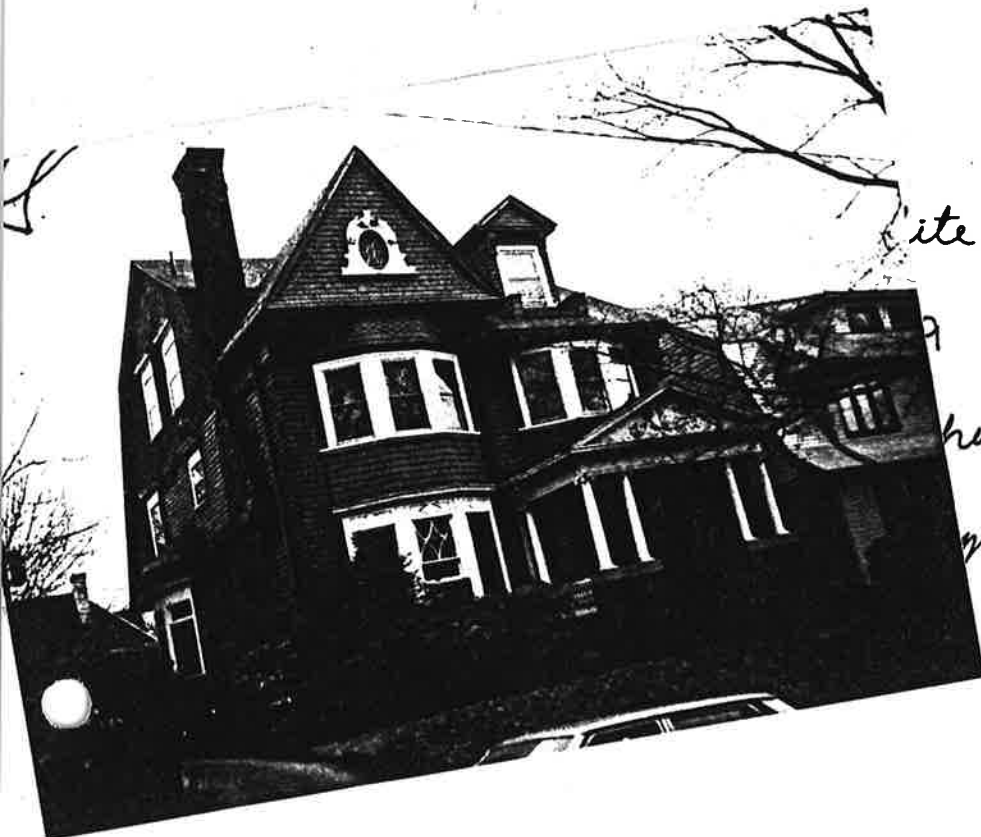
Site No. 0906-B5-gif
111 Gifford Ave.
photo Neg. ^{245/7}(203/14)
Map # 20

20.	119 Gifford Avenue Block: 1814 (W.B.H.D.)	<i>early 20th cent</i>	Y Dist.	E	R	Queen Anne/Colonial Revival; frame, wood shingles; 2 bay equivalent: tracery / 1, 1/1; recessed rectangular gable with gablet; 2 $\frac{1}{2}$. 1 bay Neo-Classical Revival porch with frieze and carved pediment. Replacement door. 2 story tripartite bay with gablet and circular window with carved surrounds in gablet end.	245/7 (203/14)

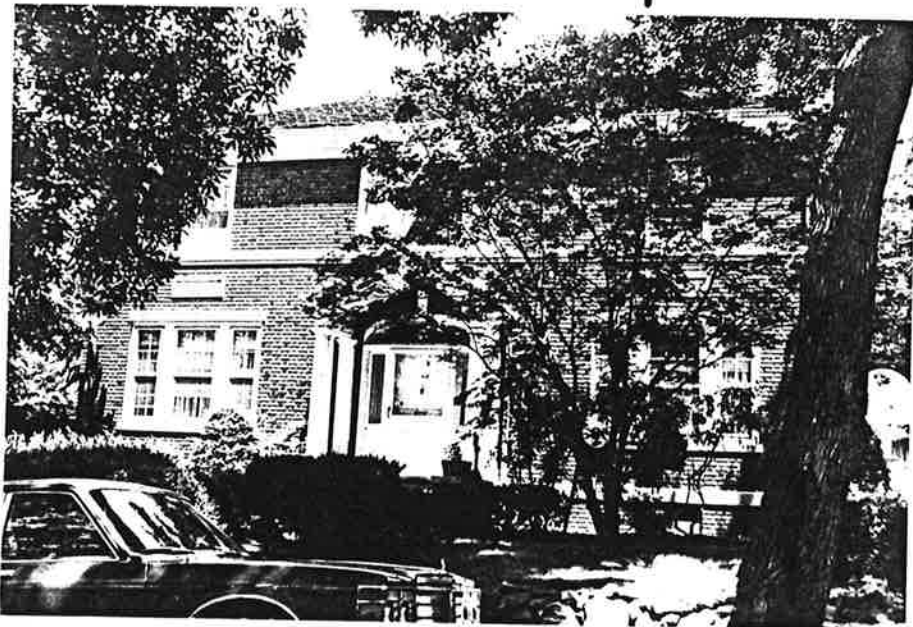
Site No. 0906-B5-gif
148-152 Gifford Ave.
Photo Neg. 203/32
Map #24

24.	148-152 Gifford Avenue (NE corner West Side Ave.) Block: 1817 (W.B.H.D.)	early 20th cent	Y Dist.	E	R	Early 20th Century Colonial Revival; brick walls, wood, terracotta; 3 bays: 6/6; rectangular; gable; 2. 1 bay porch with gable roof, round Doric columns and pilasters. Panelled door with fanlight and sidelights. Water table and string course molding. 2 rectangular terracotta panels with garland designs.	203/32
