LINCOLN PARK NEIGHBORHOOD OF SURVEY

BELMONT AVENUE IN LINCOLN PARK NEIGHBORHOOD OF SURVEY AREA (WARD) B

NEW JERSEY OFFICE OF CULTURAL AND ENVIRONMENTAL SERVICES
HISTORIC PRESERVATION SECTION
DISTRICT/STREETSCAPE CONTINUATION SHEET

N.J. HISTORIC SITES INVENTORY

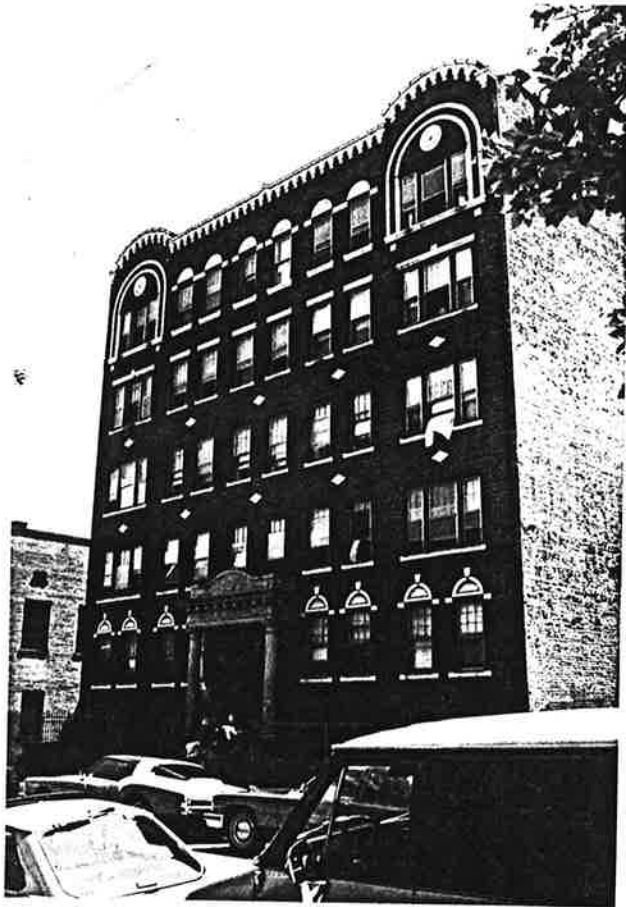
Map No. 1

MAP #	ADDRESS/LOCATION : PROPERTY NAME	DATE	Significance D/S	Condition	USE	DESCRIPTION: Style, Ext. Wall Fabric, Fenestration, Form, Roof, Major Features, Alterations, Stories, etc.	NEGATIVE FILE #
1	143-145 Harrison Avenue Block 1808	c1910- c1930	P theme	G R2		5 story, 8 bay, eclectically-styled brick, detached, apartment house, with 9 over 1 windows singly and 3 over 1 singly, and groups of 3 in 4 over 1 and 2 over 1 configurations; central projecting, stone entry with 2 support columns, entablature with modillions and apartment name on frieze; first floor 9 over 1 windows with blind arches above. "Harrison" Apartments.	Contact 202/15A
2	149-151 Harrison Avenue Block 1808	late 19th- early 20th cent	Y theme	G R1		2 detached, 2 bay Queen Anne, frame residences in excellent states of preservation and retaining their distinctive original features. # 149 has a gambrel-shaped slightly projecting gable with central Palladian window; # 151 has a corner turret with conical roof and Adamesque swags in fascia of turret cornice; both have shakes/shingle exteriors and central entry bay pediments, full front porches, and round wood columns with Ionic capitals set on brick plinths. See # 7 for continuation of description of homes to the north.	Contact 202/14A

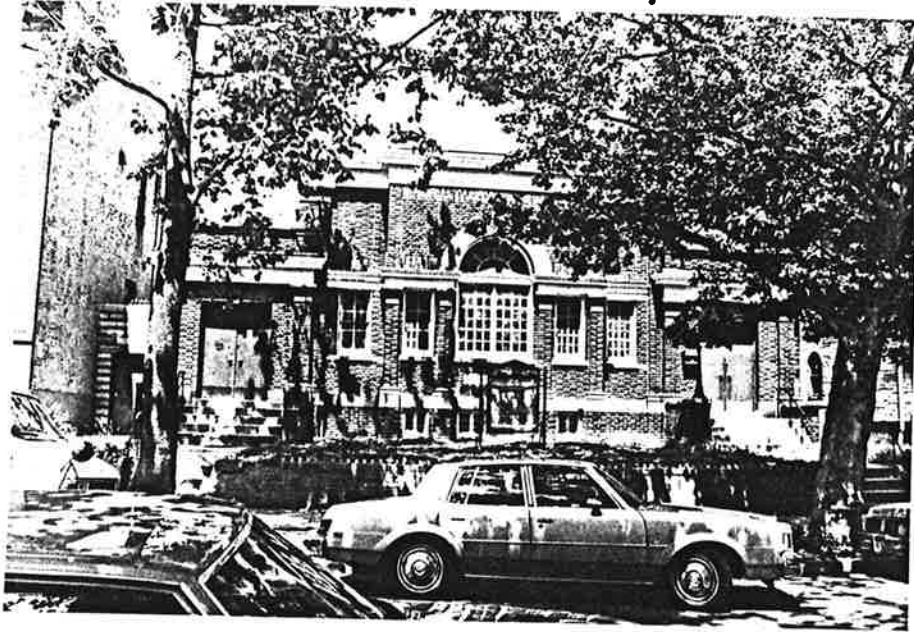
Map No. 3

3	154-156 Harrison Avenue Block 1810	1915	P theme	G T		First Church of Christ Scientist; 2 story brick, 5 bay, symmetrically-arranged Georgian Revival structure with 1 story end bays, which are the location of doorways; central, pair of 6-pane (casement?) windows with arched fanlight; pyramidal roof; patterned facade brickwork; lime-stone water table and facade trim.	Contact 202/13A

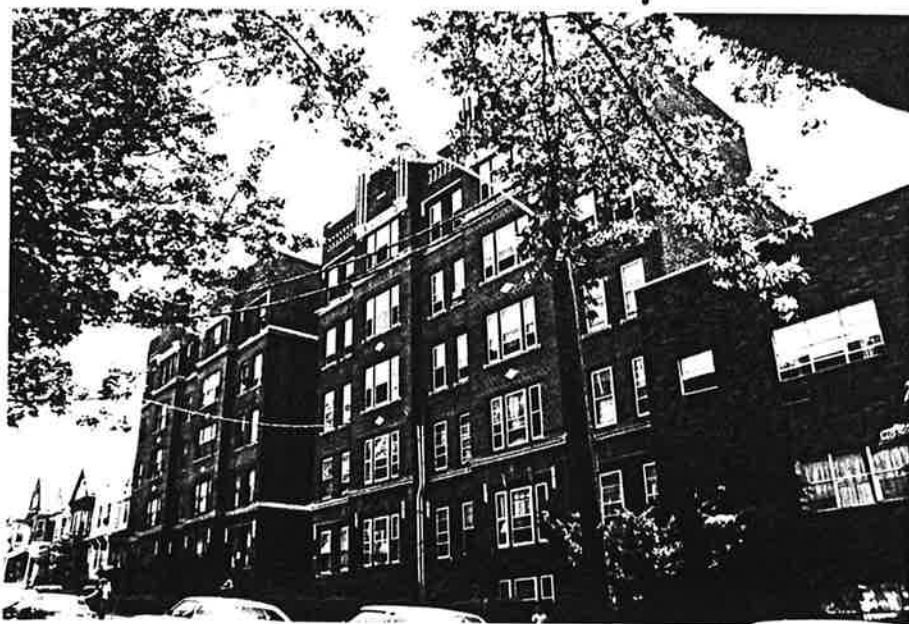
Map No. 12

MAP #	ADDRESS/LOCATION : PROPERTY NAME	DATE	Signif. to D/S	Condition	USE	DESCRIPTION: Style, Ext. Wall Fabric, Fenestration, Form, Roof, Major Features, Alterations, Stories, etc.	NEGATIVE FILE #
12	275-277 Harrison Avenue Block 1807	c1910- c1930	P theme	G R ²		2,5 story, 7 bay attached apartment houses, the "Richards Court" Apartments and the "Westview", matching buildings; windows 6 over 1, singly or in groups of 3; eclectically-styled, with limestone band-course between first and second stories, and fourth and fifth stories; standard-like projections in parapet; courtyard created between the 2 brick buildings, with recessed entries.	Contact 200/32A
13	292 Harrison Avenue Block	c1920- c1930	P theme	G R ²		3 story, 5 bay Art Deco light brick apartment house, with central entry, and lively vertical motif in contrasting brick at parapet, above basement, and in end bays; 6 over 1 windows singly or in groups of 3; diamond-pattern in metal and glass entry doors; entry also retain original vertical, wall-mounted lighting fixtures.	Contact 200/30A

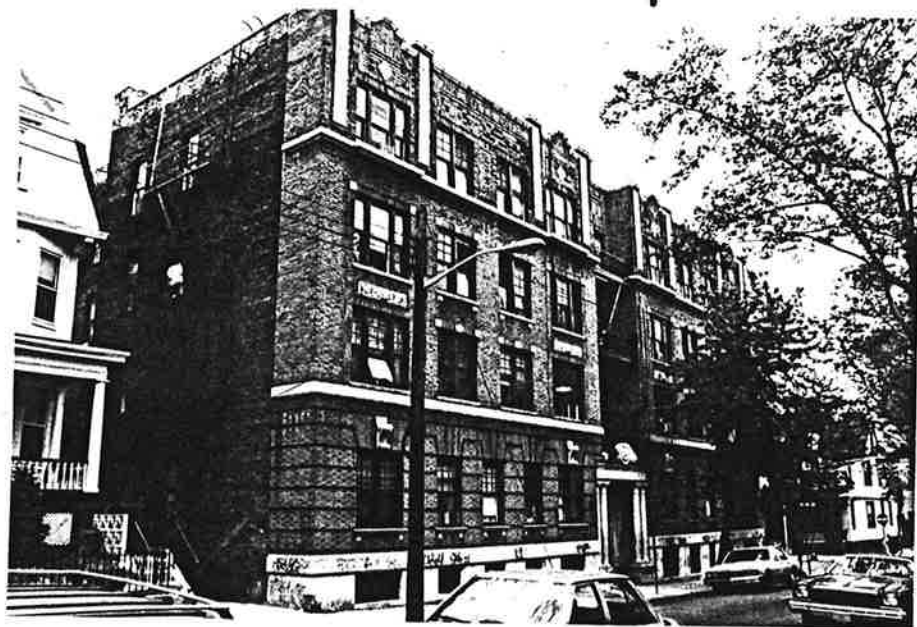
Site No. 0906-B5 jew
118 Jewett Avenue
Jersey City, N. J.
Photo Neg. No. 204/
Map No. 1 26A

MAP #	ADDRESS/LOCATION : PROPERTY NAME	DATE	Significance D/S	Condition	USE	DESCRIPTION: Style, Ext. Wall Fabric, Fenestration, Form, Roof, Major Features, Alterations, Stories, etc.	NEGATIVE FILE #
1	118 Jewett Avenue Block 1823	c1910- c1930	P theme	GR ²		see under # 637-641 Bergen Ave., "Marble Court" Apartments	
2	122-126 Jewett Avenue Block 1823	late 1940s early 20th cent	P theme	G R ²		3 similar, detached, frame 3 story, 2 bay Queen Anne residences, set stop terraced sites; each with full front porches supported by round wood columns, with a 2 story, 3 sided bay flanking entry bay, slightly projecting gambrel-shaped third story; # 124 and 126 appear to have been aluminum sided; # 122 retains exposed shingled exterior with wood ornamentation intact.	Contact 204/27A
3-4	139-143 Jewett Avenue Block 1820	early 20th cent	P theme	G R ¹		Streetscape view showing series of 2 1/2 story, 2 bay, detached, Classical Revival frame houses, with partial front porches; uniform setbacks; and including # 139, with hipped roof pierced by double-dormers, notably with first floor wide entry with flat roof, supported by 2 columns and 2 pilasters with fluted shafts and Ionic capitals, an entablature with modillions, Federal-inspired transom and sidelights at door and first floor window; 1 over 1 windows; exterior with aluminum siding, however light color complements style of home.	Contact 204/28A -29A

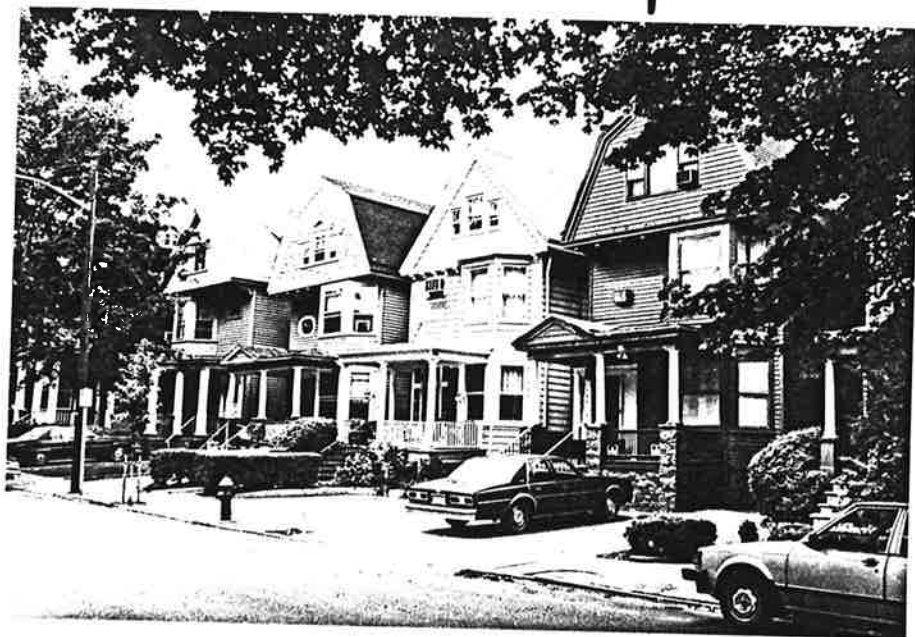
Site No. 0906-B5 jew
 142 - 148 Jewett
 Avenue
 Jersey City, N.J.
 Photo Neg. No. ²⁰⁴/_{30 A}
 Map No. 5

MAP #	ADDRESS/LOCATION : PROPERTY NAME	DATE	Signif. D/S	Condition	USE	DESCRIPTION: Style, Ext. Wall Fabric, Fenestration, Form, Roof, Major Features, Alterations, Stories, etc.	NEGATIVE FILE #
5-	142-148; 154-160 Jewett Avenue	<i>early 20th cent</i>	P G	R ¹		Series of 2 1/2 story, Queen Anne frame, 2 and 3 bay homes, with partial front porches, uniform setbacks, alternating, slightly projecting gambrel and peaked gables; 2 story, 3 sided bays either flanking entry bay or above it; variously sided; # 144 and 158 retain exposed wood shingles and trim, combining clapboard, shakes, fish-scale and chevron-patterned shingles for a varied effect, and with wood brackets and consoles at cornice and porch levels.	Contact 204/30A-31A
6	Block 1823						
7	166, 170 Jewett Avenue Block 1823	<i>early 20th cent</i>	P G	R ²		2 detached, identical, brick English Tudor apartment houses, 3 stories, 5 bays, with high basements; each with central slightly recessed entry with peaked door hood; windows 6 over 1 and in groupings of central 9 over 1 flanked by 6 over 1 over entry bay; parapet with crenellation and central peak, with limestone cartouche below; landscaped, narrow front yard.	Contact 204/32A

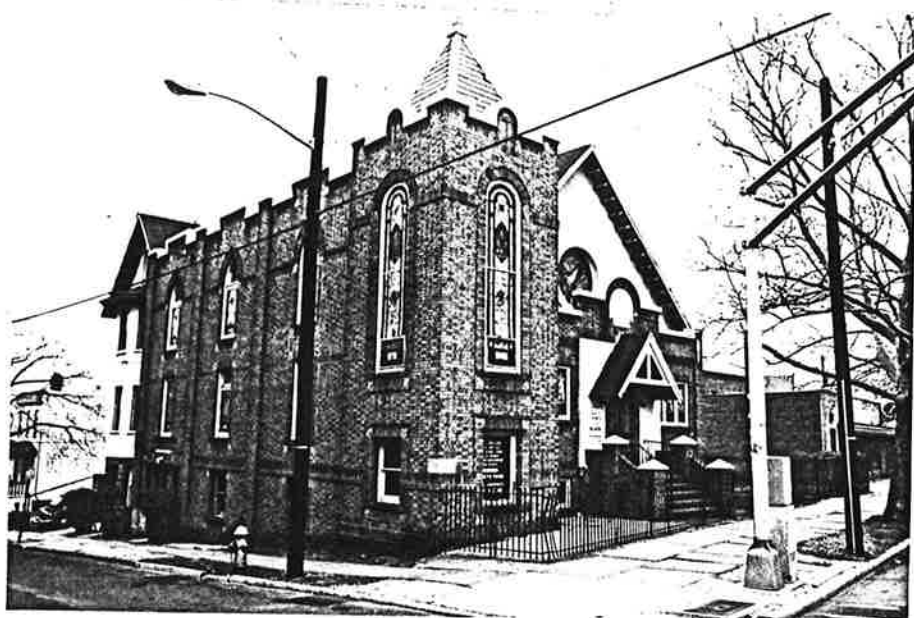
Map No. 1

MAP #	ADDRESS/LOCATION : PROPERTY NAME	DATE	Significance to D/S	Condition	USE	DESCRIPTION: Style, Ext. Wall Fabric, Fenestration, Form, Roof, Major Features, Alterations, Stories, etc.	NEGATIVE FILE #
1	2163-2165 J. F. Kennedy Boulevard Block 1786	1926	P theme	G T		Church of the Nazarene; rebuilt in 1926 (cornerstone); eclectic styled, 2 story church on corner location. with entry on Kennedy; central portion of church has peaked roof, below which the entry is set upon a low stoop and has a peaked door hood and projecting brick entry vestibule; to the left of the entry is a corner square brick tower, 2 stories high with a pyramidal roof; stained glass panels set in arched, 2 story high windows fill the tower bay; along the side street, 3 bays are divided vertically to form square-headed windows on the first story and pointed-arch headed windows at the second story, each window filled with stained glass; brick corner tower and side street facade, contrasting with stucco of peaked portion of Kennedy Blvd. facade.	Contact 15/10

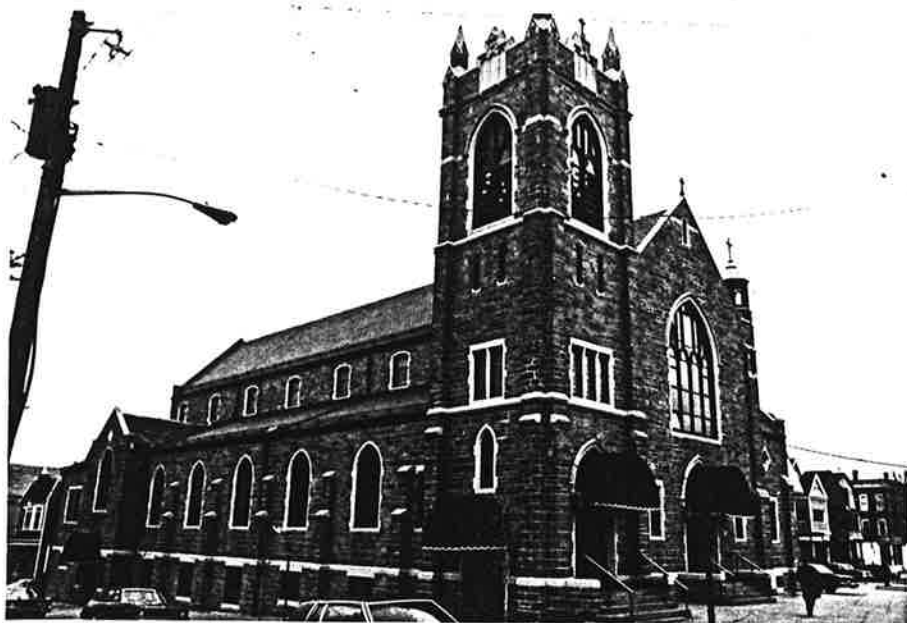
Map No. 2

2	2209-2213 J. F. Kennedy Boulevard Block 790	1922	P theme	G T		Our Lady of Victories R.C. Church; Gothic Revival corner church with main facade on Kennedy Blvd.; granite with limestone trim; 3 bays along Kennedy Blvd. and 8 along side street; arched entry in central peaked portion of facade, above which is a 2 story high, arched window with tracery; square bell tower at corner rises to 3 1/2 story level and has 2 arched doorways at its base, lancet windows at second story level, and bartizans at the corners of its parapet; high basement, window enframements and copings of limestone.	Contact 15/11

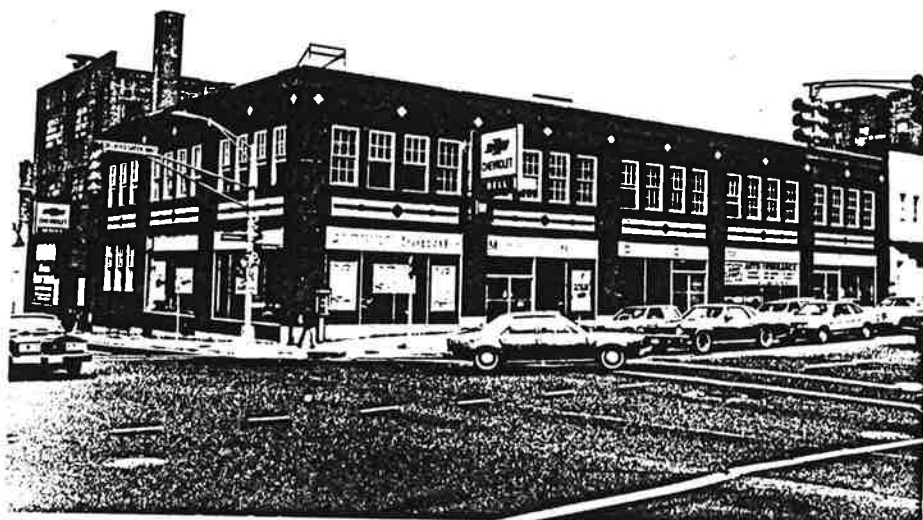
Map No. 1

MAP #	ADDRESS/LOCATION : PROPERTY NAME	DATE	Signif. of D/S	Condition	USE	DESCRIPTION: Style, Ext. Wall Fabric, Fenestration, Form, Roof, Major Features, Alterations, Stories, etc.	NEGATIVE FILE #
1	2395-2401 J.F. Kennedy Blvd. Block 1807	2003 20th cent	NA	G	C	2 story, brick commercial corner building with 5 bays on Kennedy, 3 on Communipaw; each bay with a group of 4, 6 over 6 windows at second floor, and ground floor elevations with aluminum and glass storefronts; inset brick and concrete panels in spandrels between stories.	Contact 143/5
2	2415-2431 J. F. Kennedy Blvd. Block 1811	1925	P E T Theme			Temple Beth-El; P.A. Vivarttas, architect, Zenithern Co. of Newark, N.J., builders; imposing, brick temple at corner of Kennedy and Harrison, with main entry on Kennedy, through 3 equally-sized entries. the central opening with a sloping pediment surmounted by 2 stone tablets; the entry bay is framed by a 2 story high arch with stained glass infill, including a rose window with the star of David; the arch is repeated in the shape of the parapet on both elevations; on Harrison at second story level are 5 narrow, arched stained glass windows; stone bandcoursing divides first and second stories; stone foundation at front elevation; continuous stone water table along Harrison elevation; roof has central, hexagonal dome rising to third story level with tile roof; synagogue first located at 896 Montgomery St. in 1864, as Beth Israel Congregation, then as the Isaac Ephraim Congregation; becoming Temple Beth-El in 1871. (write-up in American Architect, CXXX, Dec. 20, 1926).	Contact 15/27

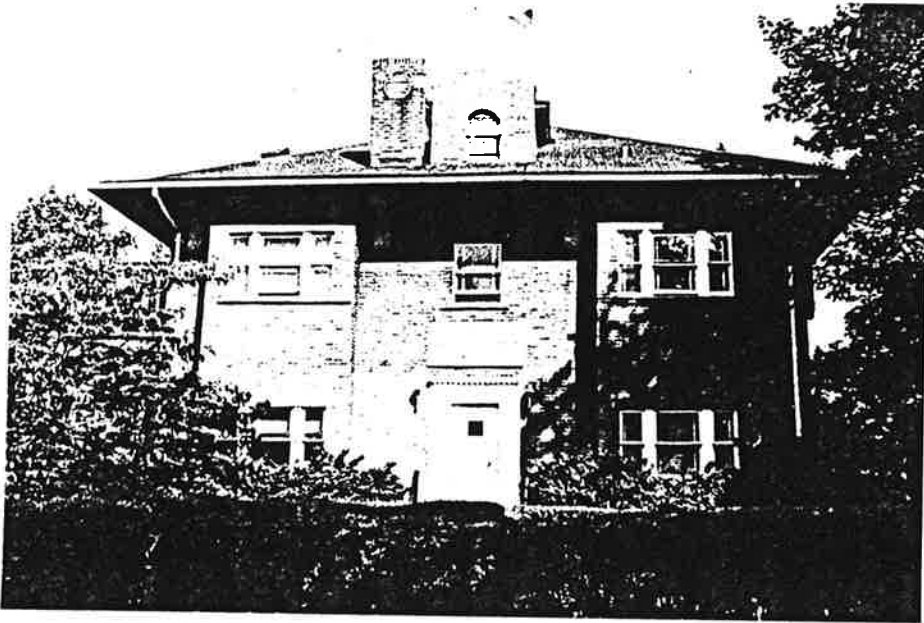
Map No. 3

MAP #	ADDRESS/LOCATION : PROPERTY NAME	DATE	Signs	Condition	USE	DESCRIPTION: Style, Ext. Wall Fabric, Fenestration, Form, Roof, Major Features, Alterations, Stories, etc.	NEGATIVE FILE #
3	2431 J.F. Kennedy Blvd. Block 1811	early 20th cent	P.D.	G	T	Temple Beth-El Temple House; vernacular with Mission Style influence; brick; 1 over 1, singly or tripartite; rectangular plan; pyramidal roof; 3 bays, central entry, large brackets under eaves, central dormer with shaped parapet; 2 1/2 stories.	Contact 203/7
4	2456 J.F. Kennedy Blvd. Block 1815	late 19th early 20th cent	P	G	T	Temple Beth-El House; Queen Anne; frame, clapboard on first story, shingles on second story; 1 over 1; asymmetrical plan; peaked roof; 3 bay; corner 3 story turret with conical roof and copper finial; entry originally recessed in semicircular porch, now former porch area used as a vestibule; 2 1/2 stories.	Contact 205/16A
5	2474-2578 J.F. Kennedy Blvd. Block 1816	c1910-1935	P	G	R2	Parkview Apartments; Moderne Style; brick; 1 over 1, or louvered; irregular U-shaped plan; flat roof; characteristic translucent corner window bays; main entry off-center; 6 stories.	Contact 205/15A

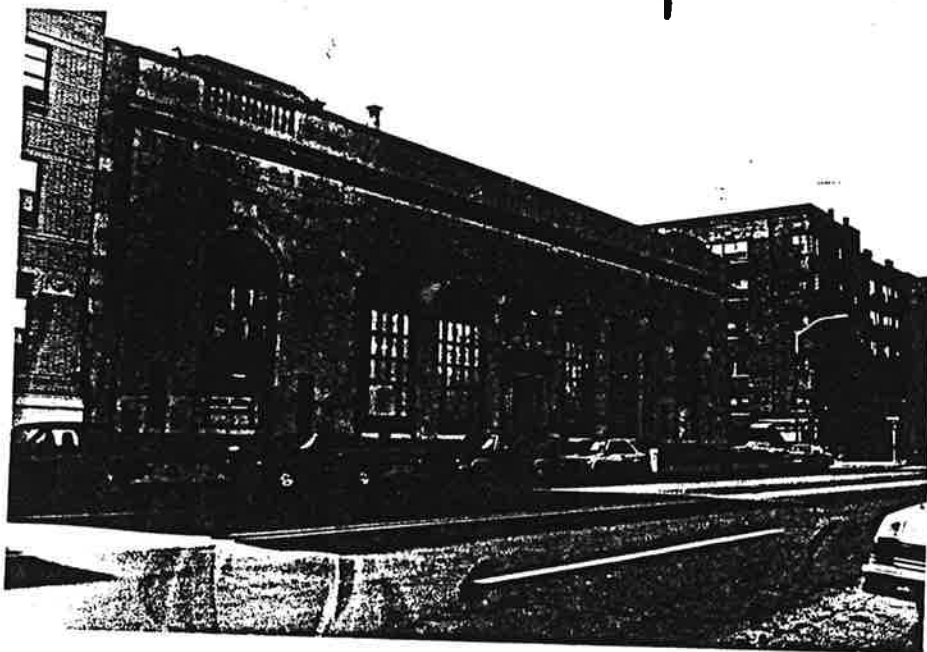
Map No. 7

MAP #	ADDRESS/LOCATION : PROPERTY NAME	DATE	Sign to D/S	Condition	USE	DESCRIPTION: Style, Ext. Wall Fabric, Fenestration, Form, Roof, Major Features, Alterations, Stories, etc.	NEGATIVE FILE #
7	2528-2536 J.F. Kennedy Blvd. Block 1823	c 1930	P theme	G C	C	Hudson City Saving Bank; Classical Revival corner bank building; marble; along Kennedy Blvd., 7, 2 story arched openings with multi-paned windows, apparently fixed-frame; rectangular plan; flat roof; entry in central arched opening, marked by a stone architrave with a clock above; bank name inscribed in frieze, above which is an unornamented cornice with stone balustrades in parapet at end bays; 2 1/2 stories.	Contact 205/18A
8	2540-2550 J.F. Kennedy Blvd. Block 1823	c 1930	P theme	G R ²		Alban Court Apartments; Classical Revival; brick with limestone foundation and terra-cotta ornament; paired 1 over 1; M-shaped plan, with central portion flanked by 2 narrow courtyards between 2 end sections of building; central rectangular entry flanked by 2 columns on Kennedy Blvd. elevation; 11 bays, 5 stories; top floor of each section has terra cotta pilasters flanking the window bays; terra cotta ornamentation at parapet and for cornice.	Contact 205/19A

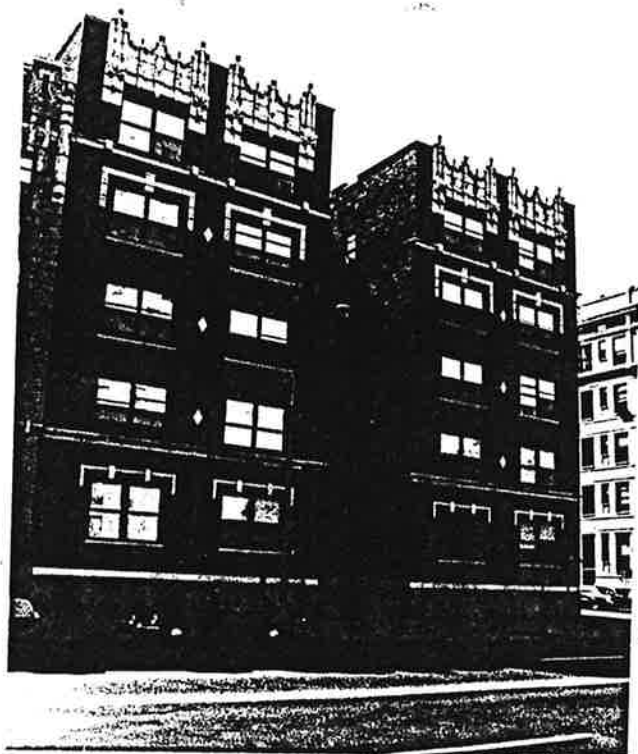
Map No. 9

9	2554-2558 J.F. Kennedy Blvd. Block 1824	c 1910-1930	P theme	G R ²		Eclectic, with Baroque elements, apartment house; brick with terra cotta ornament and limestone foundation; paired, 1 over 1 window; H-shaped plan; with entry recessed in courtyard; flat roof; above fifth-story window bays, parapet has terra cotta ornament resembling billowing fabric, with standard-like vertical elements with foliate swage at their bases; windows may be replacements; 5 stories plus basement.	Contact 205/22A

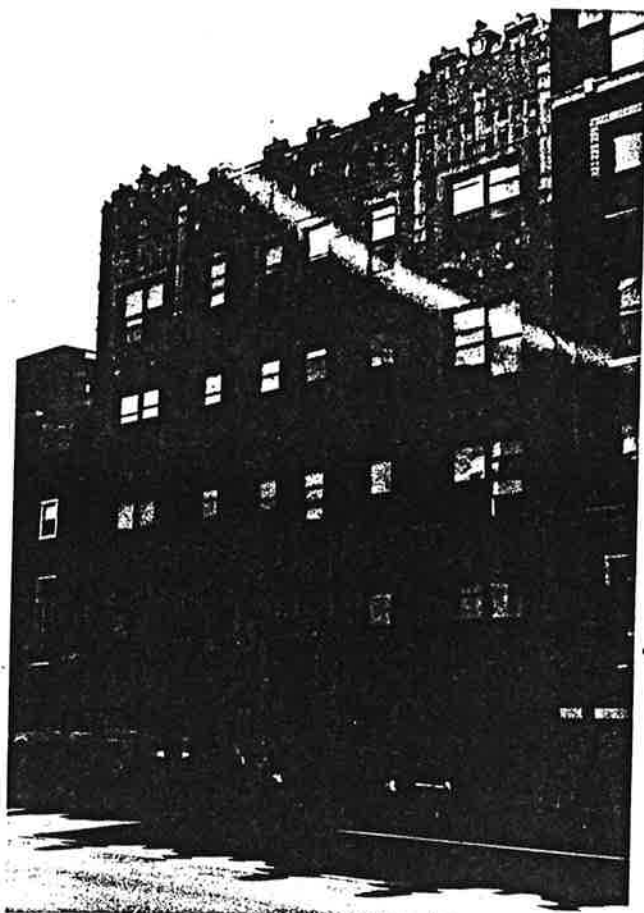
Map No. 10

MAP #	ADDRESS/LOCATION : PROPERTY NAME	DATE	Signature D/S	Condition	USE	DESCRIPTION: Style, Ext. Wall Fabric, Fenestration, Form, Roof, Major Features, Alterations, Stories, etc.	NEGATIVE FILE #
10	2560-2562 J.F. Kennedy Blvd. Block 1824	2/19/00- 2/19/30	P Scheme	G	R2	Rembrandt Apartments; castellated style; light brick; 1 over 1 windows, singly or in pairs; flat roof; central arched entry with square-headed door, flanked by standards; bandcourse between first and second stories; crenellated parapet with lime-stone coping, cartouches, and pierced by keyhole-like slots recalling battlements; 4 stories plus basement.	Contact 205/20A

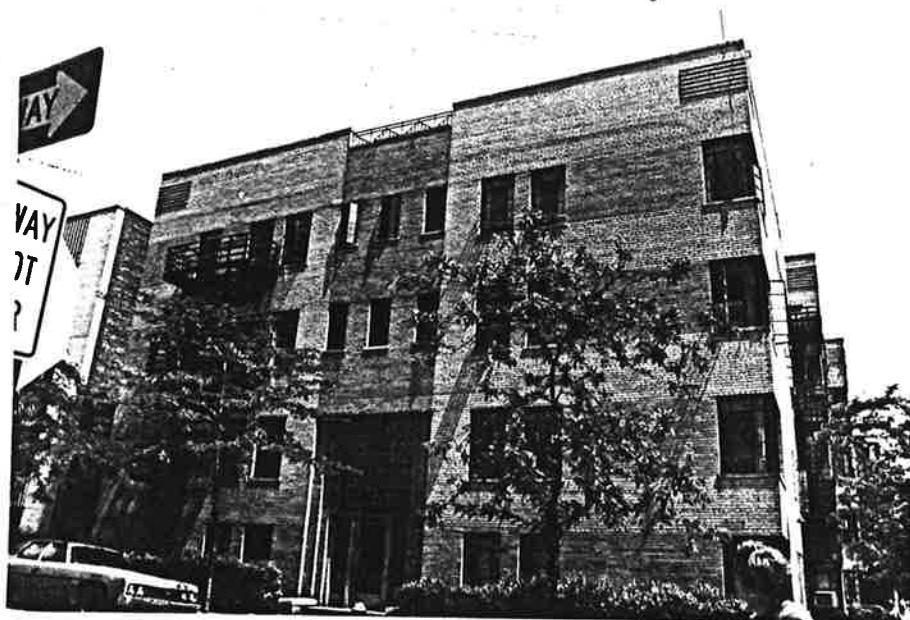
Map No. 1

MAP #	ADDRESS/LOCATION : PROPERTY NAME	DATE	Significance D/S	Condition	USE	DESCRIPTION: Style, Ext. Wall Fabric, Fenestration, Form, Roof, Major Features, Alterations, Stories, etc.	NEGATIVE FILE #
1	2 Kensington Avenue Block 1820	c1930	P theme	G R2		Art Deco; brick; casements; rectangular plan; flat roof; central, 2 story high entry, with first story level door, surrounded by glass block on sides and as 1 story high transom; brick of a darker hue used horizontally in window bays; parapet cut above entry bay and filled by a wrought-iron railing in a triangular design; corners of building have brick, vertical courses at parapet level; striking for the relative paucity of ornament and strong horizontal lines; 4 stories.	Contact 200/14A
2	10 Kensington Avenue Block 1820	c1930	P theme	G R2		Art Deco; light brick, with contrasting dark brick in vertical patterns at window bays; casements; rectangular plan; central entry with square headed door, set in 2 story high, dark brick or tile, 1 1/2 story high bay, over which at parapet is a stepped pediment in contrasting brick; 3 1/2 stories.	Contact 204/25A

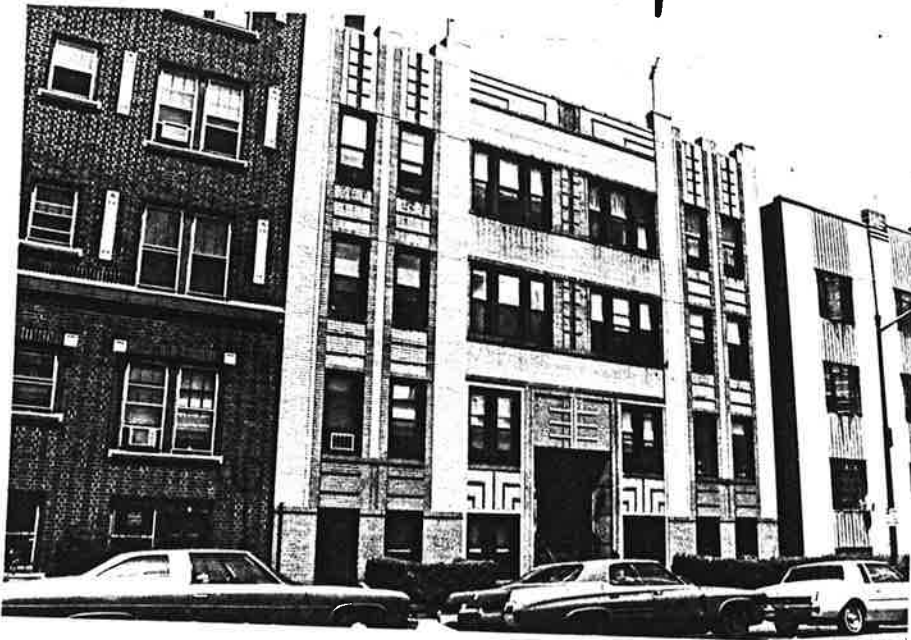
Map No. 3

3	14 Kensington Avenue Block 1820	c1920- c1930	P theme	G R2		Art Deco; light brick, with dark brick as vertical contrast; rectangular plan; 1 over 1 windows, singly or in groups of 3; flat roof; central, 1 1/2 story high entry with geometric, intersecting horizontal/vertical pattern in contrasting brick, a motif repeated in parapet of end bays; spandrels and central parapet feature brick banding, or radiating geometric pattern to create lively effect; 3 1/2 stories.	Contact 204/24 A

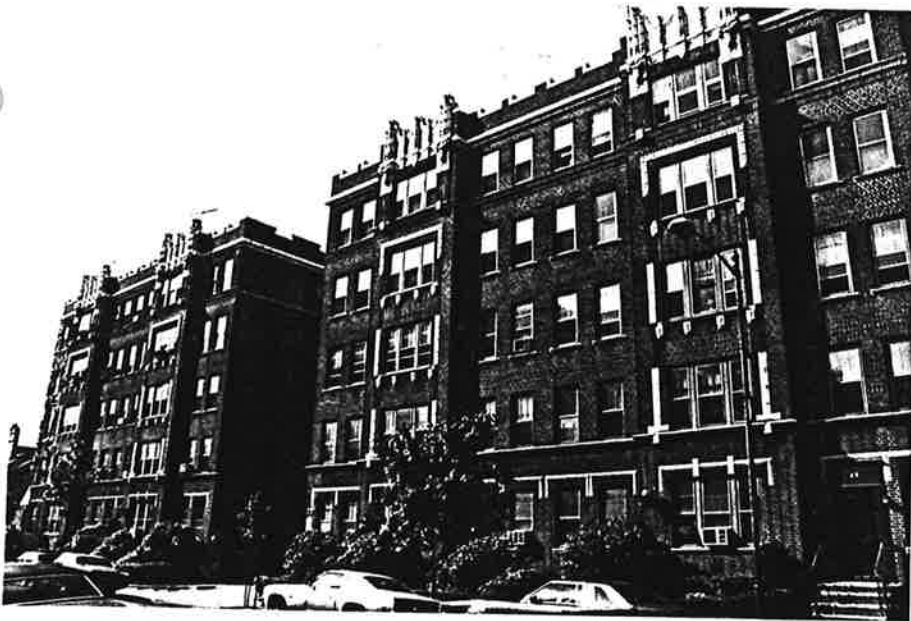
Map No. 4

MAP #	ADDRESS/LOCATION : PROPERTY NAME	DATE	Significance D/S	Condition	USE	DESCRIPTION: Style, Ext. Wall Fabric, Fenestration, Form, Roof, Major Features, Alterations, Stories, etc.	NEGATIVE FILE #
4	25 Kensington Avenue Block 1819	c1910- c1930	P G R ² theme			Kensico Gardens Apartments; eclectic, with Baroque and Medieval elements; brick, with terra cotta trim; 2 over 1 and 3 over 1, singly or in groups of 3; flat roof; parapet with draped terra cotta ornament and standard-like vertical projections over slightly-projecting tripartite window bays; crenellated parapet; central entry set in recessed courtyard; terra cotta ornament at lintels and sills of projecting bays.	Contact 205/11A
5	18 Kensington Avenue Block 1820	c1910- c1930	P G R ² theme			Kensington Hall Apartments; brick; 3 over 1 singly or in pairs; I-shaped plan; flat roof; arched, 1 1/2 story high entry; Baroque parapet detailing over end bays; terra cotta (or limestone) cornice between first and second stories; crenellated parapet with inset balusters over inner bays; 5 stories plus high basement.	Contact 204/23A

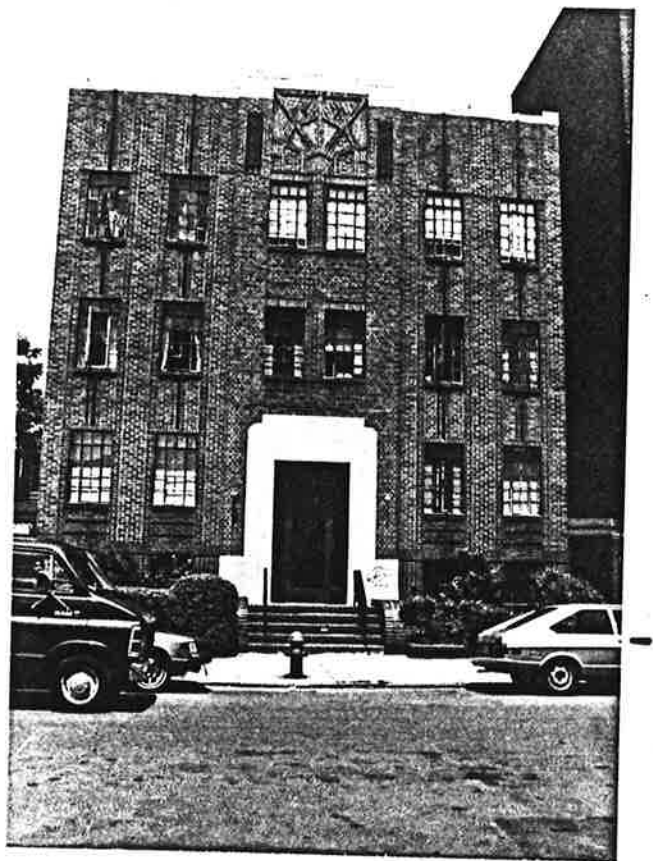
Map No. 7

MAP #	ADDRESS/LOCATION : PROPERTY NAME	DATE	Significance	Condition	USE	DESCRIPTION: Style, Ext. Wall Fabric, Fenestration, Form, Roof, Major Features, Alterations, Stories, etc.	NEGATIVE FILE #
7	34 Kensington Avenue Block 1820	c 1910- c 1930	P theme	G R ²		Art Deco apartment house; brick; multi-paned casements; flat roof; central entry, with limestone enframingent; above entry bay at parapet is a sunburst pattern in raised brick; limestone coping on parapet; 3 stories plus basement.	Contact 204/21A
8	35 Kensington Avenue Block 1819	c 1910- c 1930	P theme	G R ²		Eclectic apartment house with Art Deco elements; I-shaped plan; in 2 shades of brick with terra cotta trim; 6 over 1 in pairs or groups of 3; flat roof; recessed entry through central arched portal, with incised angular pattern; a foliate standard is at the center of the arch; walls of the entry curve back to decorative metal and glass entry doors, and are inscribed with a stylized leaf motif; the rich ornamentation found in the entry area is carried into the spandrel plaques between the center window bays above the entry bay; center bays and entire first story are in a darker brick than the upper stories of the end bays; parapet has central plaque and continued ornamentation on frieze, with pendentives.	Contact 205/9A- 10A

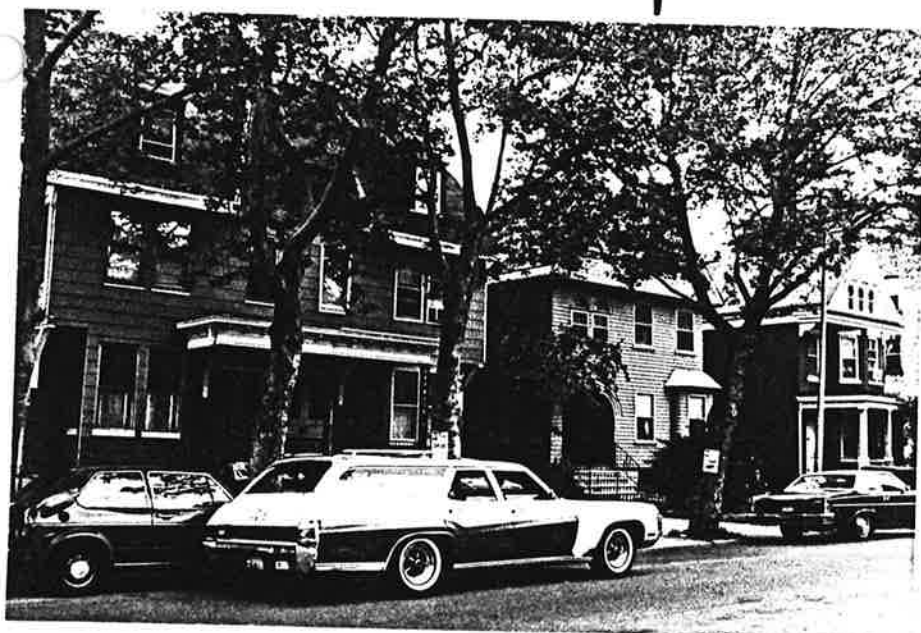
Map No. 11

MAP #	ADDRESS/LOCATION : PROPERTY NAME	DATE	Significance D/S	Condition	USE	DESCRIPTION: Style, Ext. Wall Fabric, Fenestration, Form, Roof, Major Features, Alterations, Stories, etc.	NEGATIVE FILE #
11	46-44, 42, 38 Kensington Ave. Block 1820	<i>late 19th - early 20th c.</i>	P theme	G R ² R ¹		Series of similar Queen Anne, 2 1/2 story, detached residences, variously resurfaced frame; 1 over 1 windows; peaked roofs; # 46-44 has central entry with bracketed partial front porch; roof pierced by 2 dormers; 3 bay aluminum sided; iron replacement porch supports; # 42 has arched side entry, peaked gable in attic story, is 3 bay, has shingle exterior; # 38 is brick and shingle, with side entry, 2 bays, with partial front porch, a 3 sided bay at second story, and peaked attic gable with 3 central windows.	Contact 204/20A
12	60, 58 Kensington Avenue Block 1820	<i>late 19th c.</i>	P theme	G R ¹		2 detached, 2 story plus attic mansard roofed area, Second Empire frame houses; # 60 has mansard roof retaining slate hexagonal units, 2 pedimented dormers, bracketed cornice, 3 bays, enclosed front porch with denticulation in entablature and with fluted columns; exterior clad in aluminum siding; # 58 also has mansard roof with pedimented dormers, but roof is covered with aluminum siding; 2 story, full front porch; enclosed at second story, open at first story.	Contact 204/17A

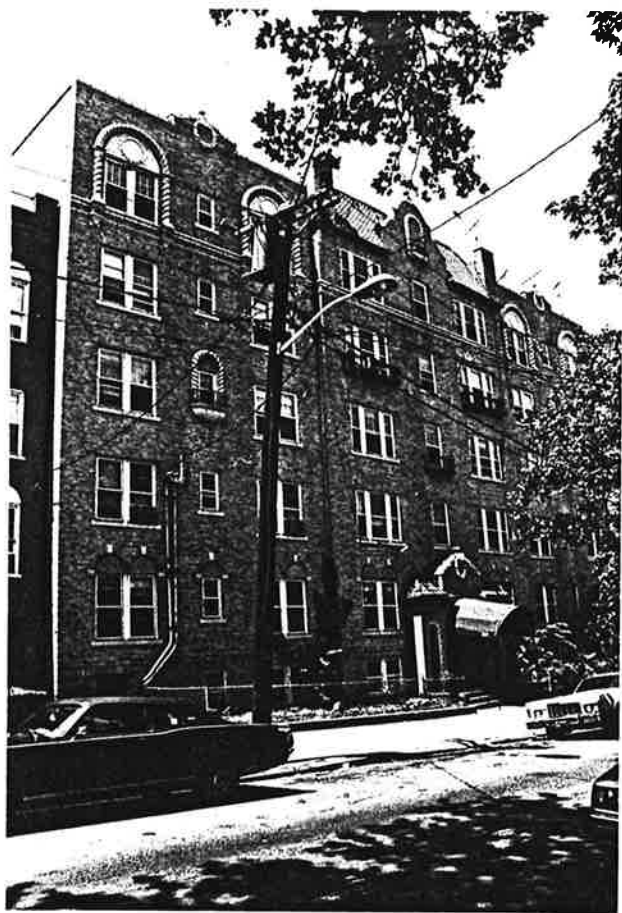
Map No. 18

107 Kensington

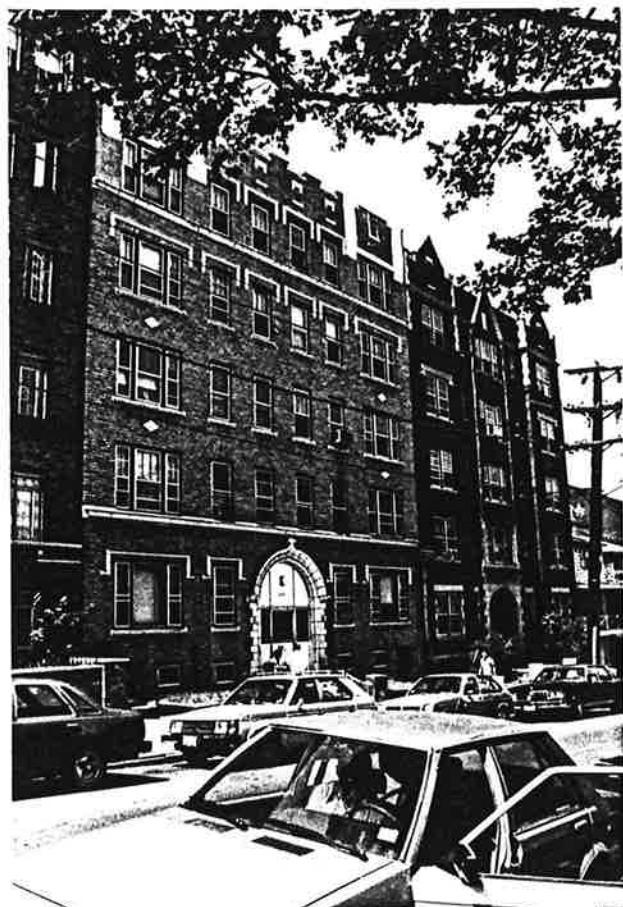
Map No. 21

137-139; 143-145 Kensington

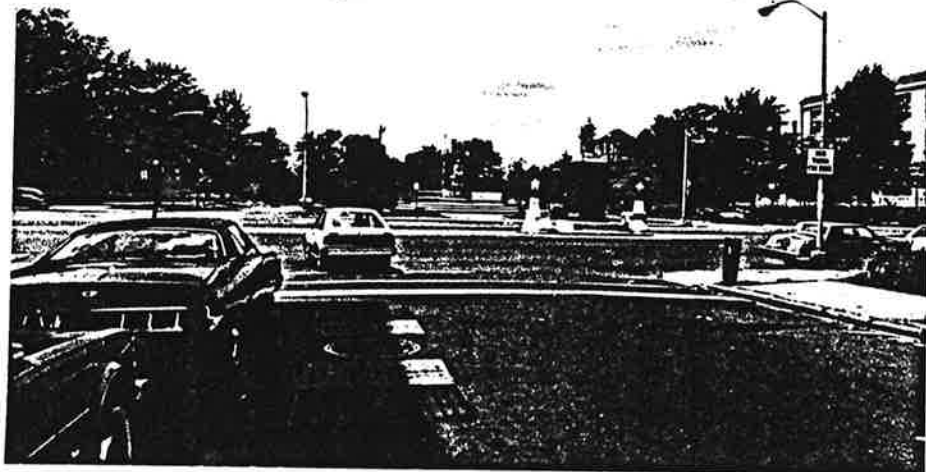
Site No. 0906-B5 lph
 Entrance to Lincoln
 Park at intersection
 of Belmont Ave and
 J.F. Kennedy Blvd.
 Jersey City, N.J.
 Photo Neg. No. 204/
 Map No. 1 15A

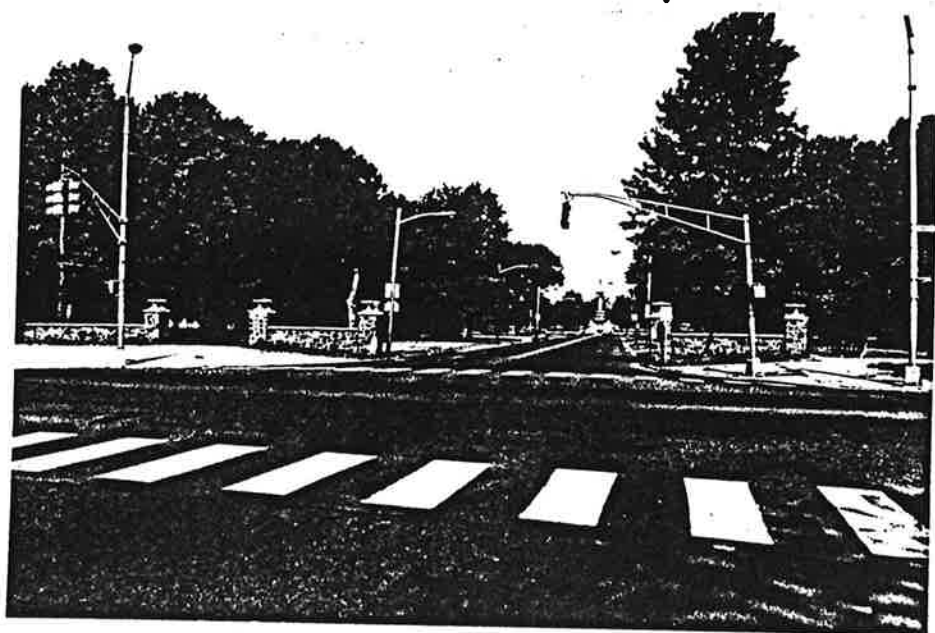
Site No. 0906-B5 lph
 West Side Avenue
 Entrance
 Jersey City, N.J.
 Photo Neg. No. 205/
 Map No. 2 30A

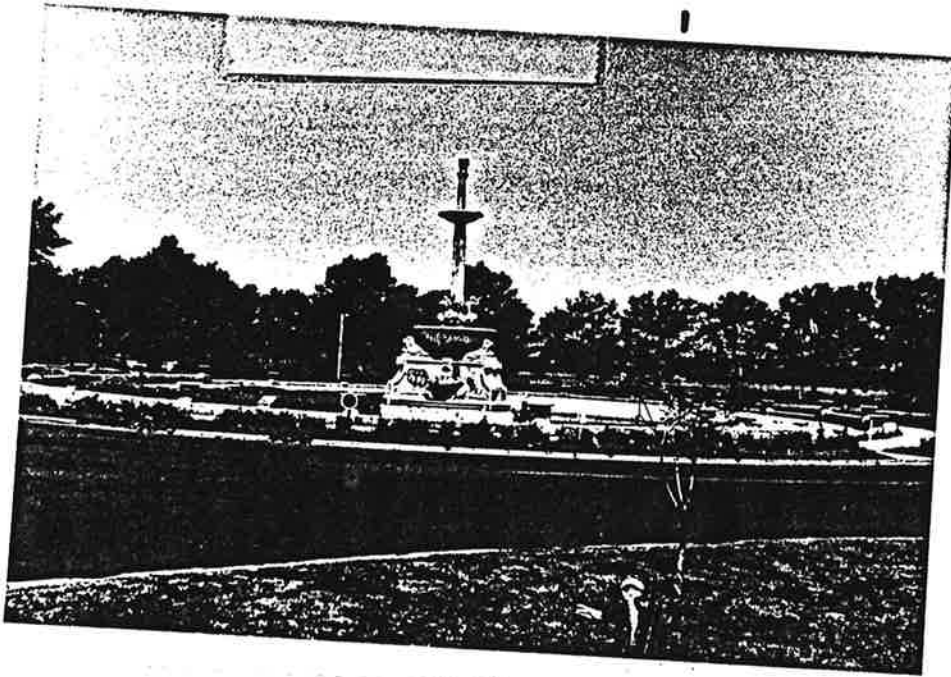
Site No. 0906-B5lph
 Fountain - Lincoln
 Park
 Jersey City, N.J.
 Photo Neg. No. 205/
 Map No. 3 31

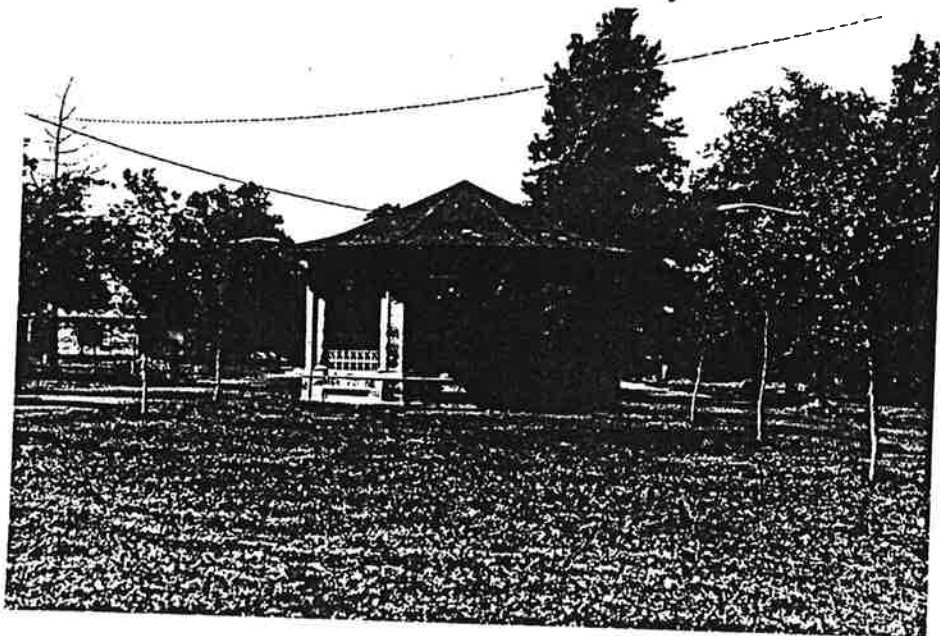
Site No. 0906-B5lph
 Gazebo - Lincoln
 Park
 Jersey City, N.J.
 Photo Neg. No. 205/
 Map No. 4 33A

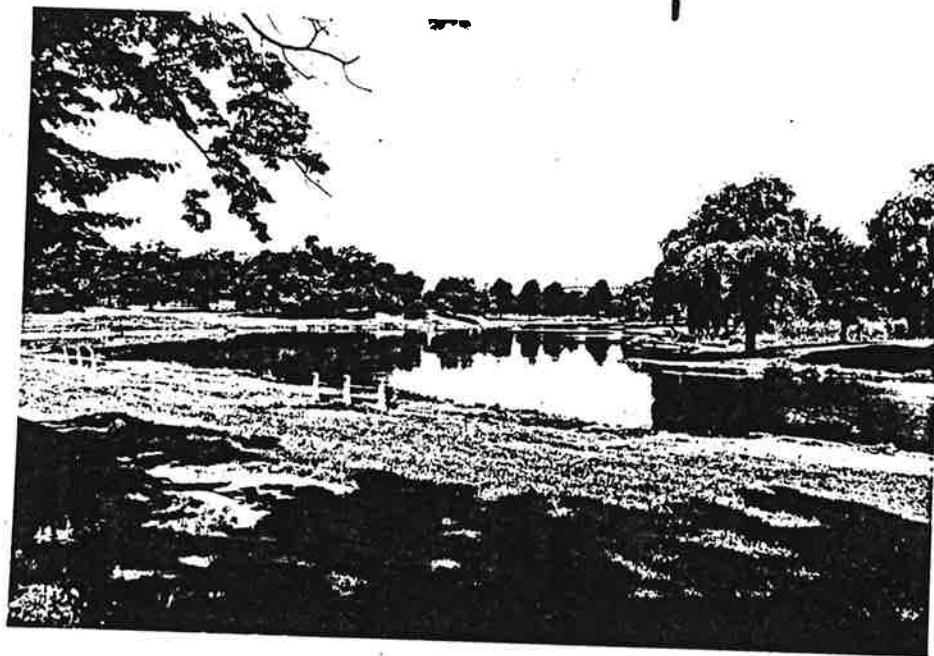
Site No. 0906-B5 lph
Edgewood Pond -
Lincoln Park
Jersey City, N.J.
Photo Neg. No. ²⁰⁵/₃₂
Map No. 5

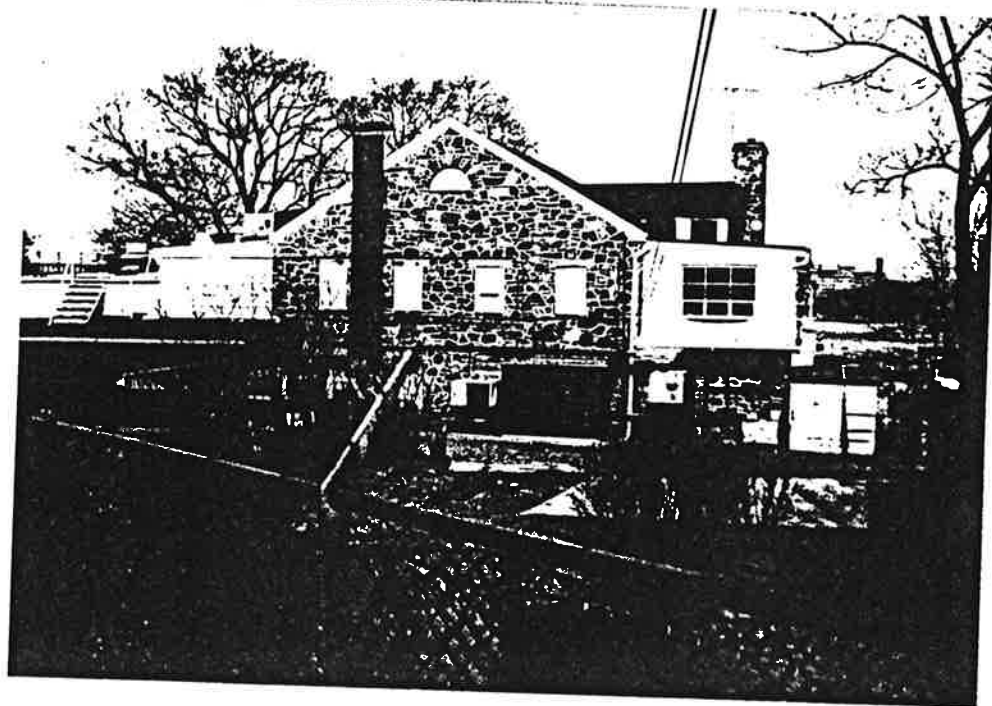
Site No. 0906-B5 lph
Casino in the Park
in Lincoln Park
Jersey City, N.J.
Photo Neg. No. ²⁴⁵/₁₅
Map No. 6

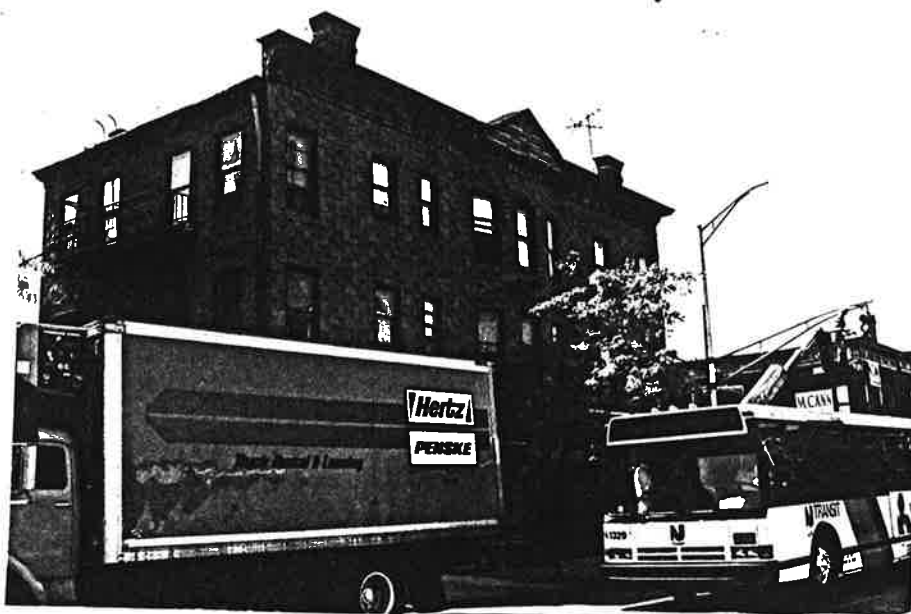
Site No. 0906-B5 wsa
586-584 West Side
Avenue
Jersey City, N. J.
Photo Neg. No. 205/
Map No. 1

MAP #	ADDRESS/LOCATION : PROPERTY NAME	DATE	Significance G/D/S	Condition	USE	DESCRIPTION: Style, Ext. Wall Fabric, Fenestration, Form, Roof, Major Features, Alterations, Stories, etc.	NEGATIVE FILE #
1	584-586 West Side Avenue Block 1807	<i>late 19th - early 20th cent</i>				see under # 800 Bergen Avenue	B5
2	592 West Side Avenue Block 1807	<i>late 19th - early 20th cent</i>	P theme	G C/ R 2		4 story, 5 bay, brick, semi-detached commercial/residential building in the Classical Revival style; commercial ground floor and side, residential entry; 1 over 1 windows with keystones of light masonry; 2 bays in southern side form a slightly projecting, rounded oreole in the second to fourth stories; storefront may retain signage panel and transom beneath existing sign; bracketed cornice with foliate frieze.	Contact 205/35A
3	594-596 West Side Avenue Block 1807	<i>late 19th - early 20th</i>	NA	G R 4		2 identical, attached, 3 story, 2 bay Queen Anne stucco over brick residential building, with 3 sided, 2 story oreoles projecting slightly over ground floor, and terminating in peaked roofs at false mansard level; aluminum replacement windows; ground floor seems to have been converted to residential use.	Contact 205/31A

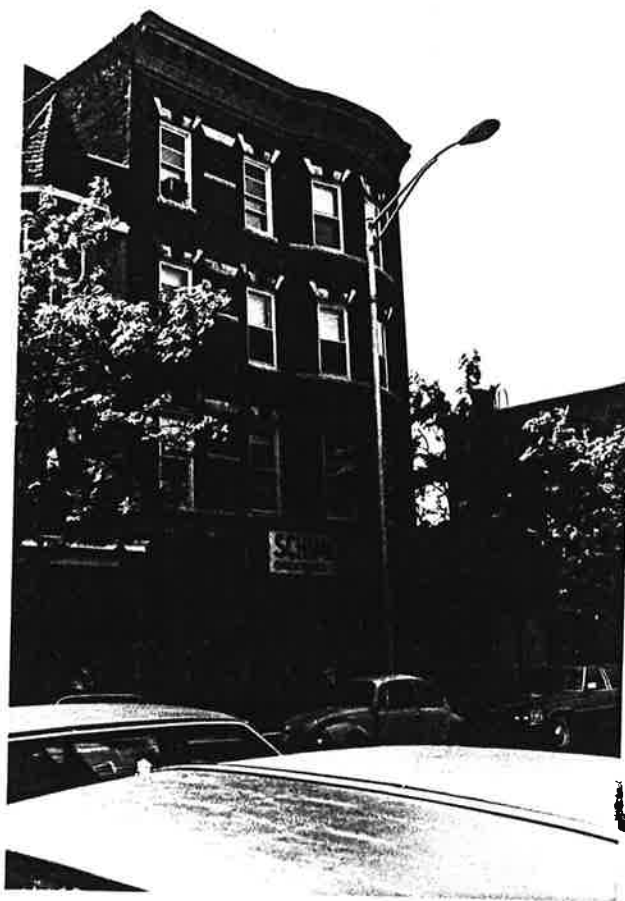
Site No. 0906-B5 wsa
592 West Side
Avenue
Jersey City, N. J.
Photo Neg. No. 205/
Map No. 2-2

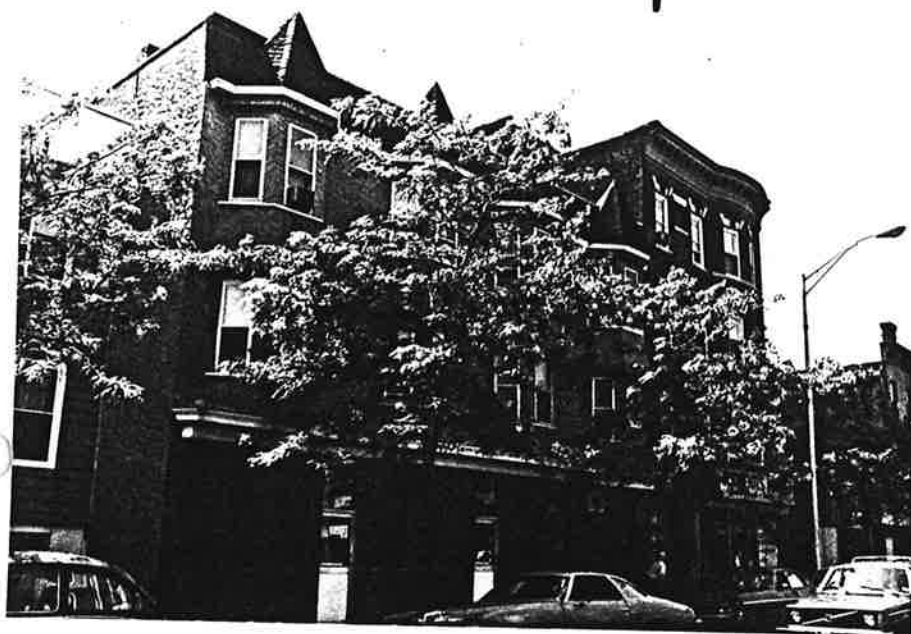
Site No 0906-B5 wsa
596-594 West Side
Avenue
Jersey City, N.J.
Photo Neg. No. 205/
Map No. 3 34A

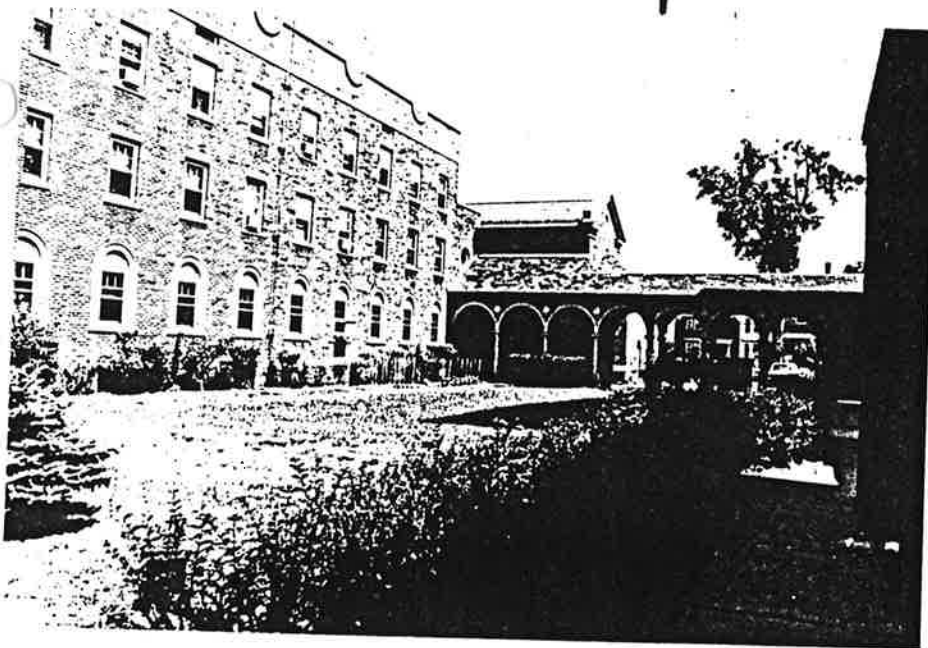
Map No. 4

176-178 Kensington

3-4	691-703 West Side Avenue (a.k.a., 178 Kensington) Block 1702			1926	Y EO complex			St. Aloysius Convent, at 178 Kensington Avenue, n.e. corner Delaware Ave.); brick with stone trim; 1 over 1; rectangular plan; rectangular or arched window enframements in stone; 3 story, 3 bays; arched entry, flanked by multi-paned sidelights, set into stone-faced 2 story arch, with central round window similar to round window of entry door; unornamented stone cornice; brick parapet with semi-circular indentations in stone over window bays; convent joined to school by arcade with round arches, and supported by slender columns with Ionic capitals. Architect Neil Covy of Newark.		Contact 201/30,5
